MIFACE Investigation Report: #10MI075

Subject: Farmer Run Over By Tractor During Idle Adjustment

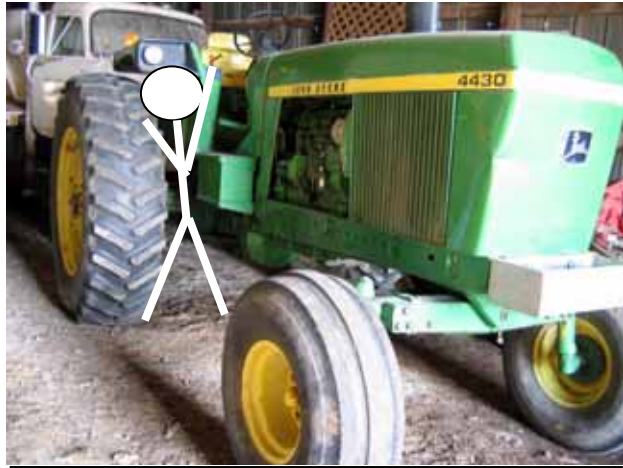
Figure 1. Position of decedent standing in front of rear right tractor wheel

At some point after the coworker departed, the decedent moved the tractor so it was facing south. The tractor was running while the decedent was adjusting the idle with a 10 mm wrench (Figure 3). Based on the decedent's resting position, marks on his clothing and injuries sustained, the decedent position could be ascertained. He was standing on the ground facing the tractor on the tractor's right side, which placed the engine area in front of him with the small front tire to his right and the large right rear tire to his left (Figure 1).

It is unknown if the tractor was in Park or Neutral. It appears that he reached up to activate the throttle. As he reached to pull the throttle back toward him, he faced the right rear tire (Figure 1). Given the configuration of the tractor, he would have been pressed against the rear tire when reaching up to the controls. At some point, he contacted the gear shift lever, pushing it back thus placing the tractor into gear. Because the tractor engine was operating at a high state of idle, the clutch would not need to be depressed to place the tractor in gear. When the tractor was placed into gear, it lurched forward at a high rate of speed leaving spin marks on the barn's concrete floor.

- Engage the tractor parking brakes and block tractor movement if tractor maintenance must be performed with the engine running.

When performing tractor maintenance with the engine running, safe work practice should include setting the tractor parking brakes and block potential tractor movement. To block the tractor movement, two options include: (1) chocking the wheels or (2) raising the back axle and placing the axle on substantial blocking high enough so the rear tires are suspended. Chocking can prevent accidental or unintended equipment movement by providing a physical stopper to the wheels. MIFACE recommends the use of wheel chocks of the appropriate size and material to securely hold the tractor based upon the tractor tire size and weight. Most chocks have the manufacturer's recommended tire size identified on the chock. MIFACE found chock suppliers on the internet that had chocks available for 8-foot tall tires for mining trucks. MIFACE recommends placing a chock against all of the tractor's wheels.

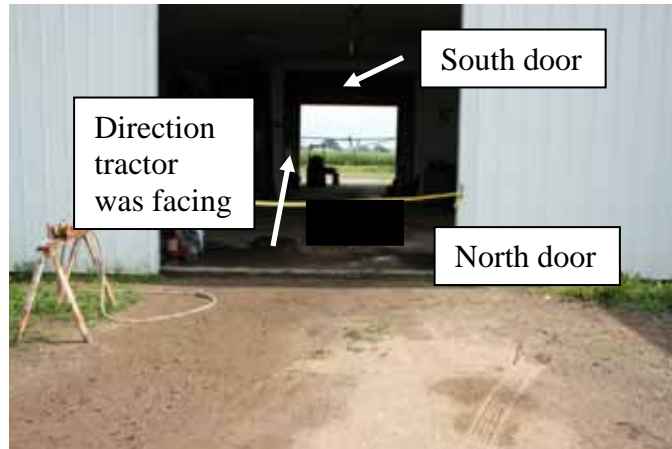
The barn in which the decedent and tractor were located was on the southwest corner of a road. There were two large entrance doors on the barn; one on the north wall and one on the south wall. The barn floor was concrete (Figure 2).

Figure 2. Overview of incident scene.

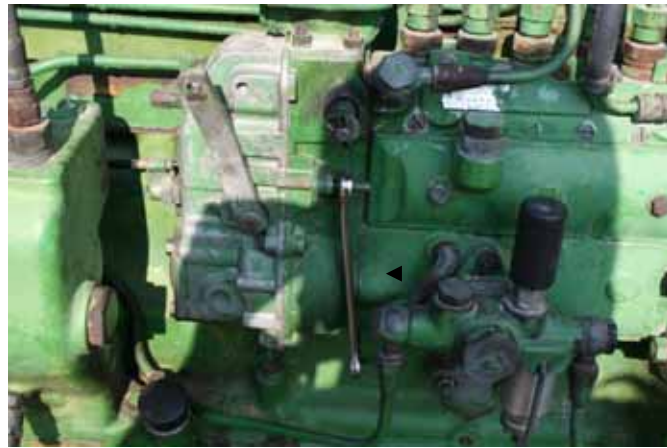
Figure 3. Police re-enactment of work decedent was performing.

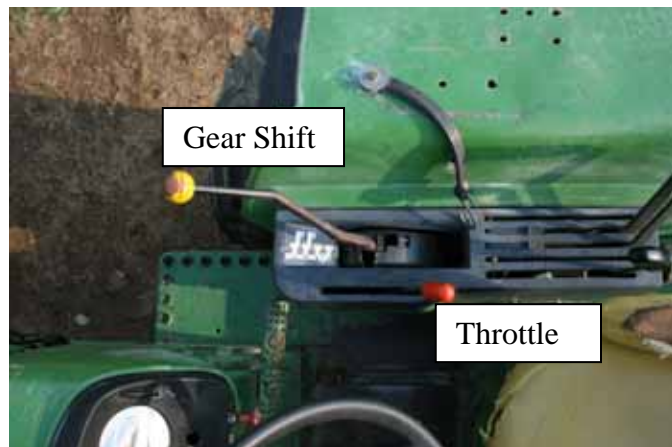
Figure 4. Gear shift and throttle identified. Picture taken from operator's seat.

the tractor's gear level, the operator pulled the gear lever backward toward the driver. From the position where the decedent was working on the tractor it would be possible for him to access both levers from the ground. Because the decedent was standing on the ground facing the tractor, the activation direction of the levers was reversed – the throttle lever activation would be toward him and the gear shift lever activation away from him. The throttle is identified by a red, cylindrical handle and the gear shift has a yellow, round ball handle (Figure 4).

After the incident, the family had the tractor inspected by a mechanic. The mechanic found that the neutral safety switch had been bypassed by the previous owner. According to the family, the decedent was unaware of this safety bypass.

The decedent bought the tractor at an auction without an inspection. He recognized there was a problem with the tractor, but did not have a qualified individual conduct a safety check/inspection to pinpoint the problem. After the incident, a mechanic found that the neutral safety switch was bypassed, thus allowing the engine to be started while the transmission was in gear, instead of allowing the engine to be started only when the transmission was in neutral or park. Prior to using a newly purchased piece of used equipment, MIFACE recommends that the owner have the equipment inspected by a qualified mechanic or dealership mechanic and repaired as required.

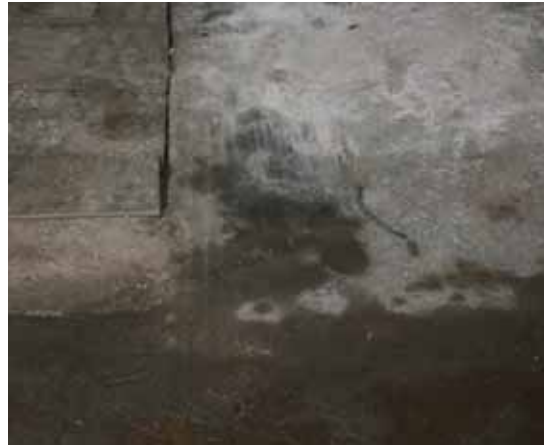
Figure 5. "Spin" marks left by the tractor's rear right wheel

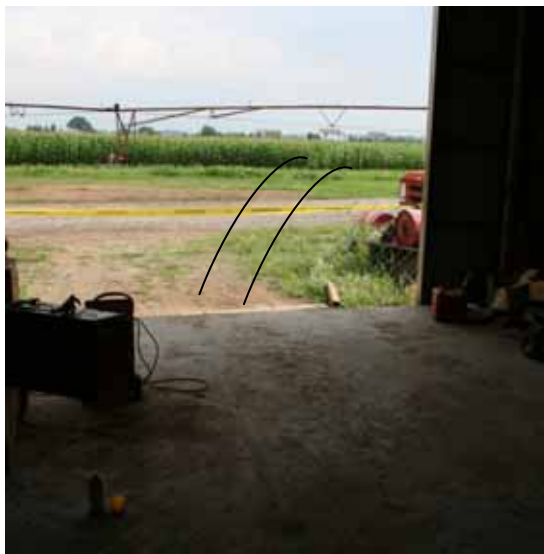
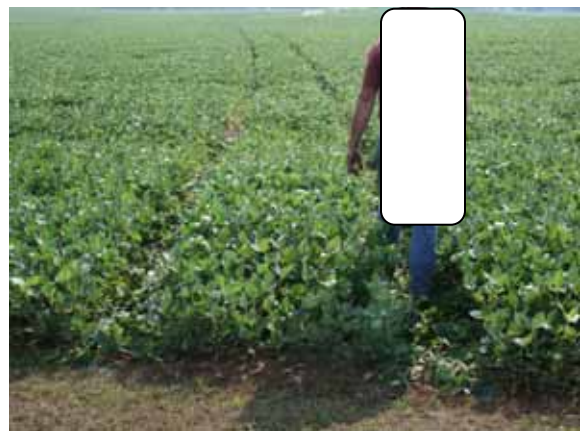
Figure 6. Path of tractor out the south door and arcing into field

Figure 7. Path of tractor across north/south road and into/out of field

Tire tracks on the floor led out the south door and the tractor began drifting to the southwest into a cornfield, and then arced to the north, crossing the road (north barn door faced this road) and continued into the field across from the barn. The tractor continued its arced path of travel through this field, and

then passed between two houses, crossed a north-south road, and finally came to rest against a tree approximately one-third of a mile from the barn (Figures 6 and 7).

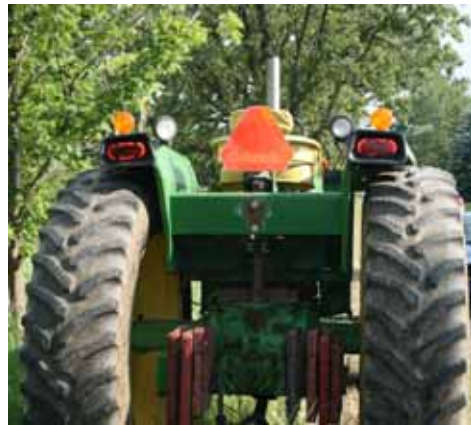
Figure 8 shows the unguarded PTO stub, faded SMV emblem, and lack of a ROPS on the decedent's tractor. Although the lack of and/or condition of these safety features were not a factor in this incident, tractor owners should ensure that shields are re-installed, faded SMV emblems are replaced, and determine if a tractor can be retrofitted with a ROPS.

Figure 8. Incident tractor showing lack of PTO master shield and ROPS and faded SMV.

- Routinely inspect tractors to identify potential safety issues, such as old/faded SMV emblems, missing PTO master shield, and roll-over protective structure (ROPS) availability. Install/re-install missing or damaged items.
