# MIFACE Investigation Report #10MI144

## Subject: Hispanic Roofer Dies After Falling Through an Improperly Secured Roof Hatch Cover

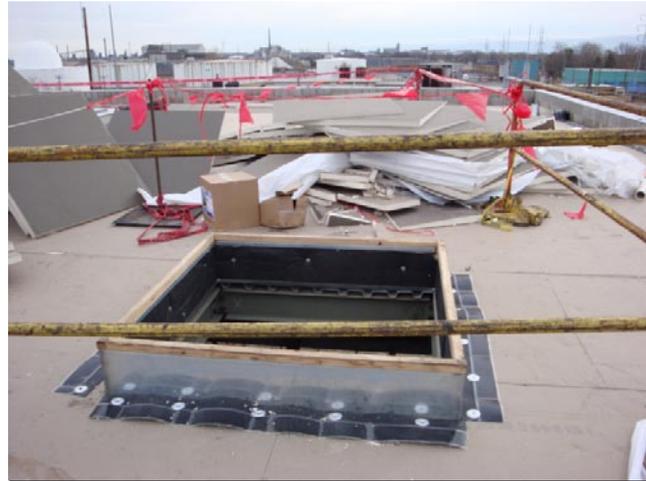
Figure 1. Roof hatch involved in incident. Note nearby pile of insulation sheets.

The incident occurred in the southeast corner of the roof. The roof cover involved in the incident was 22-gauge sheet metal, which was not secured. The sheet metal had the word HOLE written upon it in orange paint.

Located near the incident roof hatch was a pile of insulation sheets. At approximately 9:30 a.m., the decedent was assisting the foreman in moving the insulation sheets to the appropriate area of the roof for engineered roof drainage.

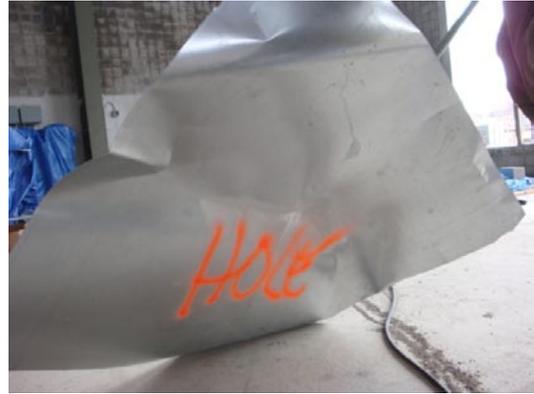
Figure 2. The word HOLE written in orange paint on top of the sheet metal cover involved in the incident.

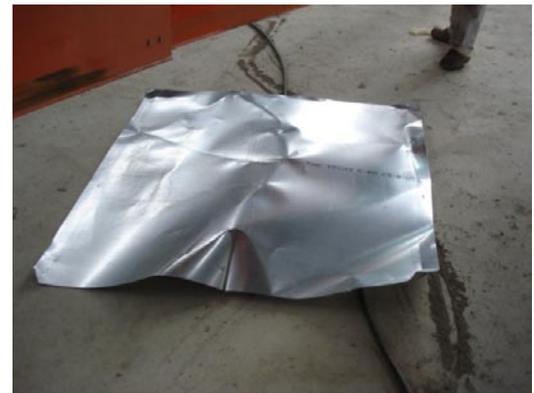
The foreman indicated that the decedent had lifted a sheet of insulation. The foreman heard a noise, turned around, and witnessed the decedent fall on the metal cover. The foreman attempted to grab the decedent without success. The cover gave way and both the cover and the decedent fell 48 feet to the concrete floor below.

Figure 3. Sheet metal cover after it fell 48 feet to the ground.

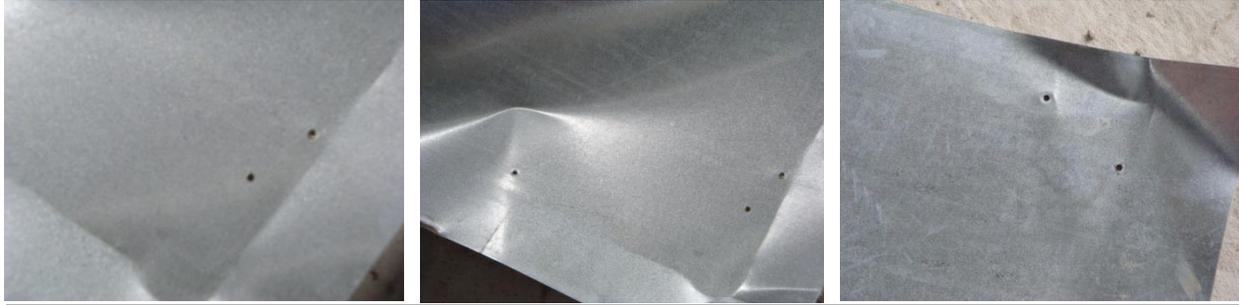
Covers were not capable of supporting without failure, at least twice the weight of employees, equipment and materials that may be imposed on the cover at any one time. Employees engaged in roofing activities. Distance to lower level approximately 48 feet. There were eight 60-inch by 60-inch covers cited by the MIOSHA compliance officer.

Employees engaged in roofing activities did not have covers secured to prevent accidental displacement by wind, equipment, or employees. Employees engaged in roofing activities. Distance to lower level approximately 48 feet. There were nine 60-inch by 60-inch covers cited by the MIOSHA compliance officer.

not utilize the traditional type of covers (plywood and corrugated metal); instead, they utilized 22-gauge sheet metal on eight covers and corrugated metal on only one cover. The covers were not secured with fasteners.

During the conduct of their post-incident investigations, MIOSHA and investigating police did not find any fasteners on the sheet cover involved in the incident, or on the ground and roof. The hatch cover had no tears or other abrasions as a result of the decedent's fall.

Figures 4-6. Absence of fasteners on sheet metal cover.

After incident, several of the decedent's coworkers moved guard rails to secure the open hatch. They also placed scraps of old deck to the tops of the remaining roof covers after the incident. Additional pieces of metal installed over the sheet metal – metal was staggered since they weren't long enough to span curb, and then screwed in place with a screw gun.

Ensuring the use of personal fall arrest systems, standard guardrails or covers secured against displacement and labeled as required by MIOSHA Construction Safety Standard, Part 45, Fall Protection would have prevented this tragedy.

Contracts should include language that states that at the time the openings are made in the roof, the firm making the roof opening should be required to install covers which are secured in place and clearly labeled, so that other work crews on the roof will not be exposed to the potential fall hazard.
