Timber Harvester Operator Killed Following a Chain Shot Incident

Investigation: # 10WA04801
Release Date: 02-24-2014
SHARP Report: # 52-30-2014

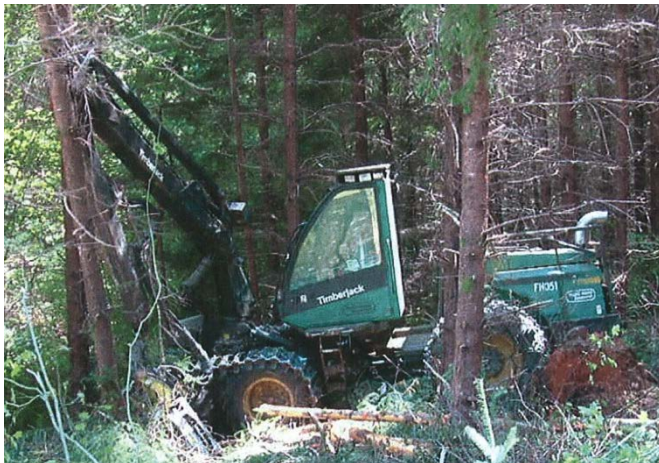
The machine involved in the incident was a 1996 Timberjack 1270B single grip harvester matched with a Timberjack 762C harvester cutting head (see photo 1). The harvester is designed to fell, limb, and cross-cut trees. The machine was purchased used, came with all service manuals, and the employer reviewed all maintenance records.

Photo 1: Timberjack 1270B harvester used by the operator.

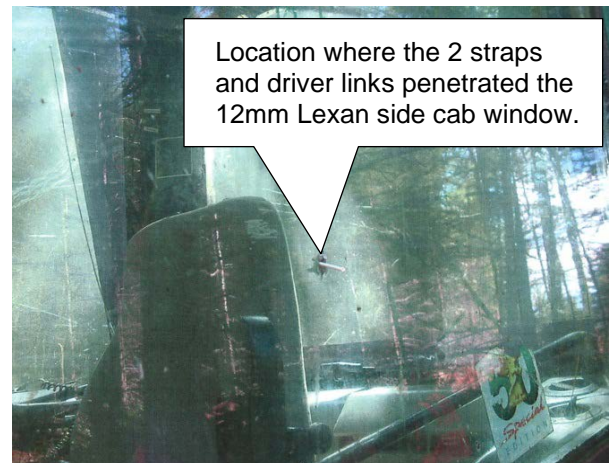
The cab window to the Timberjack harvester was made of 12mm polycarbonate made by Lexan (see photo 2). The harvester cab window model was a Lexan Margard MR5E. According to the Product Data Sheet (PDS) the Lexan Margard MR5E has 250 times the impact strength of glass and 30 times that of acrylic.

Photo 2: 12mm Lexan left side cab window that was penetrated by the two straps and driver link.

When the chain broke, a portion of the chain hit the snow hole at the front of the saw. The chain shot occurred before the saw left its housing to cut the log, as evidenced by the lack of saw marks on the tree it was processing. It is believed by the employer and the DOSH inspector, that this caused the chain shot of the three links in the direction of the cab. Two of the three chain links hit the Lexan 12 mm window and did not penetrate. The third chain link, consisting of two straps and one driver, penetrated through the left side cab window at approximately a 30 degree angle and hit the operator, cutting his left carotid artery before being embedded in his right shoulder.

The employer did retrofit some of their processor cabs with thicker, more protective, Lexan windows. This was not done for their harvester cabs for two main reasons. First, the harvester front cab window is curved. Thicker aftermarket replacement versions of the curved front window specific to this model harvester are not available. Second, the manufacturer did not support the change. According to the employer, the manufacturer does not approve of upgrading the cab windows due to concerns about the effects on the cab's operator protection structure (OPS).

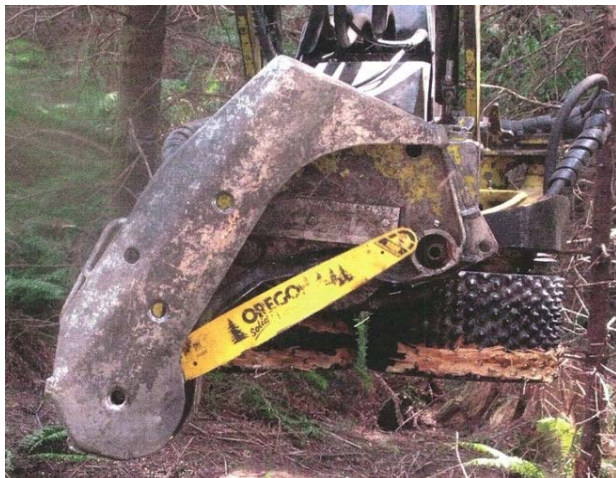
The cutting head was equipped with a chain catcher and chain shot arrestor on the heel of the bar drive to serve as a guard in case the chain breaks, but there were no guards on the tip end of the saw to prevent chain shot. The saw box that holds the saw was equipped with snow holes to prevent snow from building up in the saw area.

Photo 3: Timberjack 762C cutting head and Oregon roller tip 18H bar.

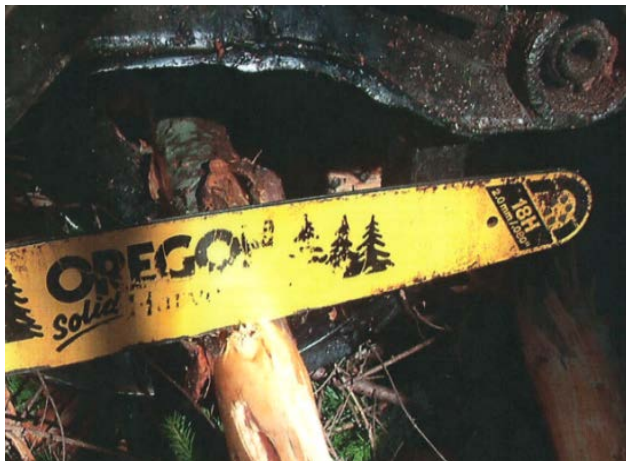
The saw on the cutting head consisted of an Oregon roller tip 18H saw bar with an 80 gage Carlton chain with a pitch of .404* (see photo 4). According to the employer, the saw moved at up to 8,000 revolutions per minute (RPMs) and was equipped with an auto tensioner. The auto chain tensioner would re-tension the chain after each cut.

Photo 4: Photo of Oregon 18H roller tip saw bar involved in the incident.

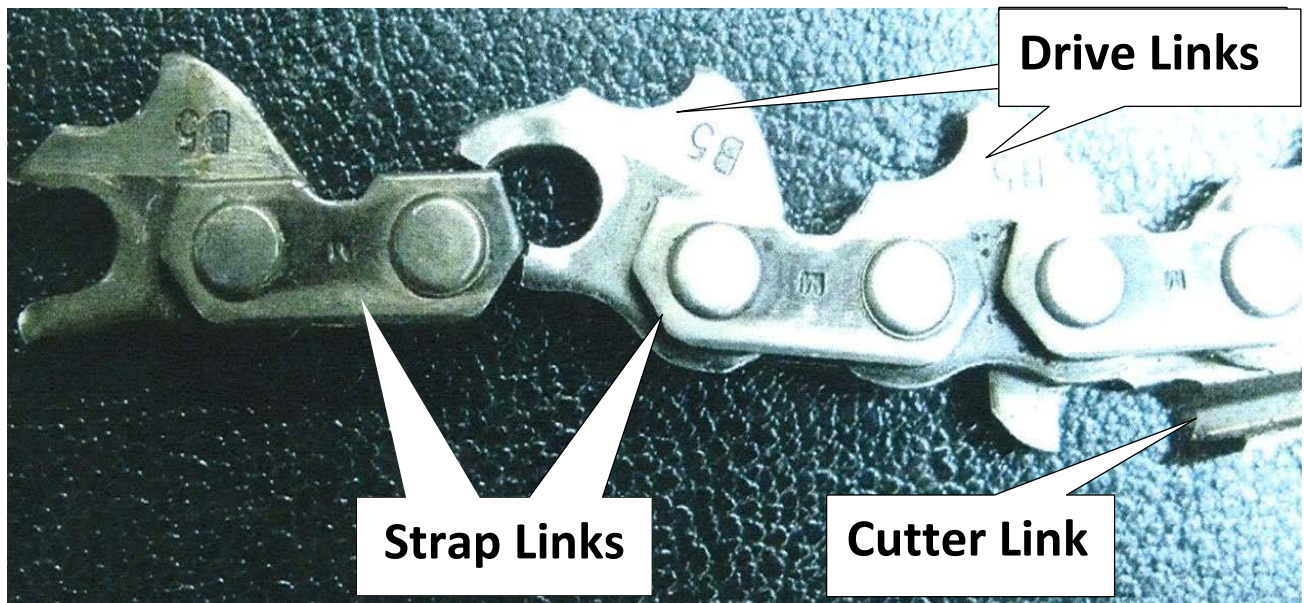
The chain on the Oregon 18H roller tip bar was an 80 gage Carlton chain with a pitch of .404. The chain sections involved in the fatal chain shot were a driver link and 2 strap links (see photos 6 and 7). A drive link is the portion of the chain that fits into the saw's guide bar; the strap link connects the cutter links to the drive links.

Photo 6: Carlton 80 gage chain with .404 pitch involved in the incident with arrows pointing out different chain links.

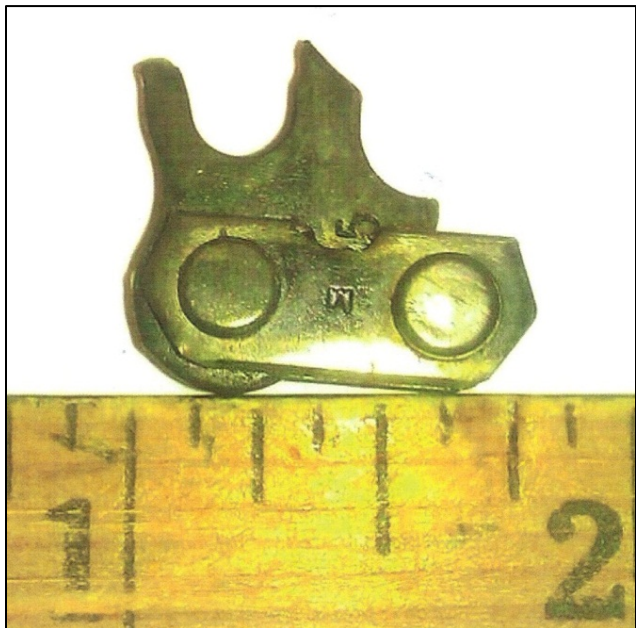
According to the HR manager, the total weight of the two straps and driver link that struck the operator was 102.6 grains (approximately 6.65 grams). According to the chain manufacturer's specifications, the fatal links could have been traveling at speeds up to 310 m/sec (approximately 694 miles/hour) when they struck the 12mm polycarbonate cab window.

Photo 7: The driver and 2 strap links that struck the operator.

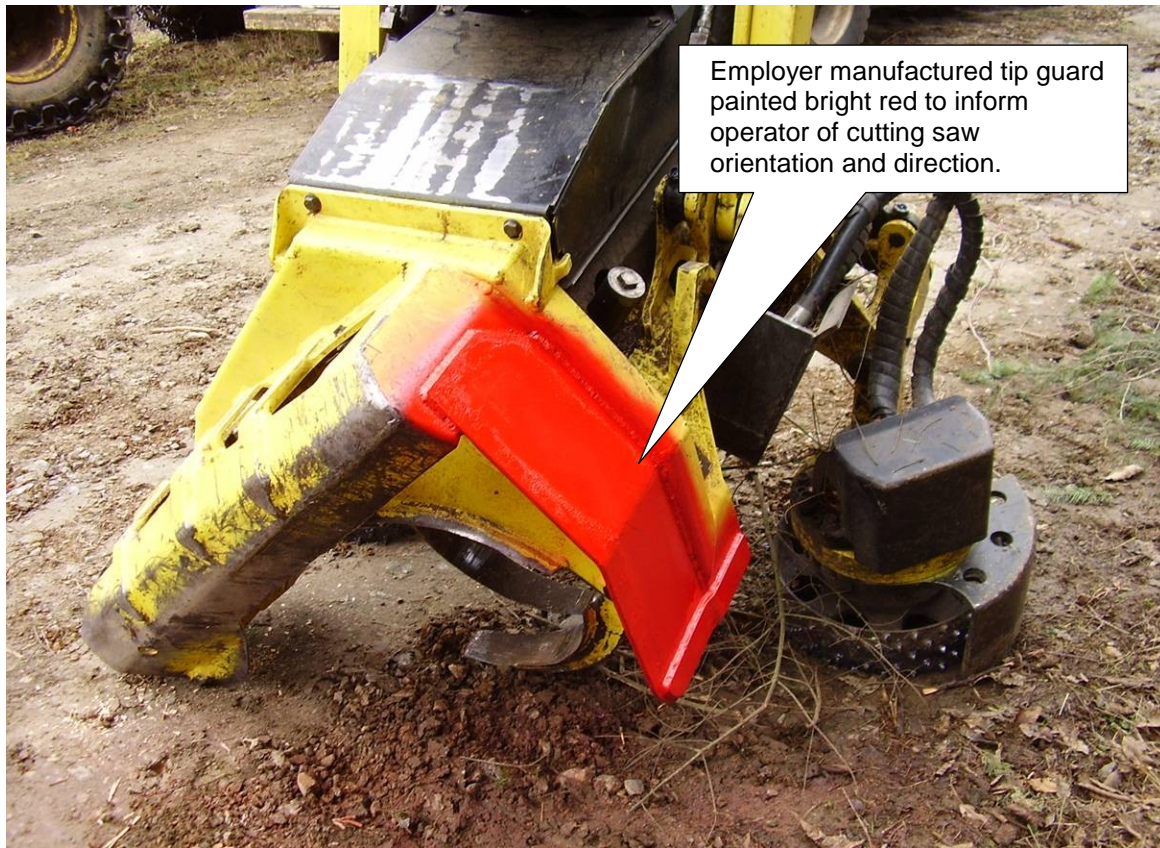
Photo 9: Tip guard manufactured by the employer after the incident. The design of the guard is intended to force any occurrence of chain shot down towards the ground.

The employer has created and attached a tip guard for the cutting saw. The tip guard is intended to direct chain shot or other propellant from the tip of the cutting saw to the ground. The employer also covered the snow holes on the cutting head. Covering the snow holes prevents chain shot from flying out one of the holes. According to the employer, the snow holes are not necessary for the environment that the company works in.

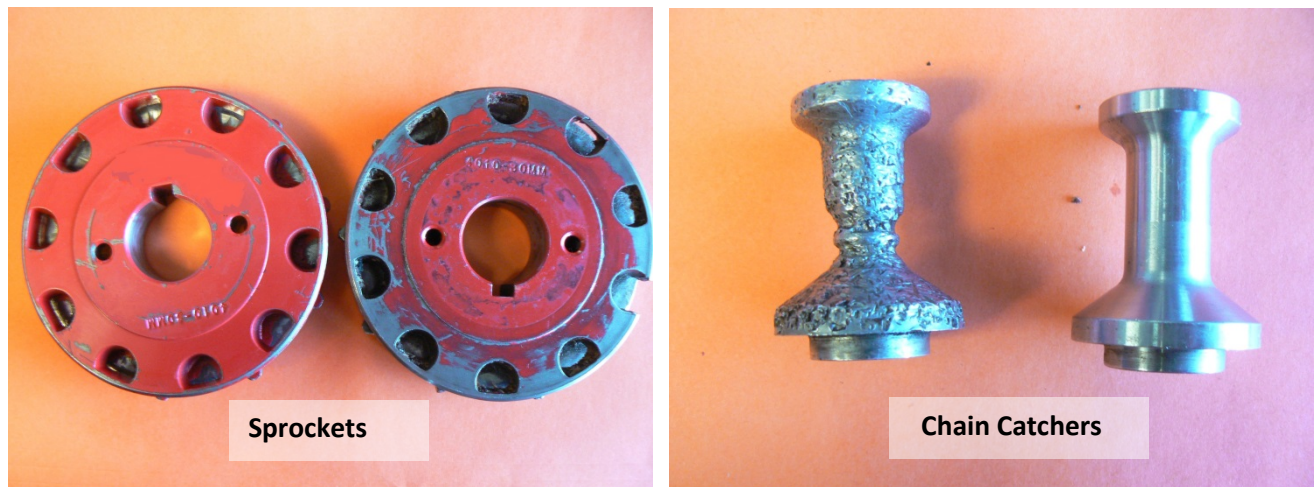
Photo 16 and 17: Used sprockets and chain catcher. The sprocket on the left is worn and was changed at the appropriate time. The sprocket on the right is worn and was run too long. The chain catcher on the left is an example of one that needs to be replaced, while the chain catcher on the right is new.

The employer also became more diligent about inspecting and changing out worn parts on a machine's cutting system. Chain shot guards including the chain catcher and chain shot arrestor as well as sprockets need to be routinely inspected and replaced when worn or damaged (see photos 16 and 17). The employer trains equipment operators to inspect their equipment daily while out in the field. Machinery operators are trained to inspect specific parts and how to identify signs of wear or damage.
