SUBJECT: An Automotive Mechanic Dies from Thermal Burns when the Gasoline He was Pouring into a Vehicle Ignited

SUMMARY
California FACE Report #11CA006

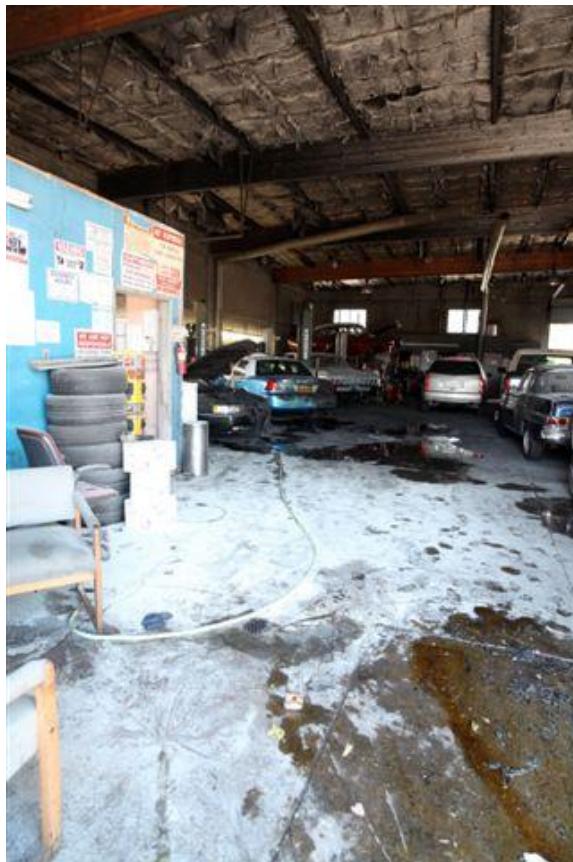
Exhibit 1 - The incident scene viewed from the entrance to the shop.

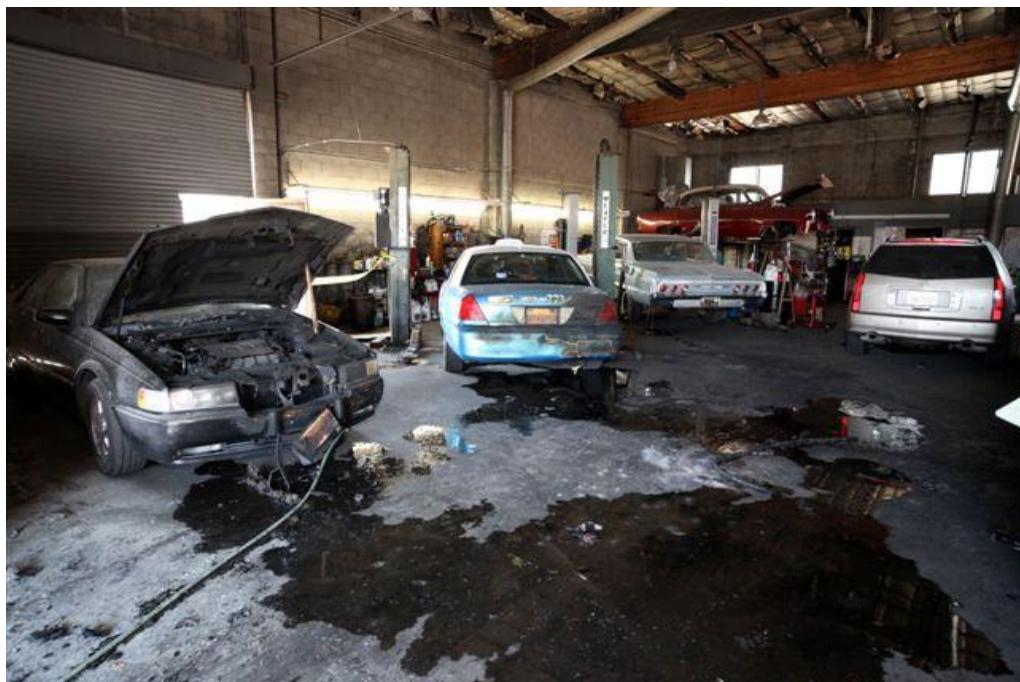
Exhibit 2. Vehicles damaged by the fire.

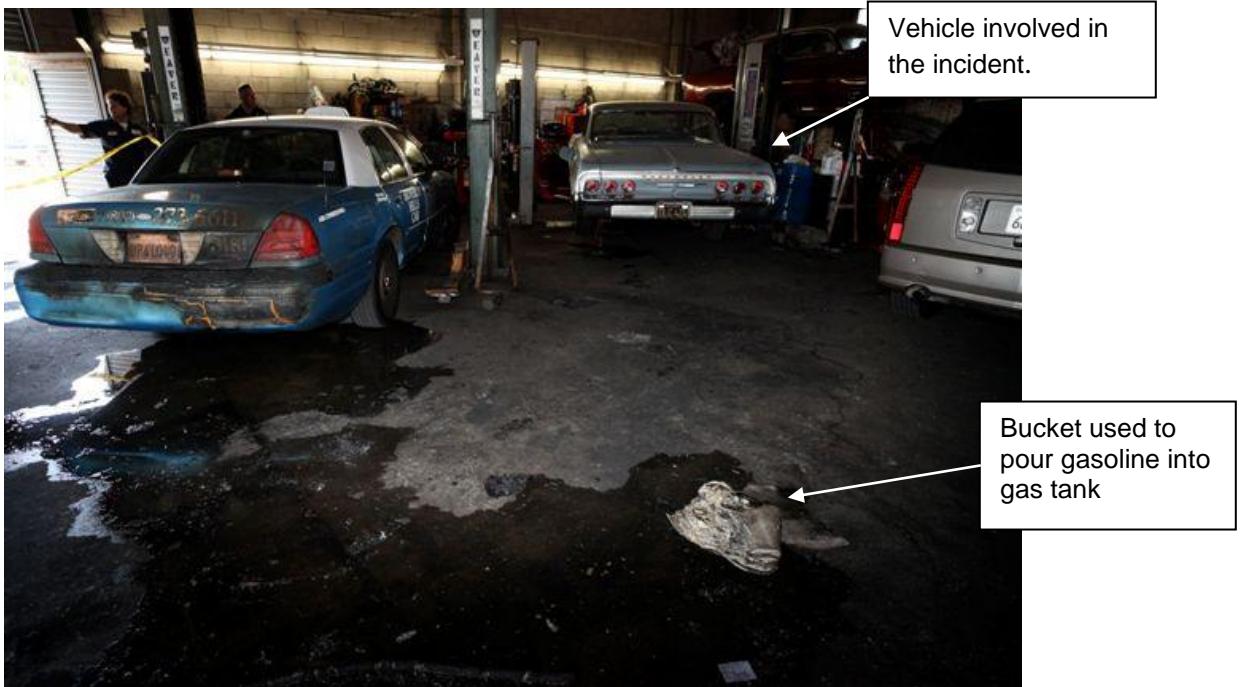
Exhibit 3. The vehicle involved in the incident.

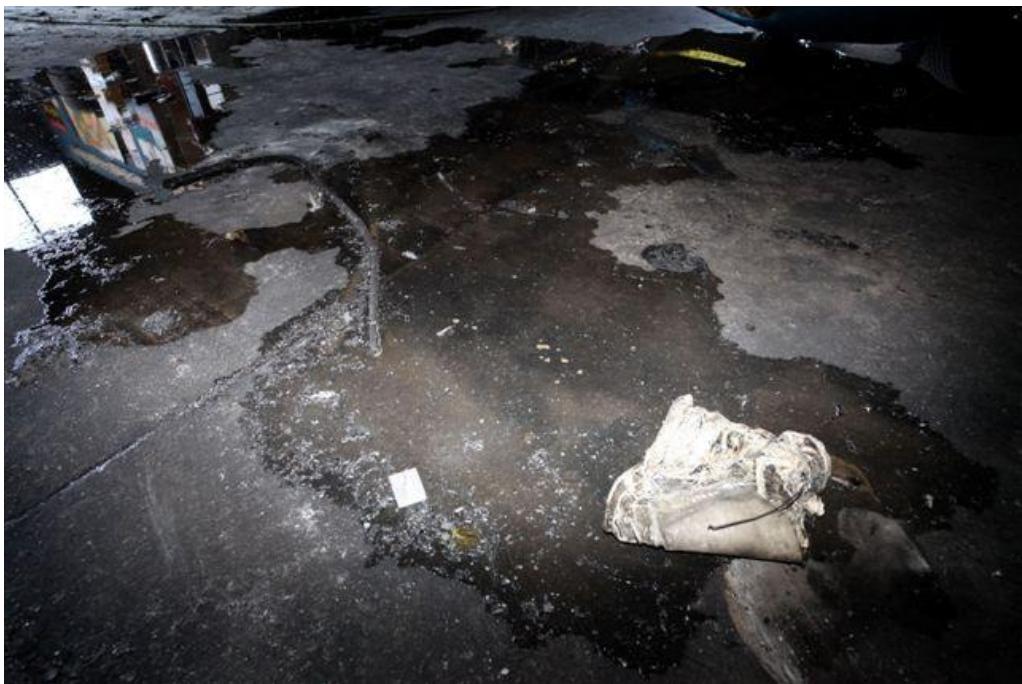
Discussion: In this incident, the victim used a plastic five-gallon bucket to refuel the vehicle. When he attempted to pour gasoline from the bucket into the vehicle, it spilled on the vehicle's tank and fender and onto the drop light hanging directly below the tank, which ignited the fuel vapors. As he ran away from the vehicle with the bucket of gasoline, he spilled fuel. This spilled fuel caught fire and then ignited the fuel in the bucket, engulfing the victim. An approved safety container equipped with an automatic closing cap and flame arrester prevents fuel from splashing out and flames from getting in. Had the victim used an approved container, the fire might have still occurred, but the container would have been protected and he probably would not have suffered fatal injuries.

Exhibit 4 - The remains of the bucket used to pour gasoline into the vehicle.

Recommendation #2: When refueling vehicles with a portable container, the container should be equipped with an automatic closing cap and flame arrester.

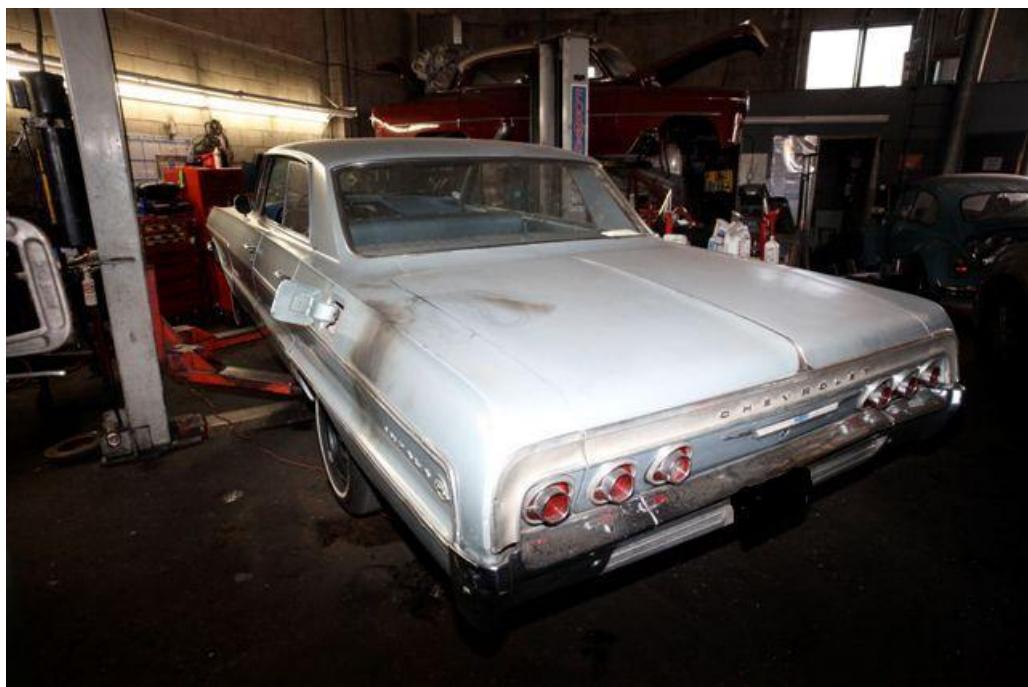
Exhibit 5 - The vehicle involved in the incident.

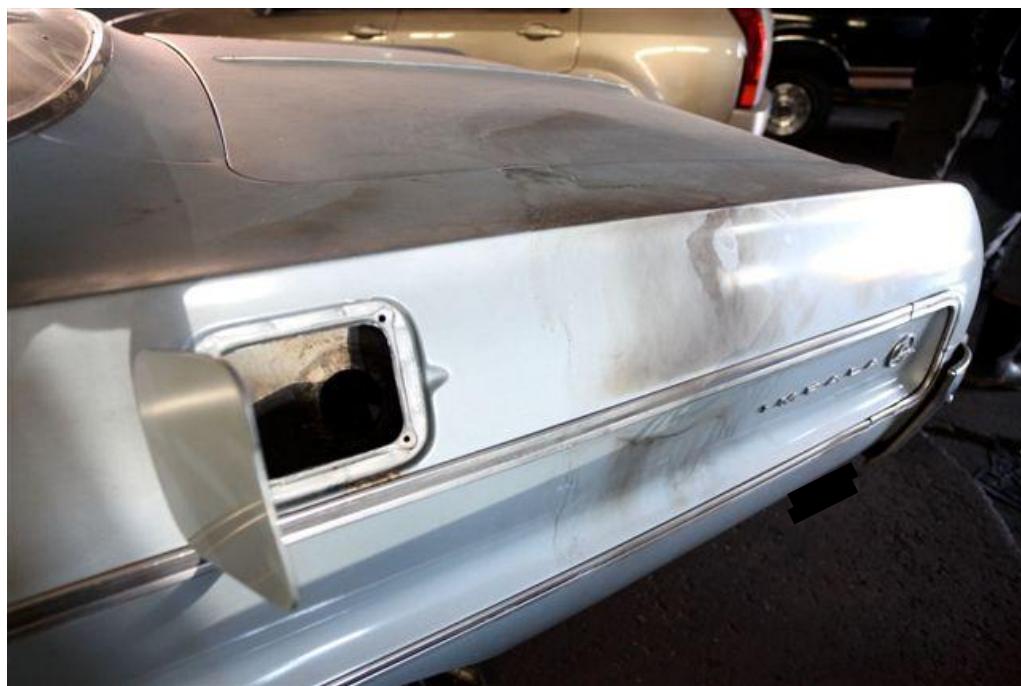
Discussion: In this incident, the victim installed a new gasoline tank in a vehicle but didn't attach the filler hose from the tank to the vehicle. A filler hose is important to the refueling process because it provides a safe and direct route to the tank where the likelihood of spillage would be minimal. Without a filler hose, the fuel would splash over the tank and fender of the vehicle allowing gasoline vapors to escape and possibly ignite if there is an ignition source close by. Had the victim inspected his work prior to adding fuel to the tank, he would have noticed the missing filler hose and likely prevented this incident.

Exhibit 6 - The vehicle's fuel tank inlet.

Recommendation #3: Gas tanks are properly installed before refueling.

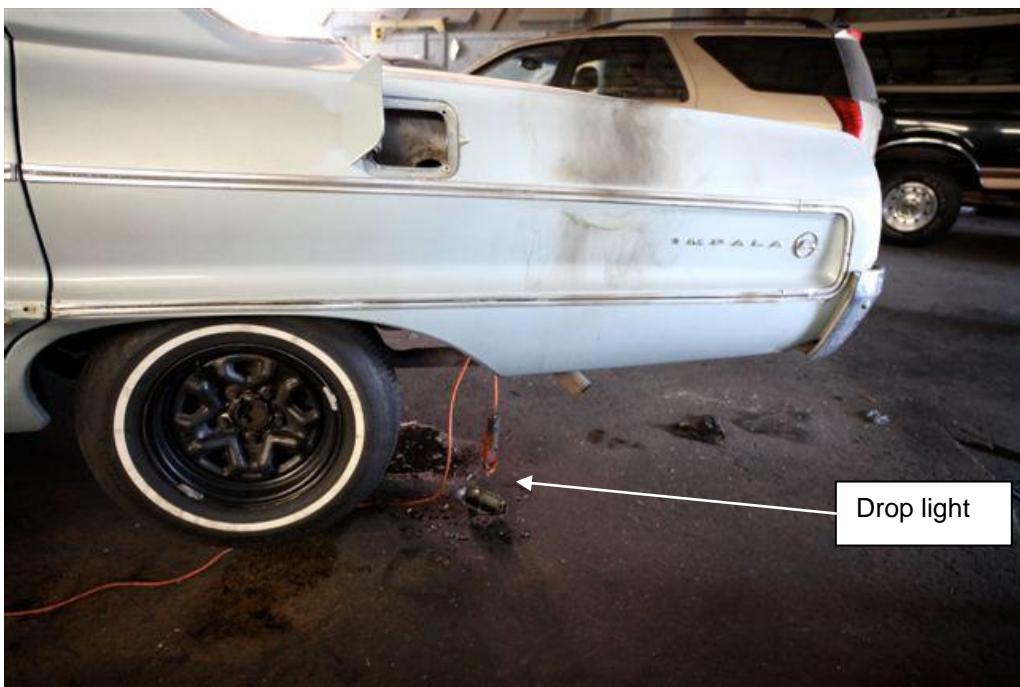
Discussion: In this incident, the victim was using a drop light with an incandescent light bulb under the vehicle while it was raised on the lift. The drop light was still under the vehicle when he lowered the lift. When he attempted to pour gasoline into the vehicle's gas tank, it spilled onto the drop light and immediately ignited. When lowering an automotive lift, the area under it should always be kept clear of tools, parts, and materials so as to avoid any damage to the item, the vehicle on the lift, or the lift itself. If illumination is absolutely required in proximity to a fueling operation, an explosion/ignition-proof or intrinsically safe drop light should be used.

Exhibit 7. The drop light that was left hanging under the vehicle when the automotive lift was lowered.

Recommendation #1: Sources of ignition are eliminated when work involves flammable liquids.

Explosion/ignition-proof lights enclose the bulbs in a case that can withstand the force of the bulbs exploding and they prevent substances from reaching the bulbs where high temperatures might cause them to ignite. Intrinsically safe lights do not reach the temperatures or allow the sparking necessary for fuel ignition. If the victim used this type of drop light or had removed the drop light from under the vehicle prior to lowering the lift, this incident could have been prevented.

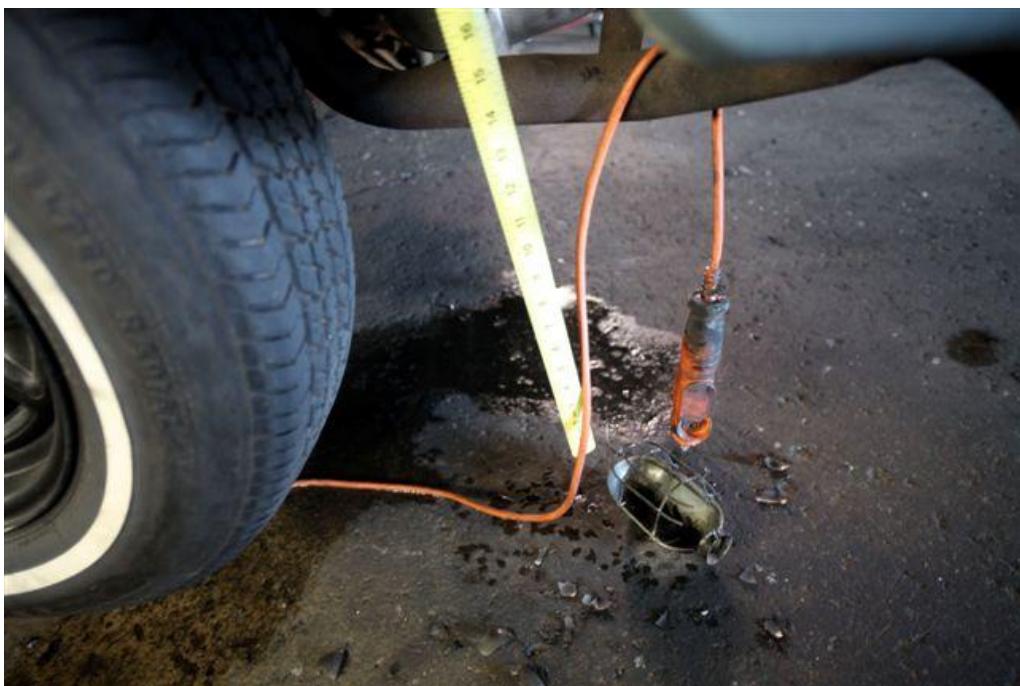
Exhibit 8. Close-up of the drop light.

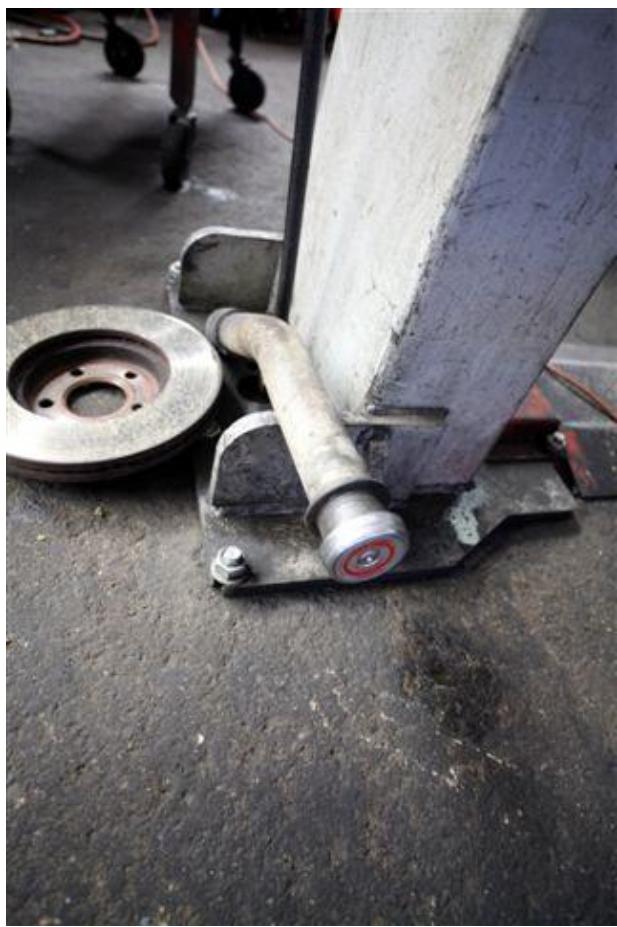
Exhibit 9. The gas tank filler hose.

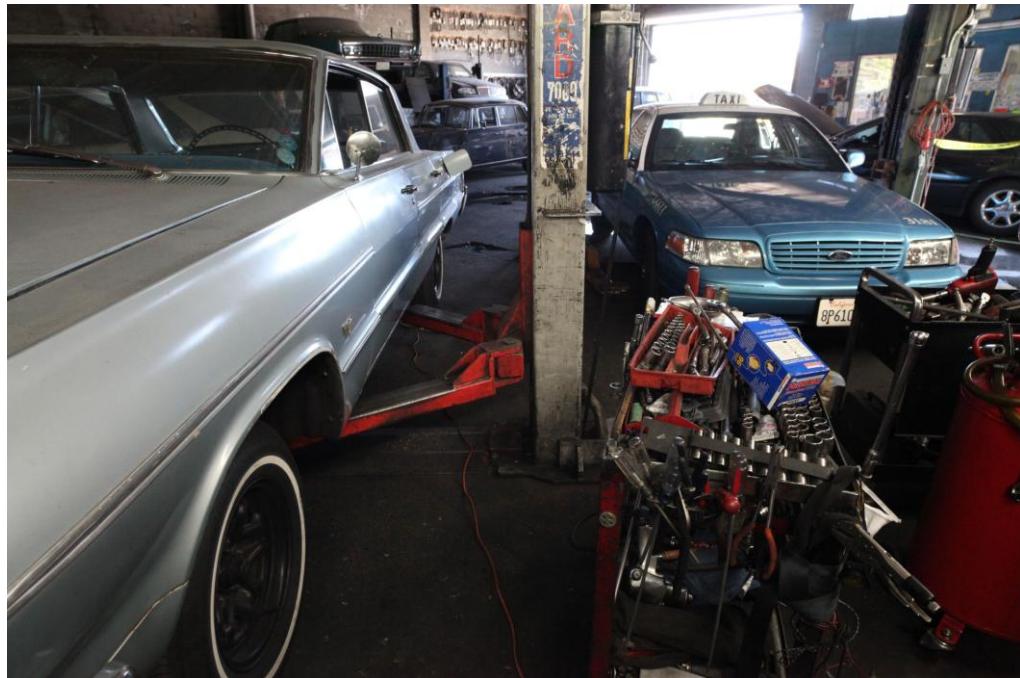
Exhibit 10. The distance from the vehicle to the shop's main entrance.
