FROM: California Fatality Assessment and Control Evaluation (CA/FACE) Program

SUBJECT: A Laborer Dies When He is Crushed by an Industrial Washing Machine

SUMMARY
California FACE Report #11CA007

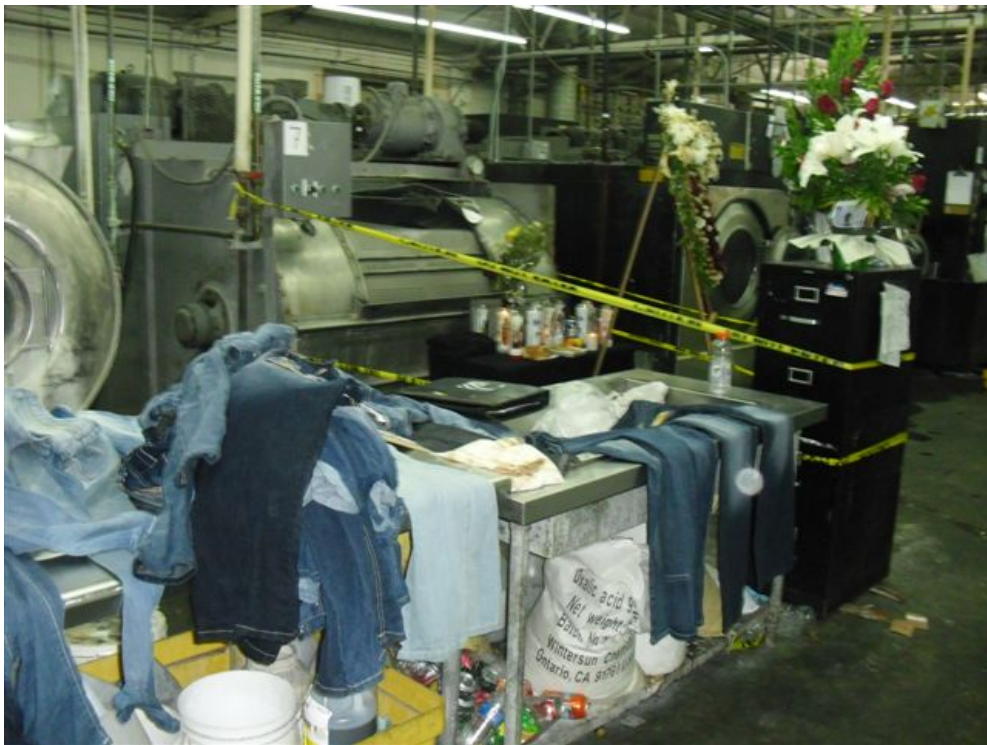
Exhibit 1. The work area where the incident occurred.

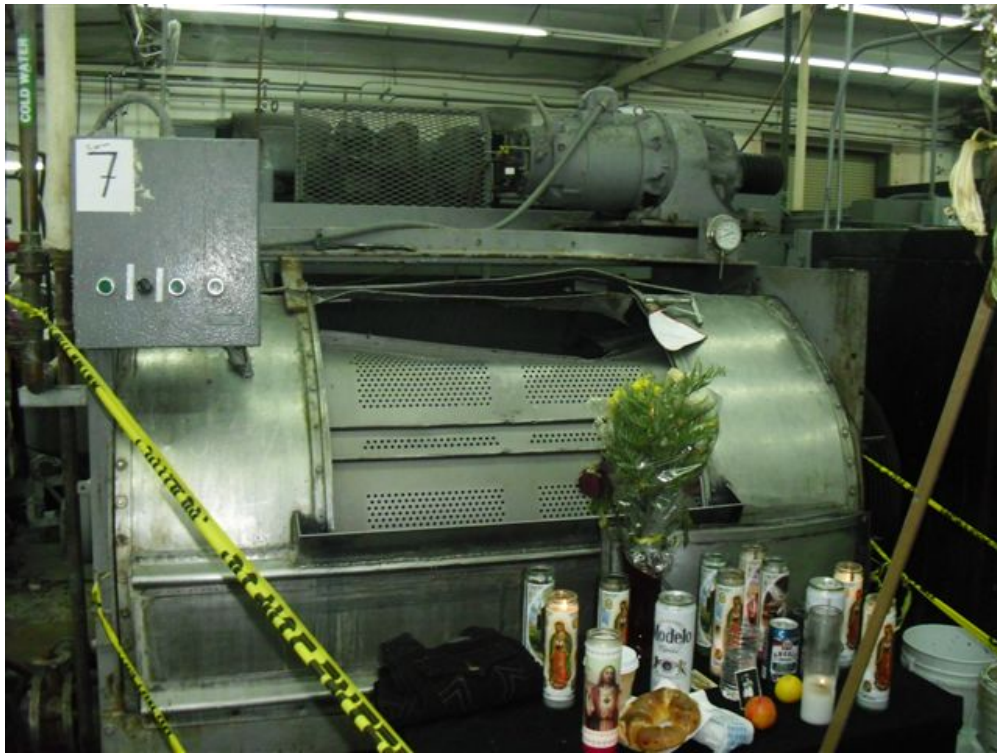
According to the victim's supervisor, the washing machine involved in this incident had been out of service for about a six-month period approximately a year prior to the incident. One of the brackets that held the horizontal drum was broken, the drum wasn't aligned properly within the machine structure, and the machine leaked water every time it was used. The employer would only use this machine when the work load demanded it. The supervisor stated that the employer was aware that the safety interlock wasn't working properly.

Exhibit 2. The industrial washing machine involved in the incident.

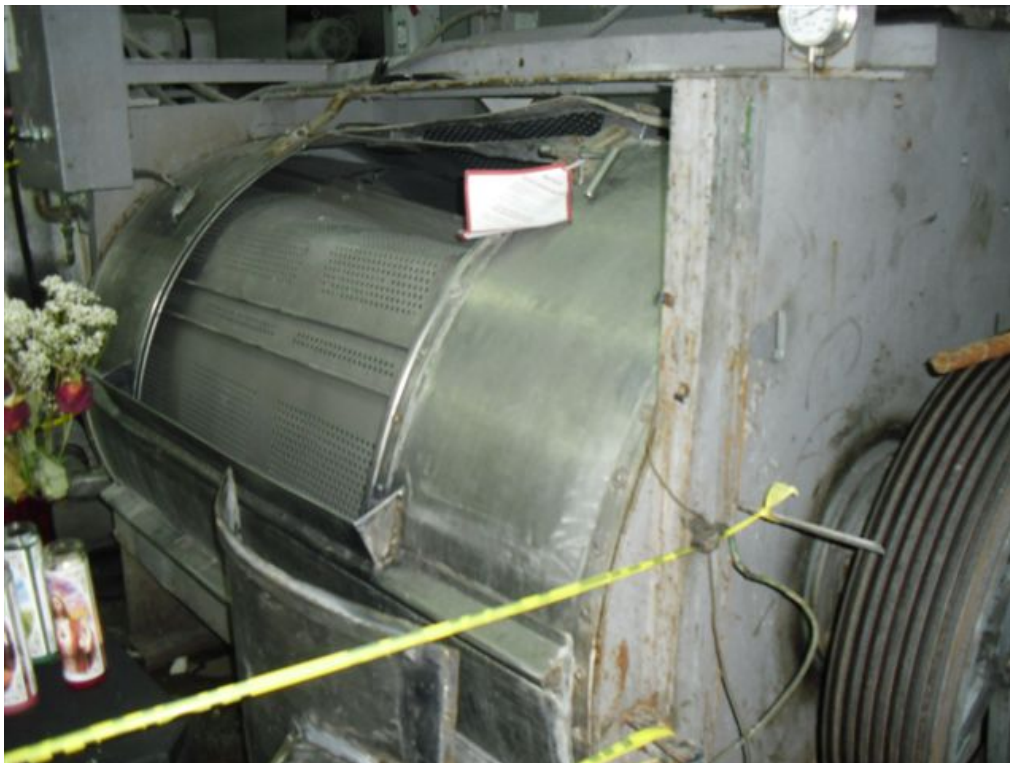
The washing machine had two doors to gain access to the horizontal drum. The outside door, which slid upward, was located on the outside frame of the machine. The inside door was located in the center of the drum. It opened upward after it was aligned with the outside door. The process to align both doors required the horizontal barrel to be "jogged" either upward or downward by manipulating the buttons on the control panel. The washing machine also had a safety interlock which was designed to disconnect the electrical power to the motor during wash cycles when the doors were open so that workers could not enter the machine while the machine was running. The safety interlock was inoperable at the time of the incident.

Exhibit 3. The industrial washing machine with the sliding door open, exposing the inner rotating barrel.

and wait for him to perform the repair or maintenance. If documentation for the manufacturer's specifications is not available, then any repair or maintenance should be directed by an engineer with knowledge and experience in the operation of that machine. Had the safety interlock on this washing machine been in proper operating condition, the machine would not have started when the supervisor turned the cycle switch, and this incident might have been prevented.

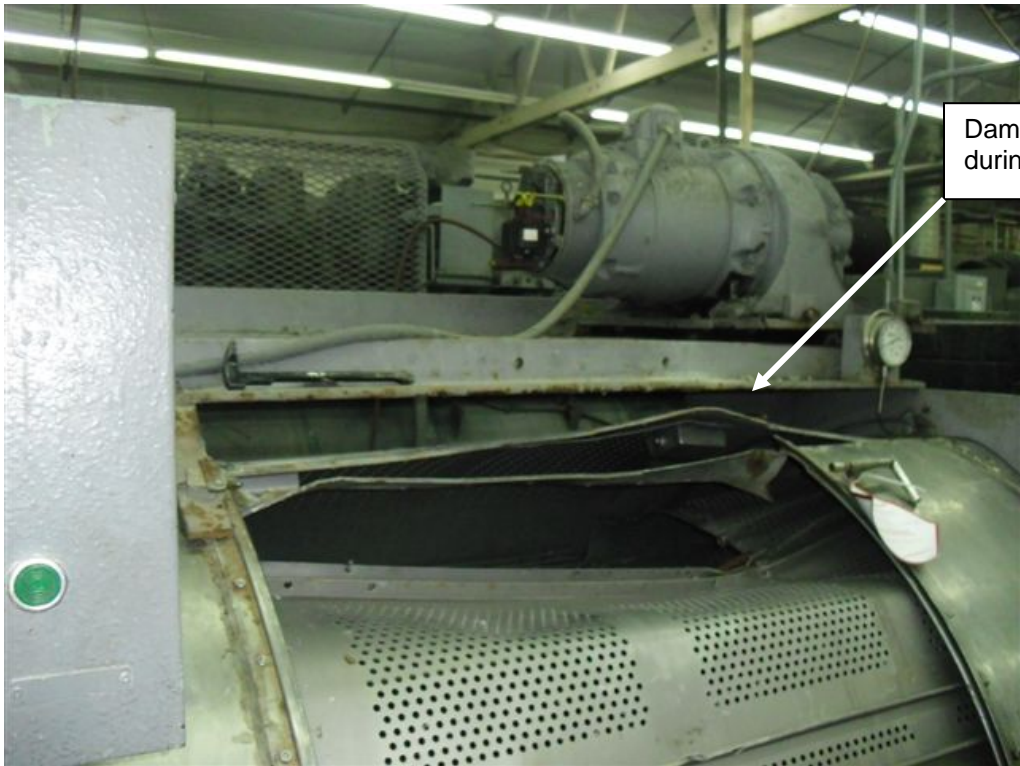
Exhibit 4. The industrial washing machine opening.

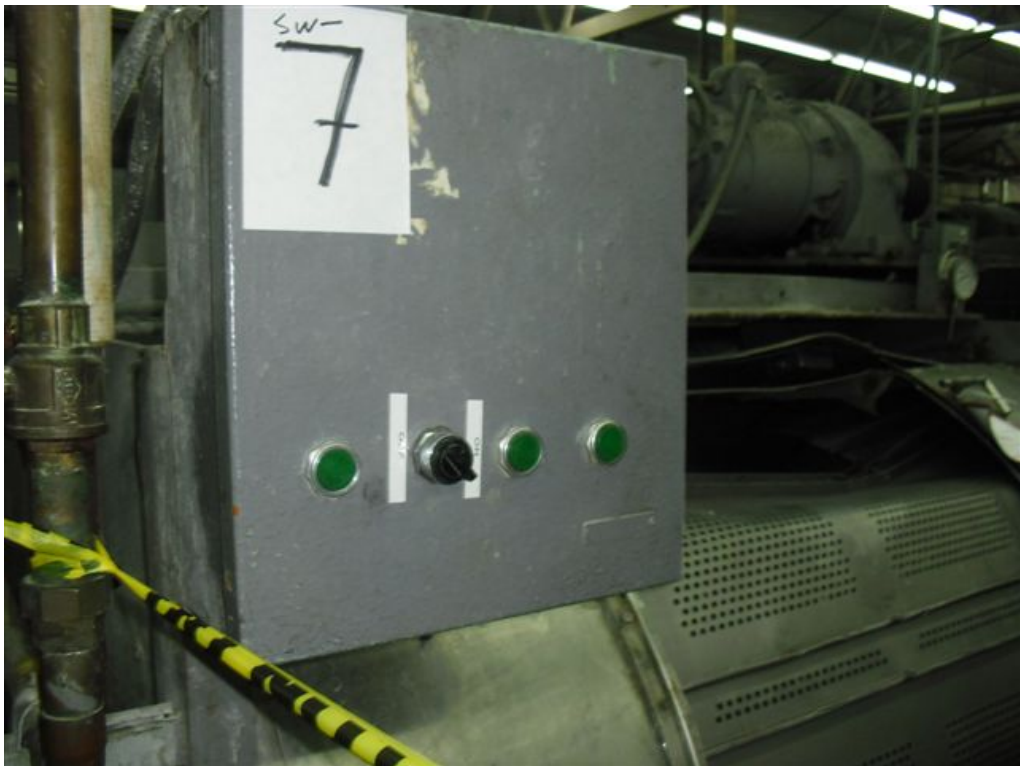
The control panel, mounted just to the left of the machine consisted of an on/off switch and three push buttons (Exhibits 5 & 6). The on/off switch did not de-energize the machine, it simply controlled the wash cycle. The buttons were used to align the inner and outer doors.

Exhibit 5. The control panel for the industrial washing machine.

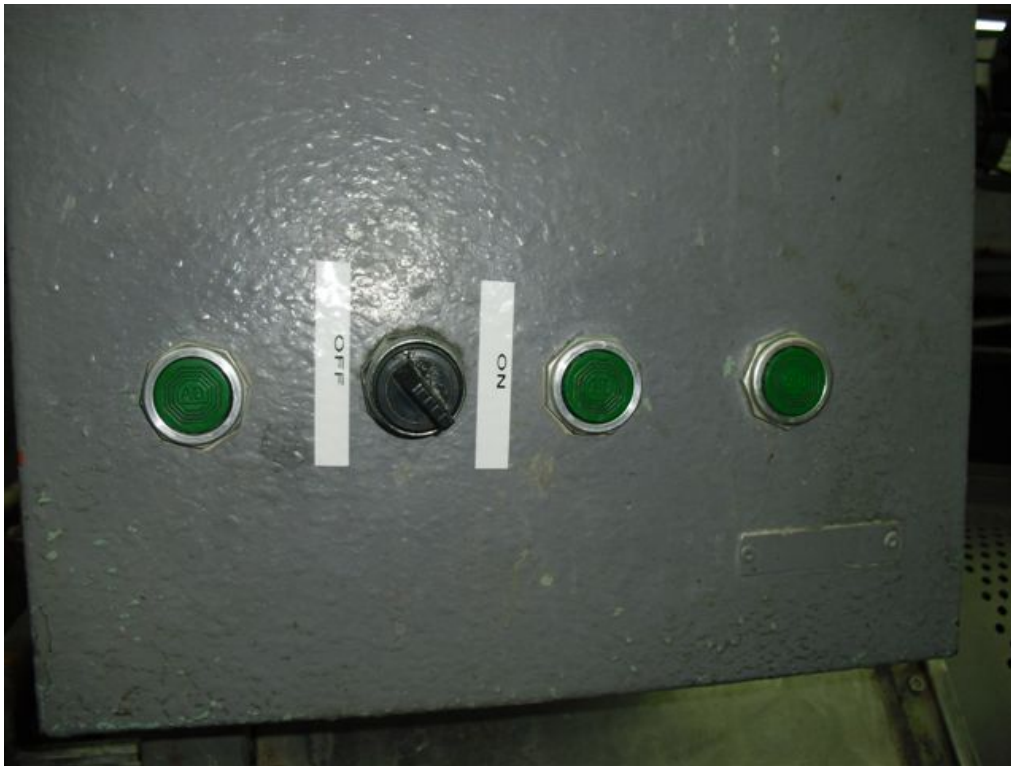
Exhibit 6. The buttons on the control panel.
