Semi-Truck Driver Dies After Being Struck by Flatbed Driver in Crossover Collision

Incident Number: 11KY001

Kentucky Fatality Assessment and Control Evaluation (FACE) Program

Release Date: January 16, 2013

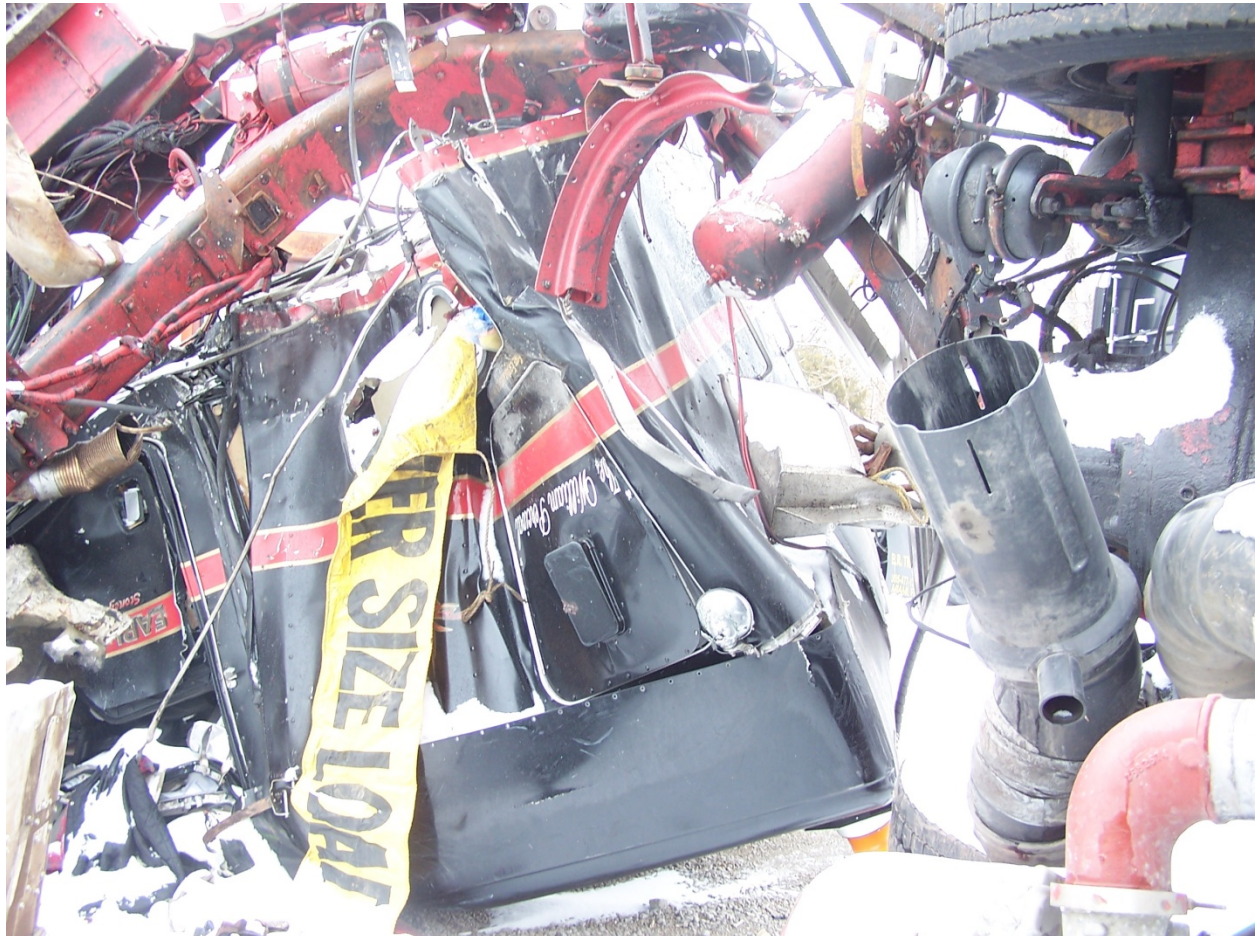
Semi that crossed median then struck by another semi of which the driver died. Photograph property of KY FACE

According to the police report, D1 did not apply the brakes after leaving the northbound travel lanes. A forensic mechanic inspected D1's semi and found the right brake defective. That defect caused the semi to veer to the left when the driver initially applied the brakes. Speeding was not a factor in this incident. D2 was the only fatality in this incident. Driver 2 had utilized the passenger restraint system.

Recommendation No. 5: Brakes on commercial vehicles should be maintained in proper working order.

According to the police report, the right brake on D1's semi was defective and when applied hard, this defect caused the semi to veer left. Guidance for proper brake alignment and inspections can be found on the Federal Motor Carrier's website, <http://www.fmcsa.dot.gov/rules-regulations/administration/rulemakings/Proposed/Brake-Readjustment-Limits%20-NPRM.aspx>.
