## **Massachusetts FACE • Occupational Fatality Report**

### **Municipal Lead Custodian Dies in Fall from Mobile Scaffolding – Massachusetts**

**Investigation: # 11-MA-008-01**

**Release Date: January 23, 2012**

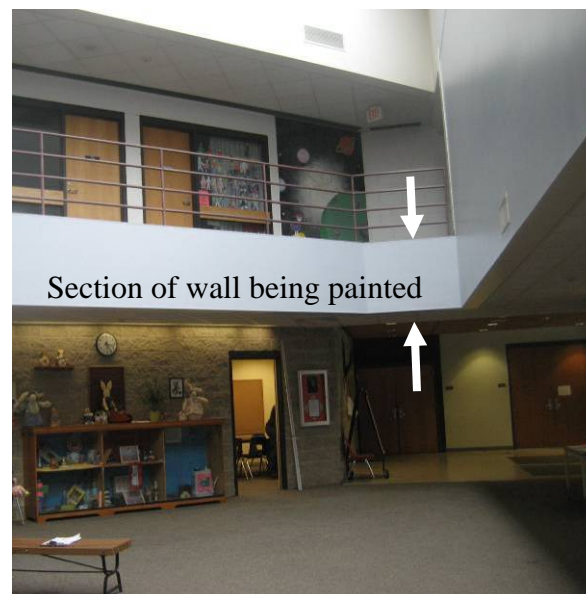
**Figure 1 – School lobby.**

At the time of the incident, the victim had been painting an interior section of the school lobby (Figure 1). The school's lobby has a carpeted floor and the middle section of the lobby is an open foyer with a two story high ceiling. Two sides of the lobby have a second story hallway with a railing that overlooks the lobby area. Painting the lobby was one of the many projects scheduled to get completed using the supplies from the grant. Painting started the day before the incident, a Saturday, but the work crew, which included the victim, was not able to finish

The section of wall that the victim was going to paint was located in the open foyer section of the school's lobby. The wall started at the first floor ceiling height, approximately 12 feet above the floor level of the lobby, and was approximately four feet high (Figure 1). A plastic drop cloth had been placed on the lobby floor to cover the carpet prior to the painting task, and the scaffolding was positioned on the plastic.

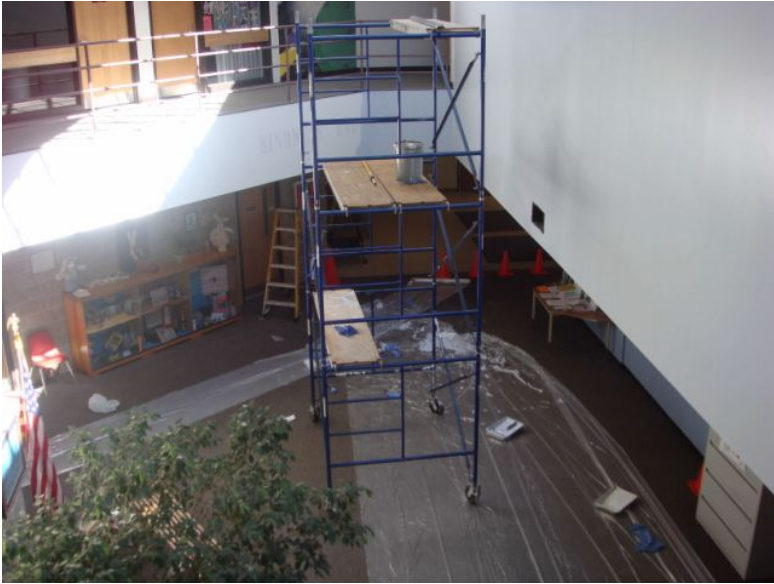
**Figure 2 – Scaffolding involved in the incident.**

There were three pieces of equipment located in the lobby that had been used during the painting tasks. These included a step ladder, a man lift, and mobile tubular frame scaffolding. Although the incident was un-witnessed, it appears that the main piece of equipment involved in the incident was the mobile scaffolding (Figure 2). The mobile scaffolding was approximately eight years old and appeared to be in good condition. The scaffolding had been donated to the school. The school did not have the owner's manual for the scaffolding.

The scaffolding found in the lobby on the day of the incident was assembled three levels high. It had four lockable caster wheels, some cross bracing, and some aluminum and plywood planking. None of the three scaffold levels were fully planked. The lowest level and the highest level of the scaffold had one plank each and the middle level of the scaffold had two planks. Cross bracing was missing on one side of the top level of the scaffold. Each section of scaffold was a little more than five feet high and approximately six and one half feet long. Therefore, both the middle and the highest sections that were planked would have been more than ten feet high. (Fall protection for scaffolding is needed on scaffold more than 10 feet above the ground or floor.) It appeared that only two of the four caster wheels were locked during the incident.

According to the time that the school alarm had been turned off, the victim had arrived at the school at 8:00 a.m. on the day of the incident. It appears that the victim was on one of the planked sections of the scaffolding when he fell from the scaffolding and landed on the floor below. There was a large amount of paint spilled covering some of the lowest level of the scaffolding, the plastic drop cloth, and the victim. There was a closed five gallon bucket of paint located on the scaffold's middle level and two paint trays with paint in them on the floor.

### **Recommendation #1: Municipal schools should ensure scaffolds are erected according to the manufacturer's guidelines and OSHA standards.**

**Discussion:** In this case, the school did not have the owner's manual for the scaffold. The first step to ensure that a product is being set up and used as it was intended is to follow the procedures outlined in the manufacturer's owners manual. Therefore, in this case, an owner's manual for the specific scaffolding involved in the incident should have been obtained.

OSHA has regulations for the safe erection, use, and dismantling of scaffolding (29 CFR 1910.28, 29 CFR 1926.451 and 1926.452). OSHA requires that scaffolding is erected and dismantled under the supervision of a competent person. OSHA defines a competent person as a person who is capable of identifying existing and predictable hazards in the surroundings or working conditions which are unsanitary, hazardous, or dangerous to employees, and who has authorization to take prompt corrective measures to eliminate them. OSHA's general requirements for mobile tubular frame scaffolding includes, but is not limited to:<sup>1</sup>
