FROM: California Fatality Assessment and Control Evaluation (CA/FACE) Program

SUBJECT: A Tree Trimmer Dies When He is Crushed by Palm Tree Fronds

SUMMARY
California FACE Report #12CA006

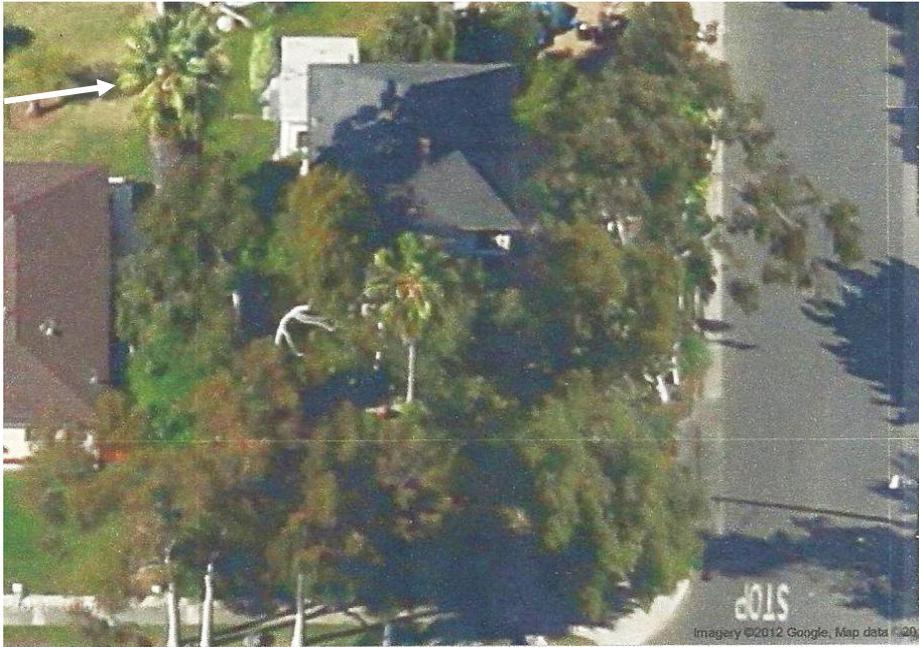
The incident scene was a private residence on a street corner that had numerous palm trees and brush (Exhibits 1 & 2).

The palm tree involved in the incident.

Exhibit 1. An aerial view of the private residence where the incident occurred.

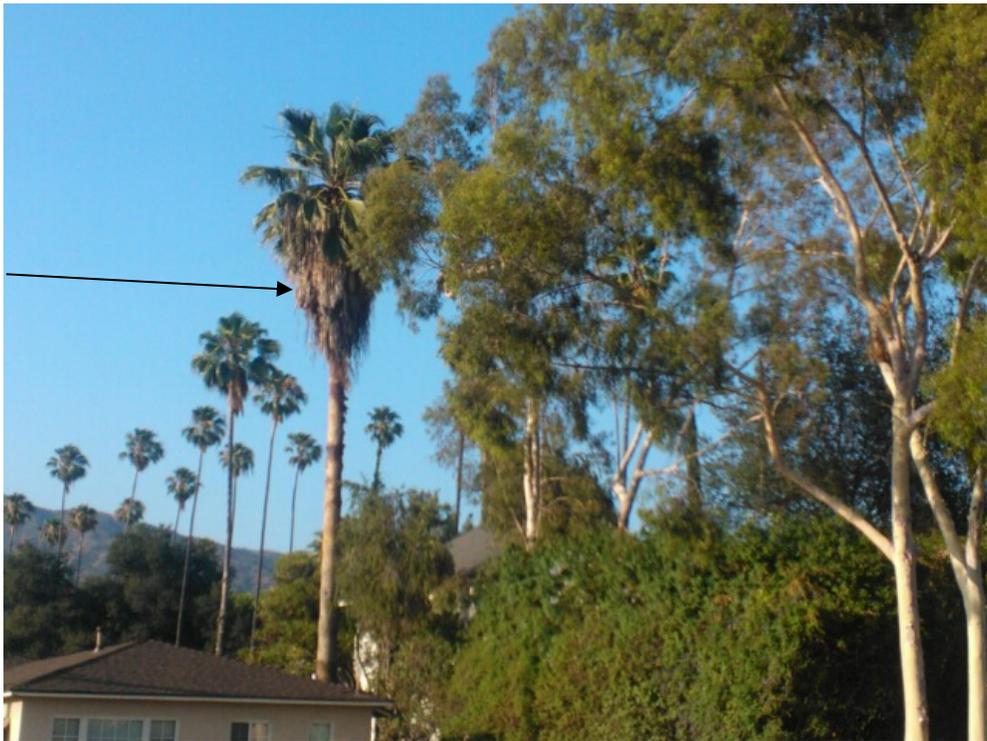
The palm tree involved in the incident.

Exhibit 2. A street view of the palm tree involved in the incident.

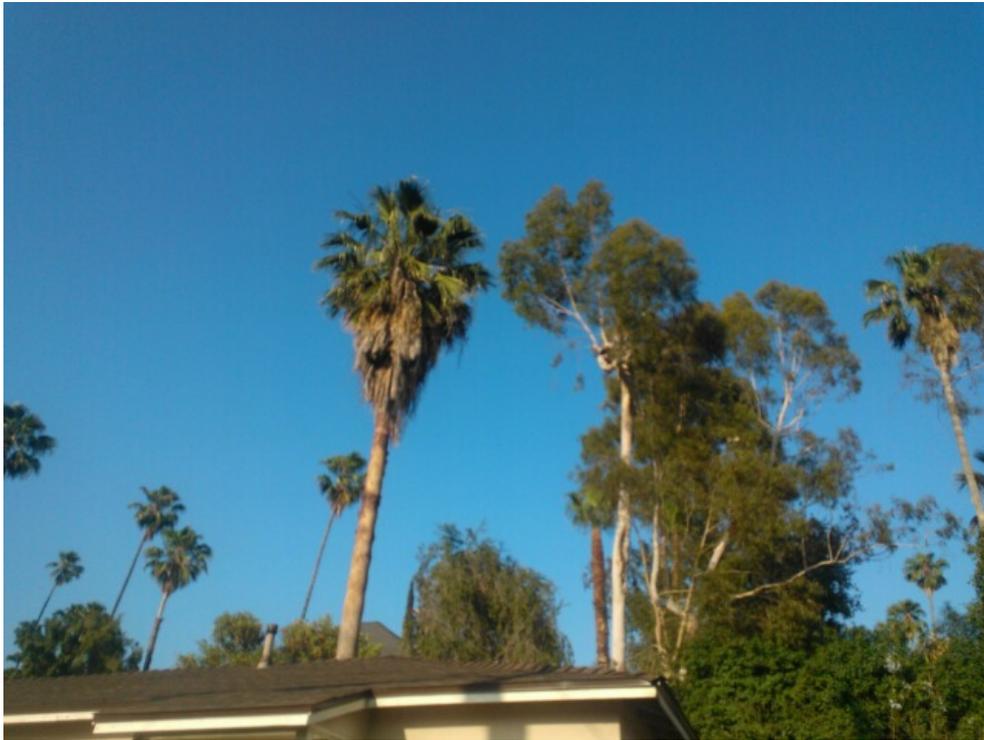
Exhibit 3. A view of the palm tree from the neighbor's driveway.

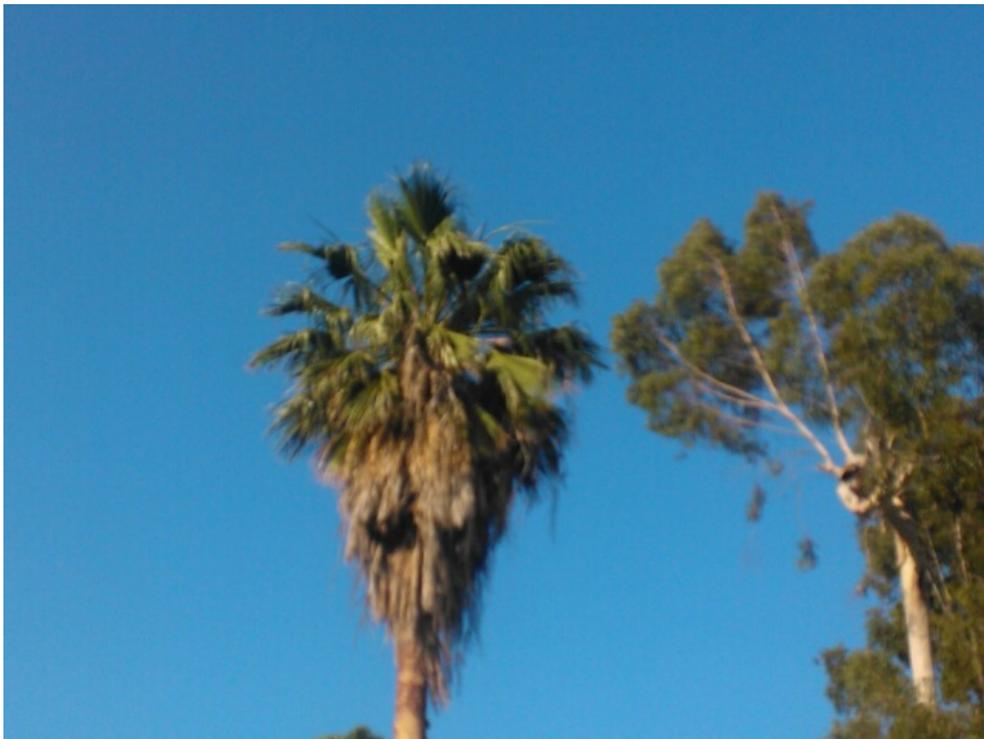
Exhibit 4. A close up of the palm tree involved in the incident.
