**FROM:** Iowa FACE      Case No. 2012 IA 009      Report Date: 11 September 2012

**SUBJECT:** Bathtub refinishing technician died from inhalation of paint stripper vapors

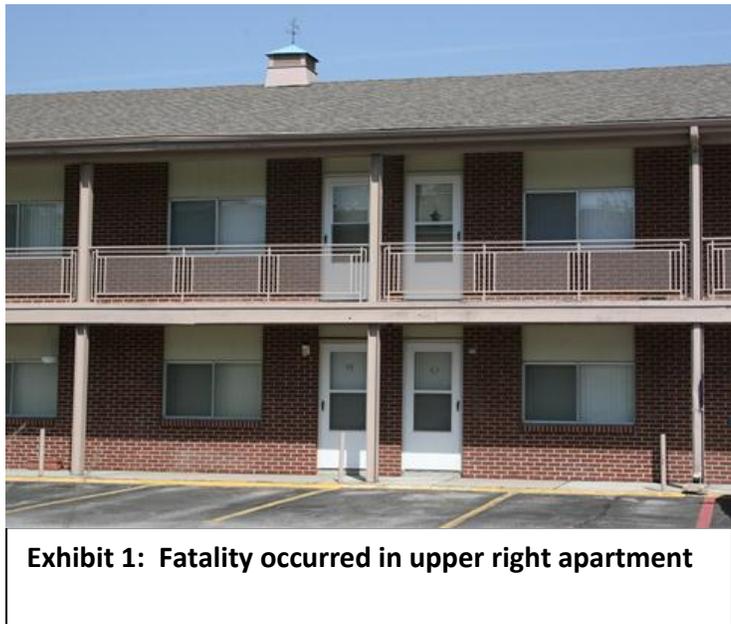
The fatality occurred during early 2012, in a second-story apartment of a multi-apartment complex (Exhibit 1). The apartment was accessed by a single exterior door, via an exterior stairway at the end of the building. The manager of the apartment complex noted that it was common practice to contract for bathtub refinishing services when needed, in preparation for leasing to new renters. The day of the fatality was the third or fourth time this resurfacing business had worked at this apartment complex. The apartment manager recalled that the decedent had worked at the apartment complex on at least one of those occasions prior to the fatality.

**Exhibit 1: Fatality occurred in upper right apartment**

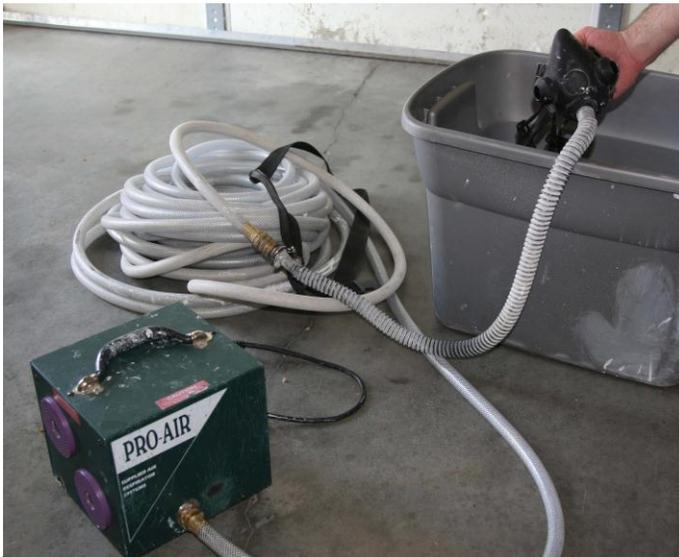
**Exhibit 2: ProAir 40 Fresh Air Respirator was to be used while stripping bathtub surface**

There are several shortcomings of the half-face Pro-Air 40 respirator device available to the surface refinishing employees. The Pro-Air 40 is not included in the NIOSH Certified Equipment List and does not meet minimum respiratory protection requirements for methylene chloride exposure. (The Pro-Air 40F – “F” designating for use with full face mask – is currently certified with approval number 19C -0320.) Pro-Air 40 systems are marketed online at several vendors and described as “NIOSH-approved” respirators, which misleads prospective users of the capabilities and protection provided by the respirator.

The configuration and protection factor of the Pro-Air 40 Fresh Air System does not meet criteria for methylene chloride exposure that may reach IDLH concentrations. Additionally, half-face mask configurations do not protect the eyes from irritation caused by methylene chloride vapors. The proper respirator for exposures up to 5000 ppm is an atmosphere-supplying respirator with full face mask, operated in pressure demand or positive pressure mode.

The Pro-Air 40 system used by the company instructs users to place the turbine in fresh ambient air of Grade D quality<sup>4</sup> or better. The Pro-Air 40 turbine unit includes two high efficiency particulate air (HEPA) filters that are replaceable but users do not have good indication to gauge a pressure drop if airflow is restricted or decreased due to turbine malfunction or filter loading. Using this system

within a room or apartment or even interior area of a home or business would provide no protection from methylene chloride vapors that would bypass HEPA filters and re-entrain into the supply system. Using this system in the winter, placing the turbine outdoors in a “fresh air” environment may have resulted in uncomfortably cold air being delivered to the wearer; it is not known if this deterred the technician from using the respirator equipment in her van. Although two 40-foot lengths of 5/8” tubing were found in the van that could have allowed an outdoor placement of the turbine, the NIOSH certification (for the Pro-Air 40F) specifies only an approved length of 40 feet. The technician and employer were uninformed of the limitations of this type of respirator, although it was recommended by the parent company selling regional distributorships. The employer was unaware that only full-face atmosphere-supplying respirators are approved for methylene chloride.

A formal respirator program would have assigned responsibility for proper selection, maintenance, use, and employee training, and assured that proper fitting full-face respirators were available for employees. The appropriate respiratory protection for methylene chloride exposures that could reach IDLH concentrations is a full-face, supplied-air respirator.

If methylene chloride-based paint removers continue to be used, they should be used only with positive pressure supplied air systems such as self-contained breathing apparatus (SCBA) or airline respirators with SCBA backup, especially when exposure concentrations are not known or if it is not possible to effectively ventilate the work area. Workers and bystanders should not rely on odor as a warning property for dangerous exposures, as the odor threshold (250 ppm) is 10 times the OSHA Permissible Exposure Limit (PEL, 25 ppm) and near the 15-minute short term exposure limit (STEL, 125 ppm). Direct-reading equipment would be needed to determine hazardous concentrations of methylene chloride on site. Examples of direct-reading equipment include detector tubes, which allow “grab samples” or air to be collected that show the presence and concentration of vapors tubes that change color, or portable direct reading instruments

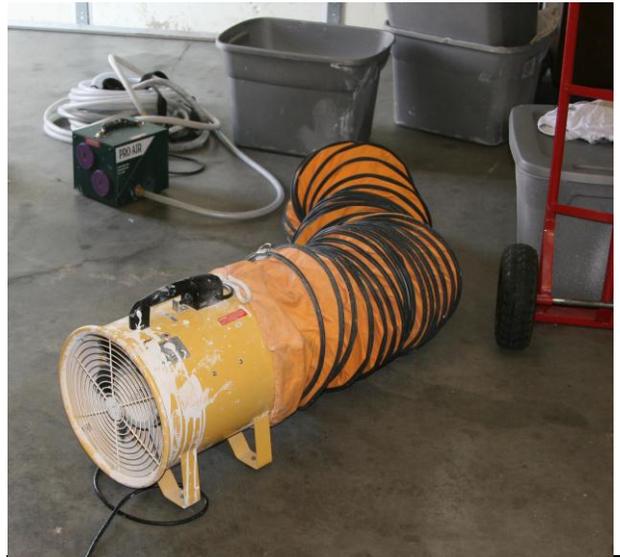
**Exhibit 3: FlowPro utility blower (in foreground) was to be used to exhaust chemical vapors from the work area**

Employees were also directed to use a portable Q Standard Utility Blower (12-inch diameter fan, 2905 cubic feet per minute, 4/7 horsepower, Model 39012) with Q Standard Ventilating Hose (12-inch diameter, 20-foot, Model 177771) flexible duct to remove contaminated air from the work area and exhaust it outside to a location remote from the respirator air supply source (Exhibit 3).

Technicians were instructed to place the blower unit fan in their work area, with the ducting extending out through a door or window to exhaust contaminated air from (i.e., blow air out of) the room. Makeup air – which would replace the air being exhausted by this utility blower – was not mechanically provided for during the procedure, but theoretically would passively enter the room or apartment via any open doors or windows, including the exterior door through which the blower ductwork was extended.

A 2905-cfm utility ventilation blower with two 20-foot sections of flexible ductwork was found in the work van that the technician drove to the site. This equipment was in the van with a portable hand cart to transport her storage totes of supplies and equipment. It is not known why, on this occasion, the decedent did not use ventilation controls and respiratory equipment, since apartment personnel had on prior occasion seen her use this equipment. Since the utility blower was not known to have malfunctioned or had operating problems, possible explanations may be that:

with the technician, would be an improvement to no ventilation, but provisions must be made for clean supply or “makeup air” for the exhaust system to work properly. A better option is to locate a local exhaust hood closer to the stripper product, since the tub wall and even the technicians themselves could potentially block the direct pathway of contaminated air at the source to the fan.

Using appropriate makeup air and local exhaust ventilation in a push-pull system would have diluted methylene chloride vapors in the room. Because methylene chloride has a high vapor pressure and is heavier than air<sup>3</sup>, the better alternative is to position an exhaust hose to the side and as low to the interior of the tub as possible to draw vapors down and away from the worker who may be leaning over the tub to work. Capturing and removing vapors closer to the source is a more effective exhaust.

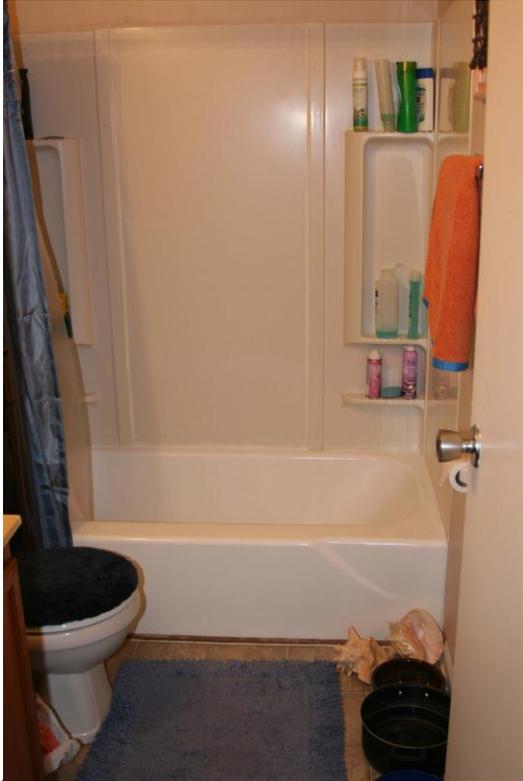
**Exhibit 4: Configuration of bathroom**

The decedent had been working in a small bathroom that was approximately 5' wide x 7.5' deep x 8' high (Exhibit 4). The standard size bathtub (29" wide x 60" long) was on the far end of the room and extended the width of the bathroom. The room had a ceiling exhaust fan which was not turned on. Most of the original tub finish had been removed, and the decedent's scraper and knee pad (presumably used as a cushion) were found in the tub (Exhibit 5).

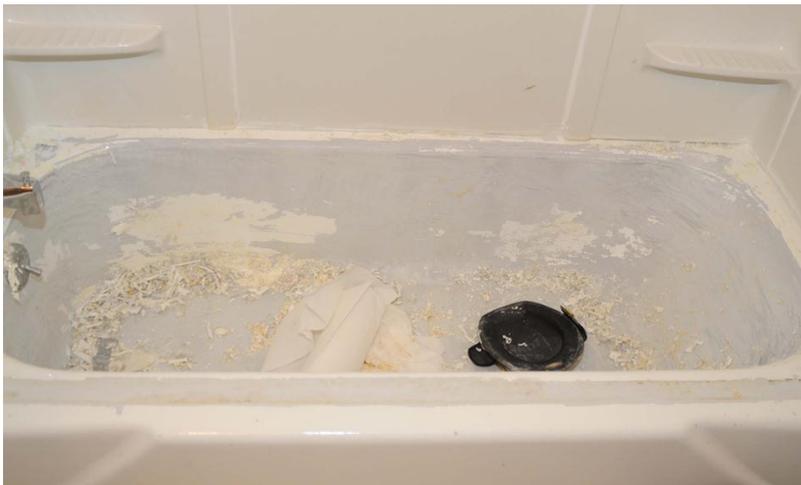
Responders described a strong chemical odor in the apartment. An open one-gallon can of Klean Strip Aircraft® Low Odor Paint Remover was found in the room, with about 105 ounces of product remaining in the 128-ounce can (Exhibit 6). The door and windows of the apartment were closed, and there was no supplemental ventilation supply or exhaust in use.

**Exhibit 5: Bathtub where technician was found**

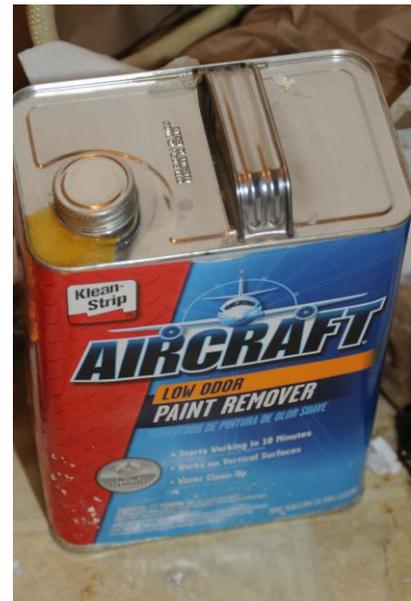
**Exhibit 6: Recapped can of methylene chloride paint remover found in room**

Labeling information on the one-gallon can of states: *THIS PRODUCT IS DESIGNED FOR APPLICATION BY TRAINED PROFESSIONALS USING PROPER EQUIPMENT UNDER CONTROLLED CONDITIONS. THIS PRODUCT IS NOT INTENDED FOR SALE TO THE GENERAL PUBLIC.* The business owner at this site purchased the product locally from a retail supplier specializing in coatings, hardware, solvents, and spray equipment; the product is currently available to the general public through coatings suppliers and automotive supply companies in brick and mortar stores, and through online sales (e.g., amazon.com)<sup>1</sup>. While chemicals may be generally available to the public for purchase and use, employers must understand and communicate the hazards of workplace chemicals to all affected employees, whenever chemical uses are greater in duration or frequency than those of a common consumer<sup>2</sup>. The product label indicates that this material is *not* intended for use by the common consumer, necessitating chemical-specific training.

In this case, the employer returned to finish the tub stripping and resurfacing a few days after the fatality; he avoided using the usual methylene chloride stripper and instead completed the stripping process manually, using scrapers and sanding. This manual process is likely to take longer, but would avoid chemical exposures. Other alternative products that are low-toxicity - such as benzyl alcohol or soy-based stripping products - should be considered, to determine if these low-hazard products can achieve the efficacy of methylene chloride products even if the method may take longer to work.

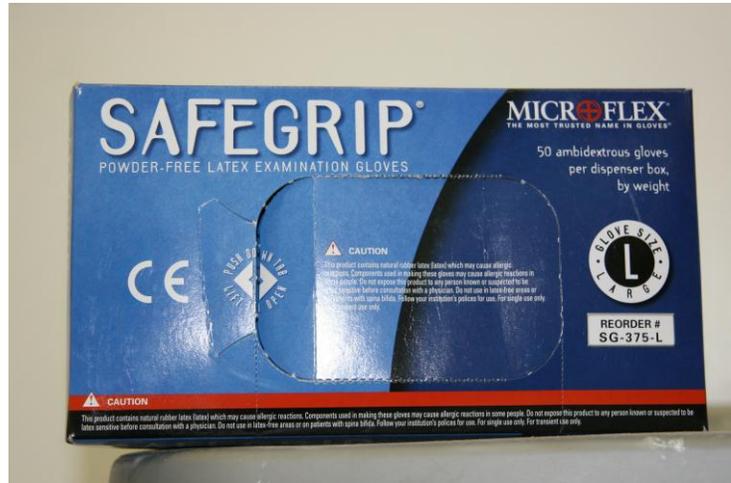
The decedent was wearing a short sleeved tee-shirt, painter pants, and two layers of latex gloves (Exhibit 7). She wore no respiratory protection or eye protection. The decedent's cup of fountain pop was on the counter of the vanity in the room. The employee's Pro-Air 40 Fresh Air Respirator with two 40-foot sections of supply tubing and FlowPro utility blower with two 20-foot sections of flexible duct were found in the cargo area of the company van the decedent had driven to the site.

**Exhibit 7: Gloves used by technician**

Adherence with the standard would have also provided guidance for clothing and gloves to protect exposed skin. The technician's work clothing did not provide coverage to her forearms; the latex gloves she wore were not chemically resistant to methylene chloride. Long gloves made of butyl rubber, polyethylene/ethylene vinyl alcohol (PE/EVAL, 4H™ and Silver Shield™ brand), or Teflon™ would protect the hands and forearms from contact with methylene chloride and methanol.
