# Truck Driver Dies When Tractor-Trailer Overturns After Leaving Road

**Incident Number: 12KY011**

**Kentucky Fatality Assessment and Control Evaluation (FACE) Program**  
**Incident Number: 12KY011**  
**Release Date: May 14, 2013**  
**Subject: Truck Driver Dies When Tractor-Trailer Overturns After Leaving Road**

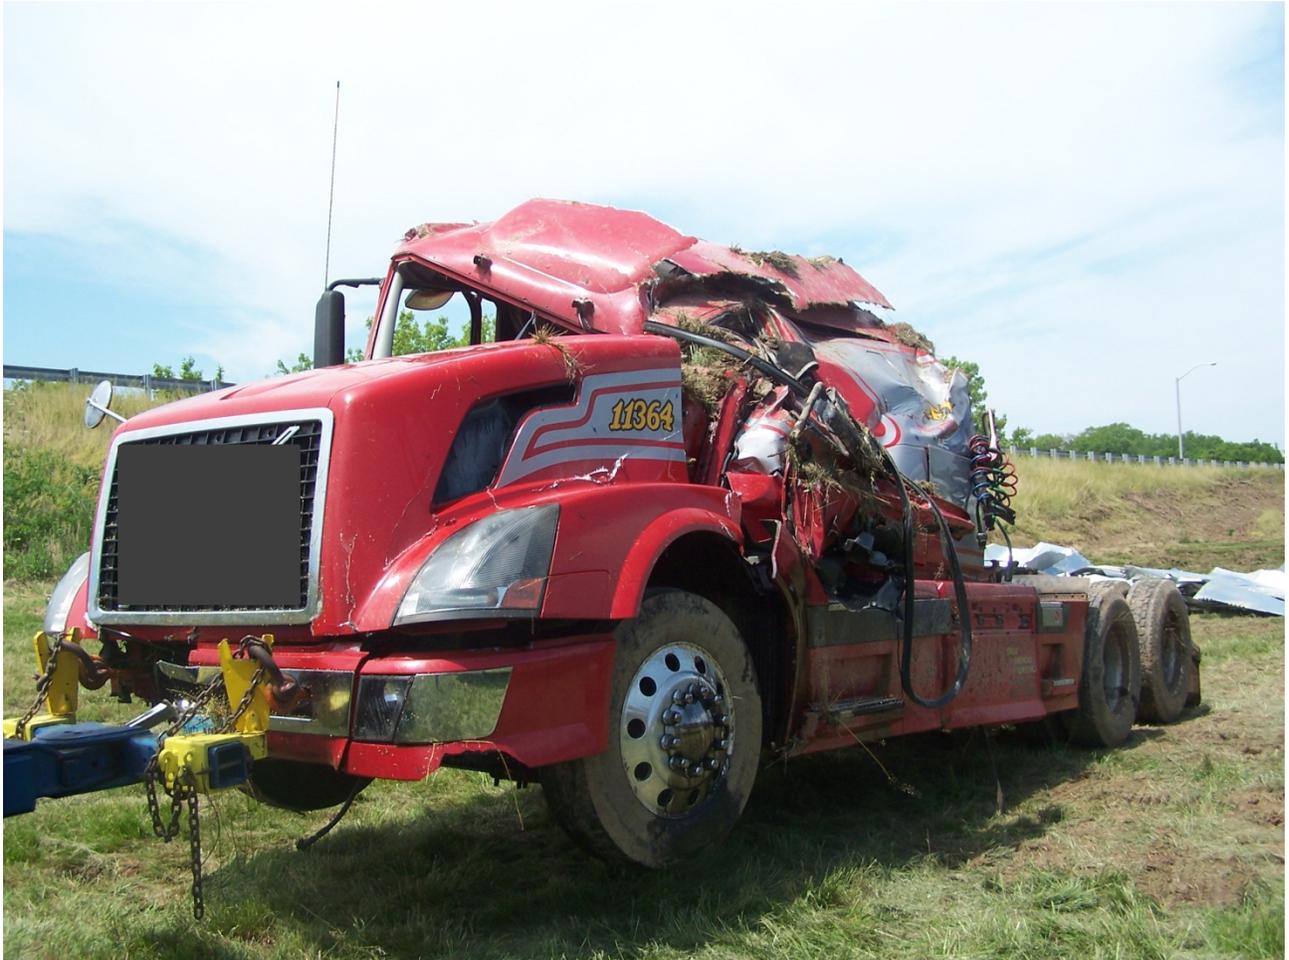
**The tractor involved in the crash. Photograph property of KY FACE program**

Sheriff's deputies could not determine if the driver was trying to negotiate the ramp and was unsuccessful or if he lost control for some other reason. Test results on the driver indicated he had not been drinking or using any controlled substances. A heart attack was also ruled out as a causal factor in the crash. Speed was not listed as a factor. The damage to the tractor and trailer was noted to be very severe.

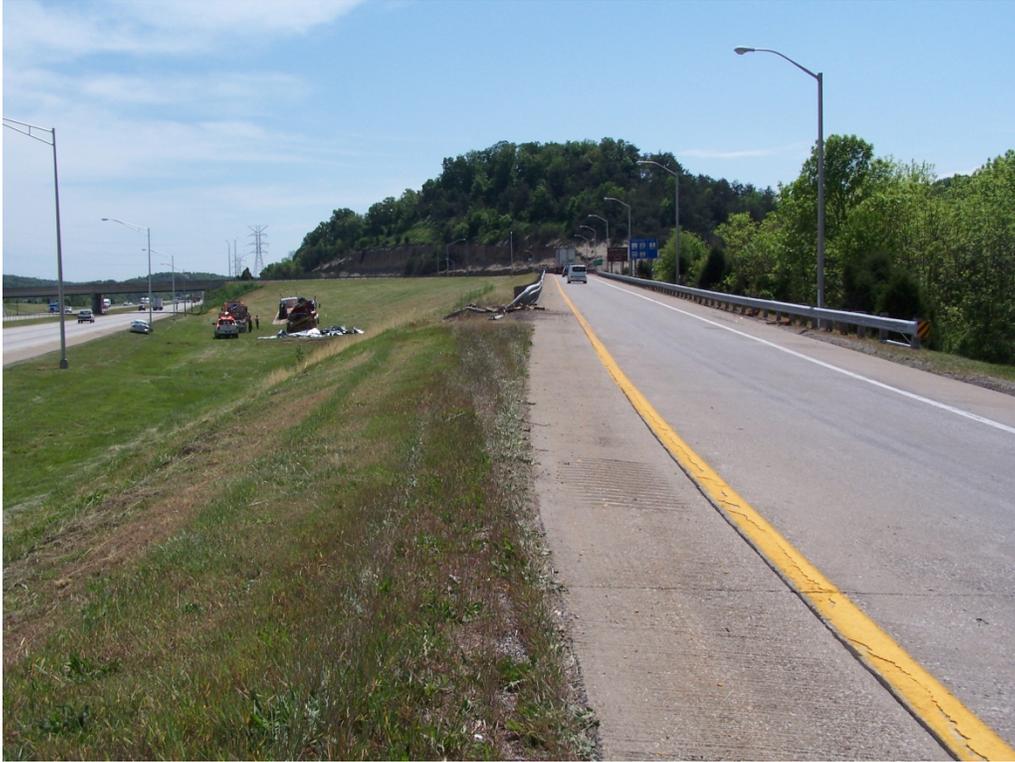
The driver exited the interstate and began to travel up the exit ramp. While traveling on the ramp, the truck struck the left side guard rail and continued off the road. The truck traveled down an embankment and overturned onto its roof at approximately 5:50 a.m. According to the police report, the driver was restrained and there was no evidence of braking at any point. Two sections of the guardrail and five support posts were damaged in the collision.

The exit ramp where the tractor-trailer left the road. Property of KY FACE

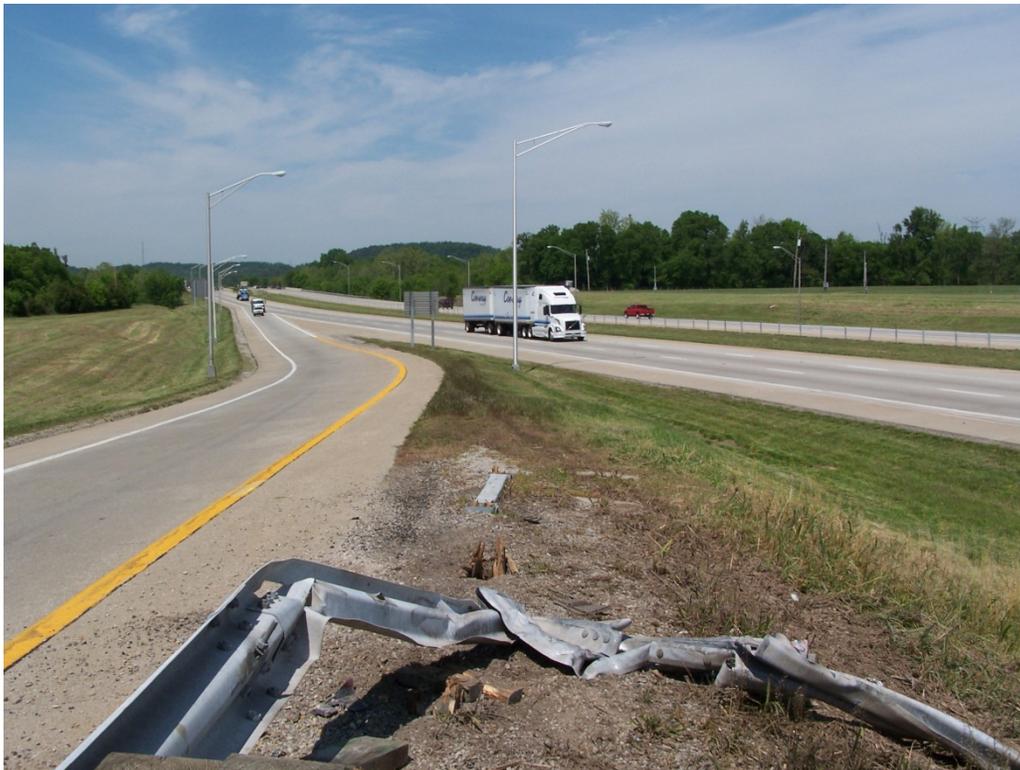
View back to the interstate from the crash site. Property of KY FACE
