# Owner of Towing Company Dies When Struck by Driver of a Box Truck

**Incident Number: 12KY035**

**Kentucky Fatality Assessment and Control Evaluation (FACE) Program  
Incident Number: 12KY035  
Release Date: 2014  
Subject: Owner of Towing Company Dies When Struck by Driver of a Box  
Truck**

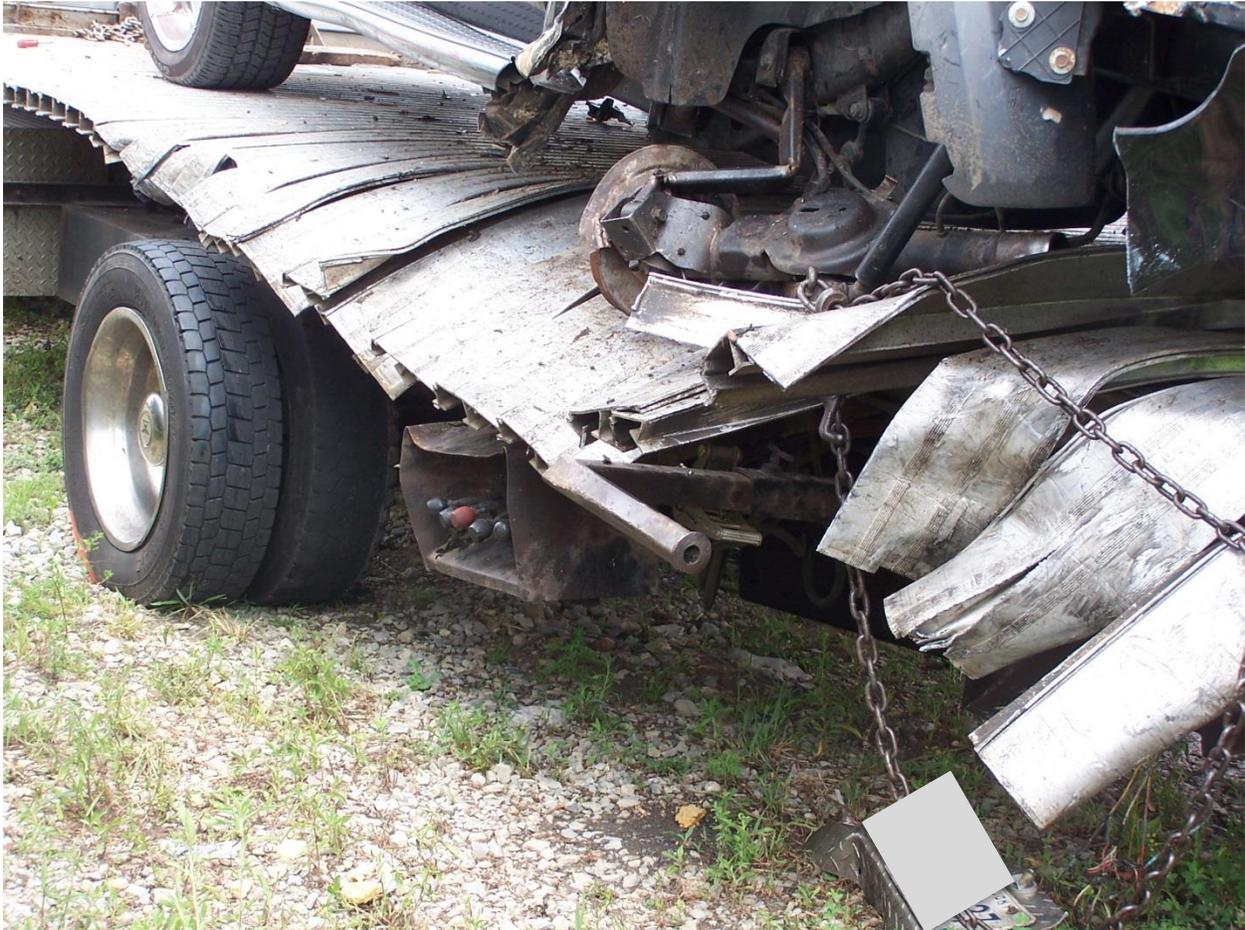
The tow truck struck by the box truck. Photos included in this report are property of Kentucky FACE.

About one hour later, the box truck approached the mile marker where the tow truck driver was snugging up the winch on his load. As the box truck driver approached the parked tow truck he veered right, crossing the solid white line onto the shoulder. The front right side of the box truck struck the rollback section of the parked towing vehicle where the tow truck operator was standing and where the winch controls were located.

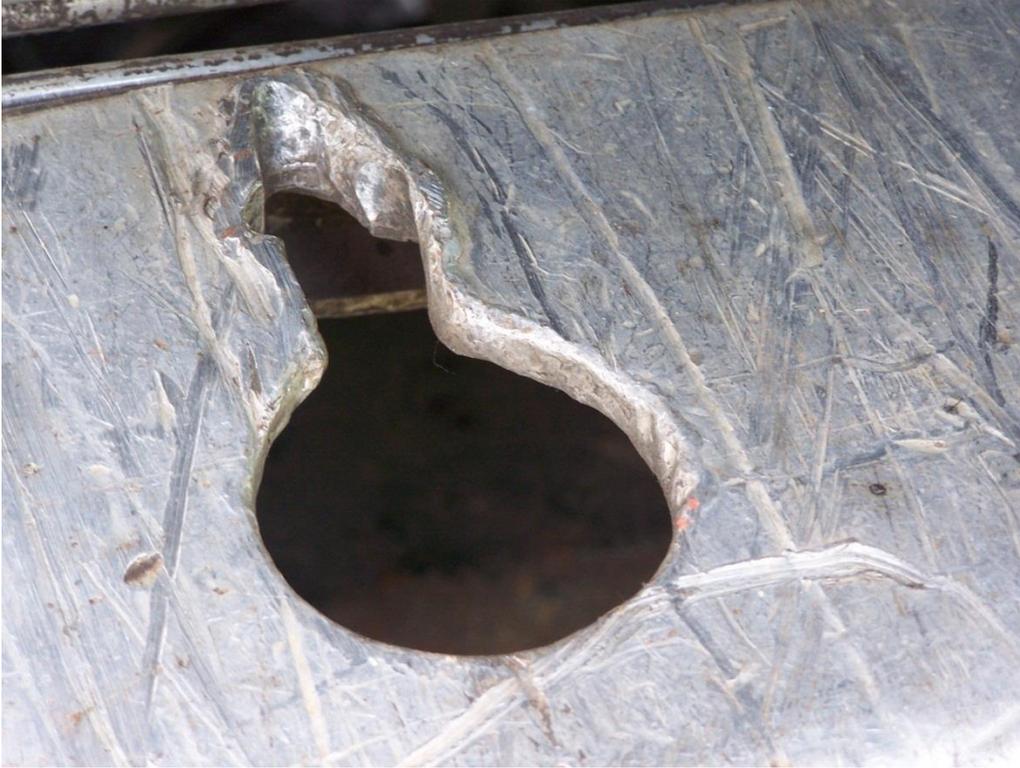
The securement sites on the tow truck were stretched beyond their original shape, suggesting the truck had carried loads beyond its maximum capacity. The excess weight of a load can cause a securement site to become warped and misshapen. This could have caused the load to shift back and forth while on the bed of the tow truck, causing it to feel unstable.

A worn securement site on the tow truck.

### **Recommendation No. 3: The maximum carrying capacity of a tow truck should not be exceeded.**

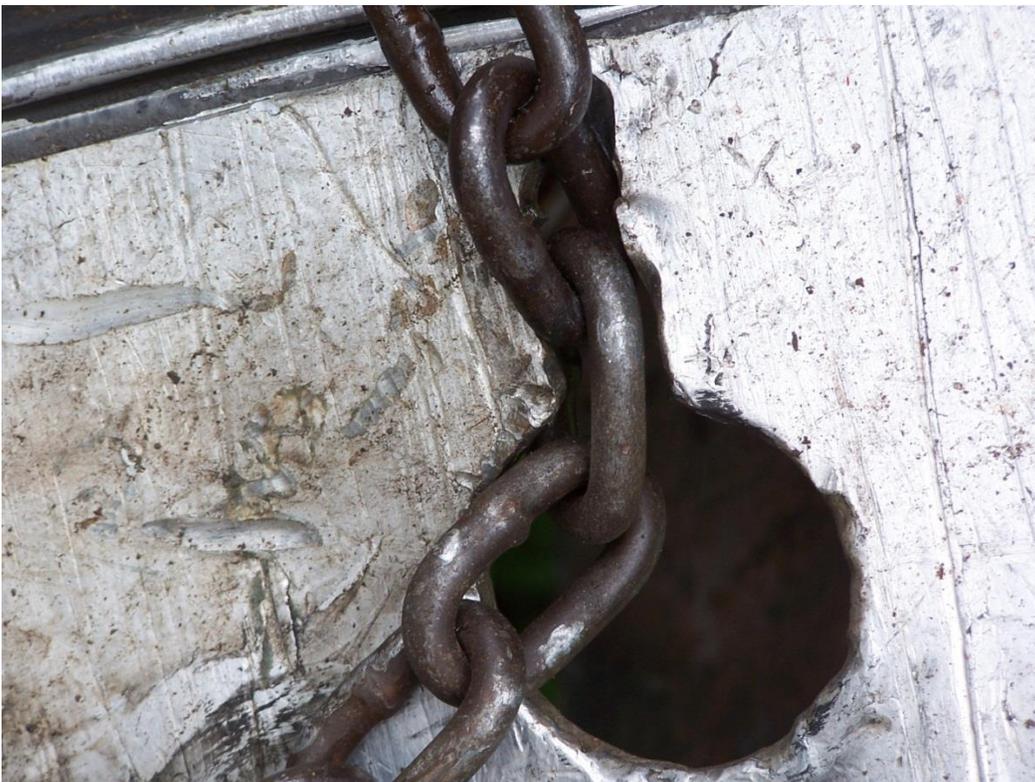
Four points of securement should be used when transporting a motor vehicle. The truck only had three points of securement. The four points are located on each corner of the two truck bed and should be properly fastened to the tires on all four corners of the vehicle. Using less than four points of securement may cause the load to shift back and forth and feel unstable. Additionally, not using all four securement sites can put added stress on the remaining ones, causing them to become stretched.

A worn securement site with chain on the tow truck.

### **Recommendation No. 1: Four points of securement should be used when transporting a load.**

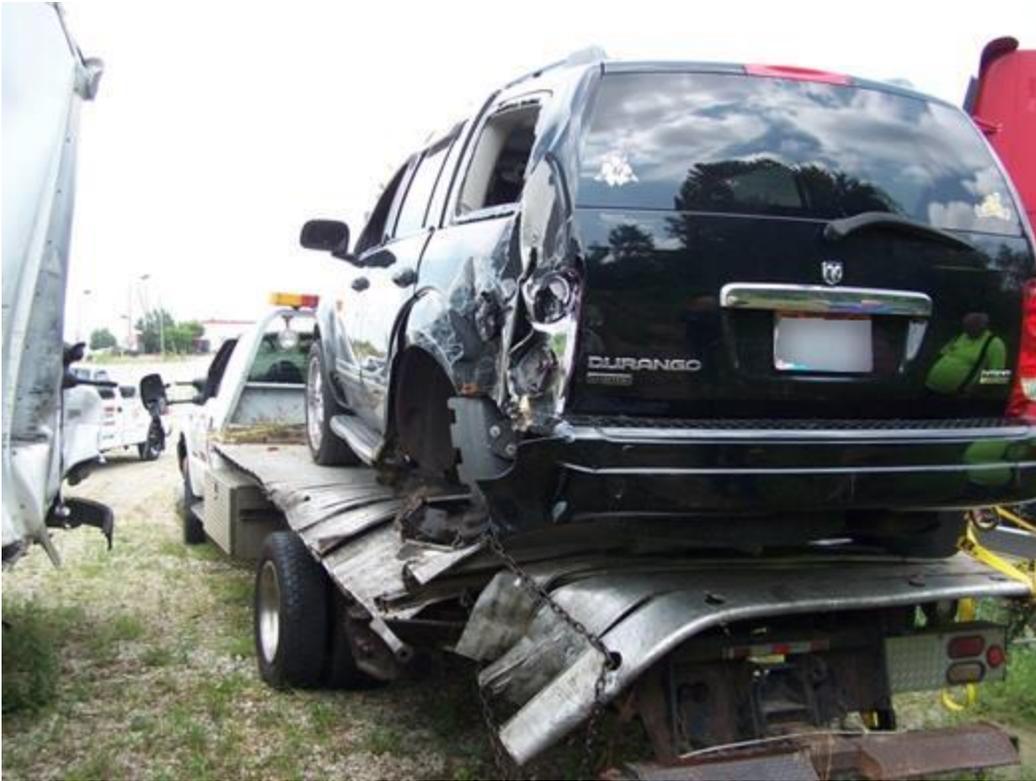
The tow truck with SUV.

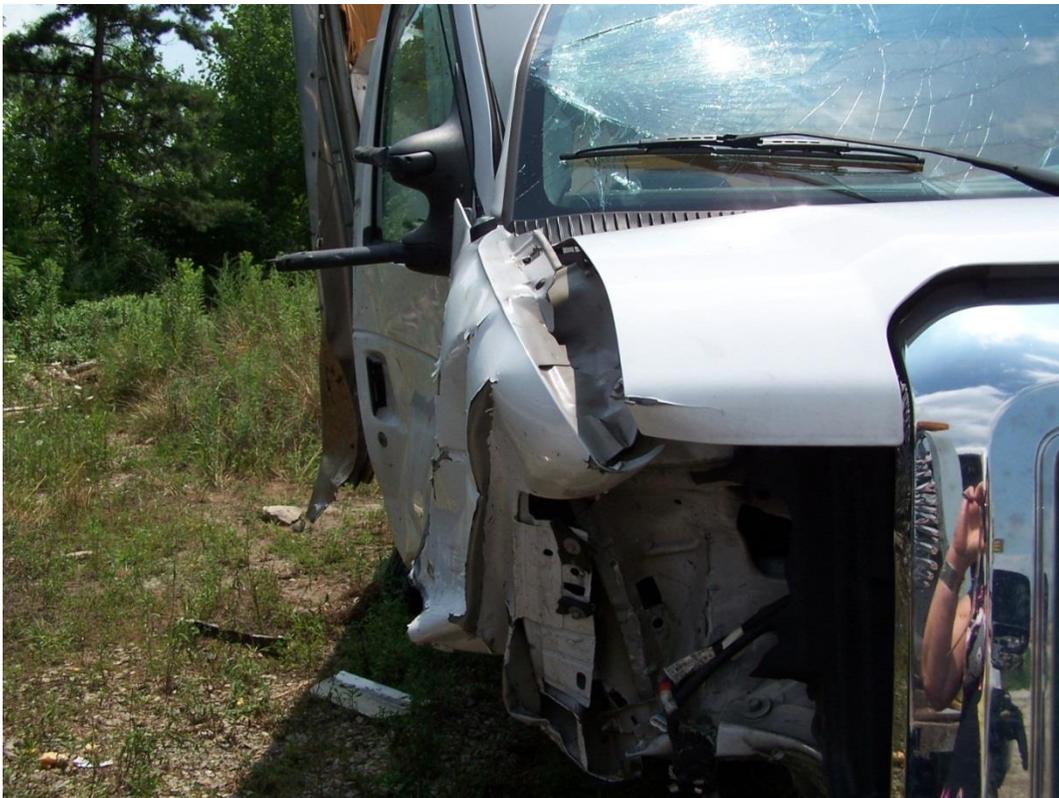
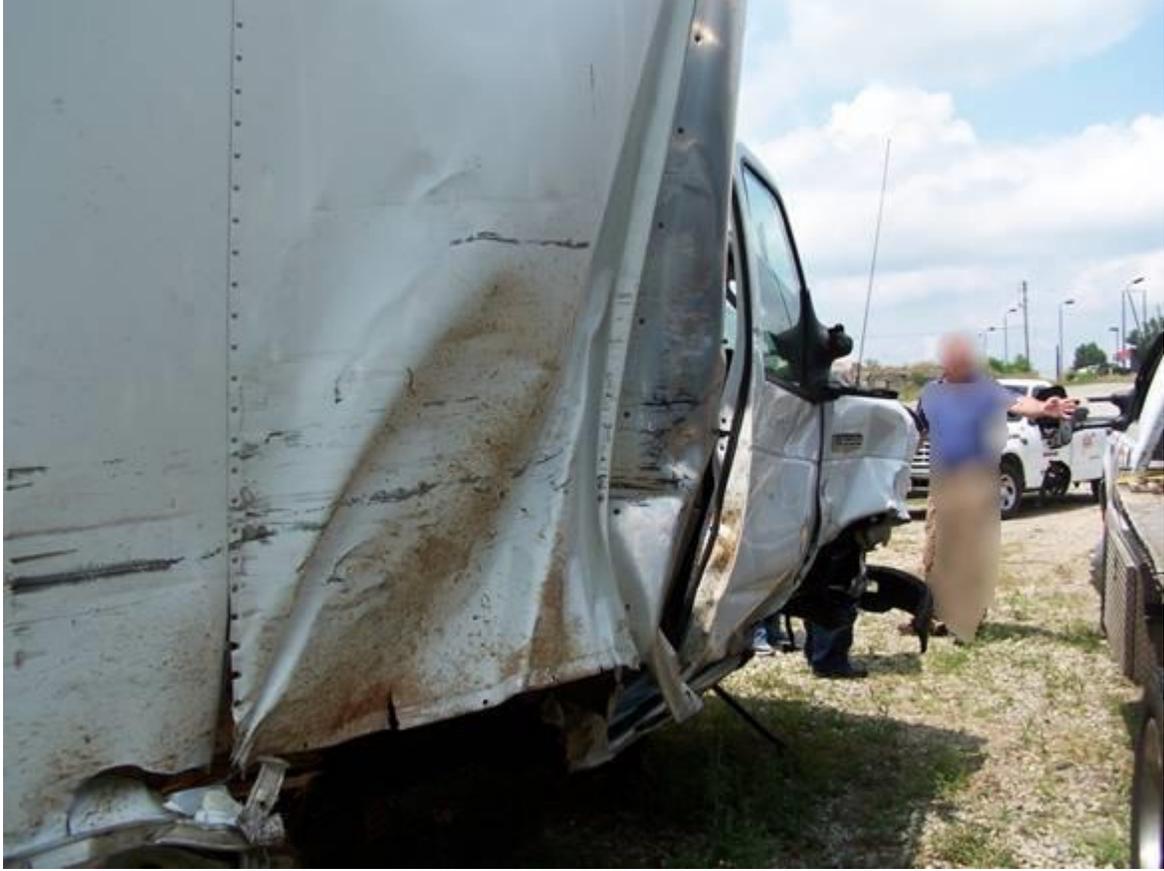
The force of the impact against the tow truck sent the box truck careening back onto the interstate in a northward trajectory before flipping onto its side and skidding to a halt some 38 yards away from the tow vehicle. Inside the damaged box truck, the driver remained conscious. The doors in the cab were lodged shut; the driver traversed the back of the cab and the empty cargo space to the exit in the rear of the vehicle.

The box truck that struck the tow truck.
