Factory Laborer Dies When a Car Driven by Coworker Crashes into Him in Parking Lot

Incident Number: 12KY037

Kentucky Fatality Assessment and Control Evaluation (FACE) Program
Incident Number: 12KY037
Release Date: June 30, 2013
Subject: Factory Laborer Dies When a Car Driven by Coworker Crashes into Him in the Parking Lot

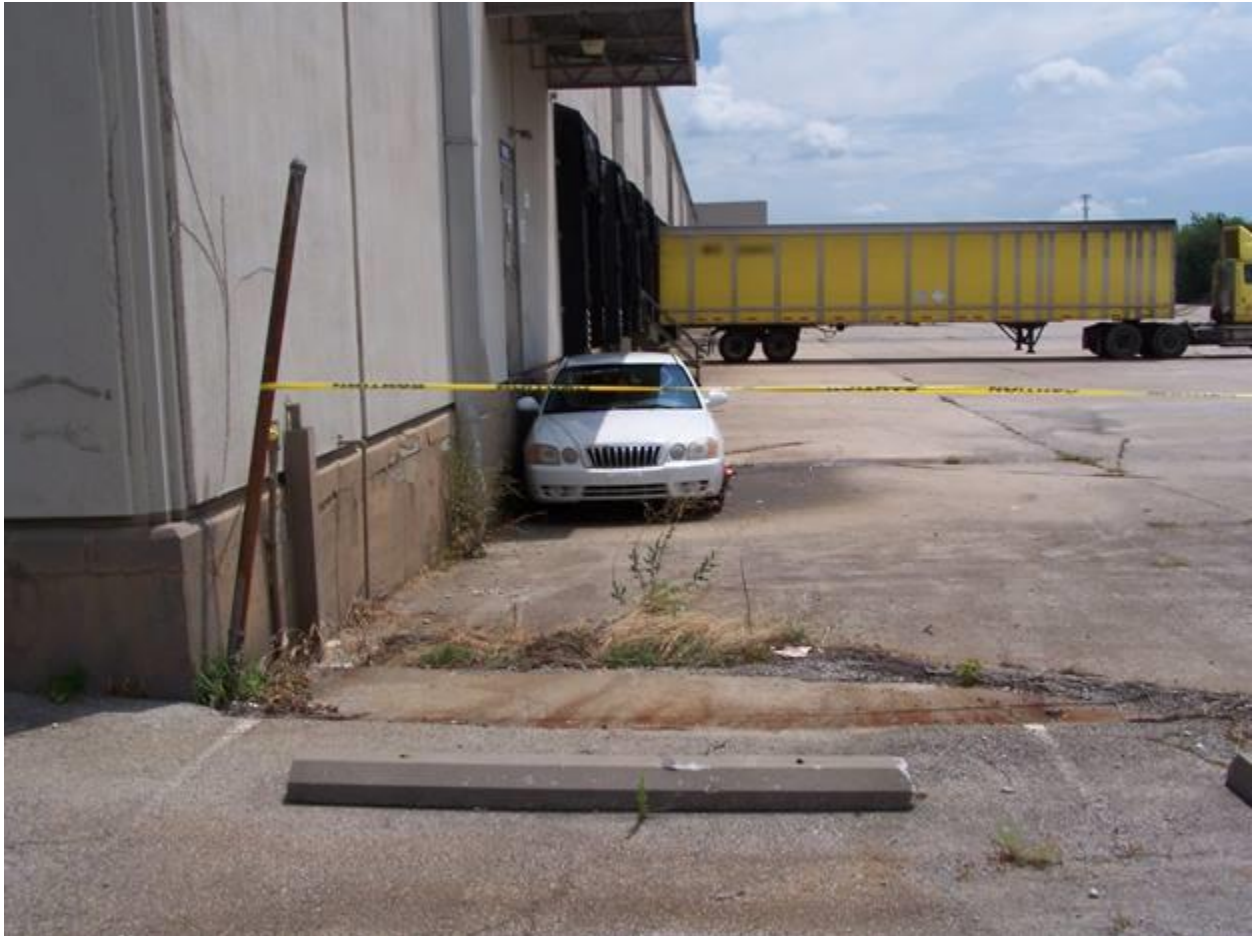
The car in the area where the crash occurred. Photograph property of KY FACE program.

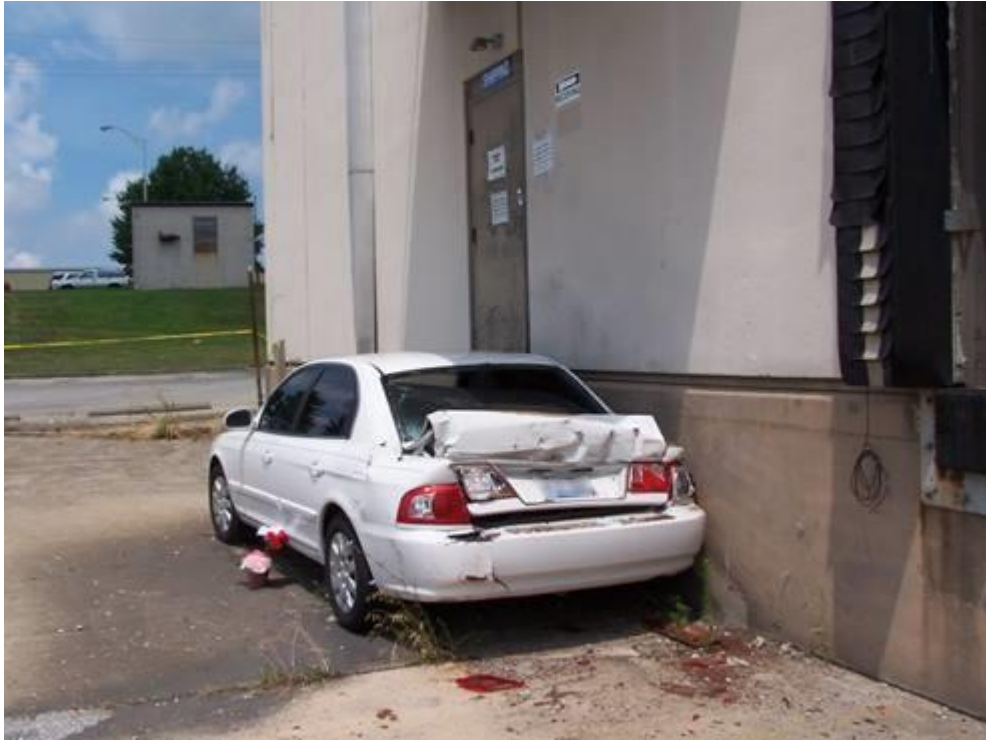
Attachment 1

Laborer 2 reported that a vehicle malfunction occurred as she backed up, causing the accelerator to become stuck. The car suddenly sped backward, over a concrete wheel stop, through a chain-link fence, scraping the passenger side of the car against the side of the building, and crashed into the metal stairway under which Laborer 1 was sitting. The car continued traveling backward alongside the building and the force of the car moved the metal stairway approximately 15 feet. Laborer 1 had just arrived underneath the metal stairway, according to coworkers, and was crushed between the building and the passenger side of the car.

The car crashed into the metal stairway, pushing it backward from underneath the door in the picture. Laborer 1 had been under the stairway. The stairway had been removed when this photo was taken. Photograph property of KY FACE

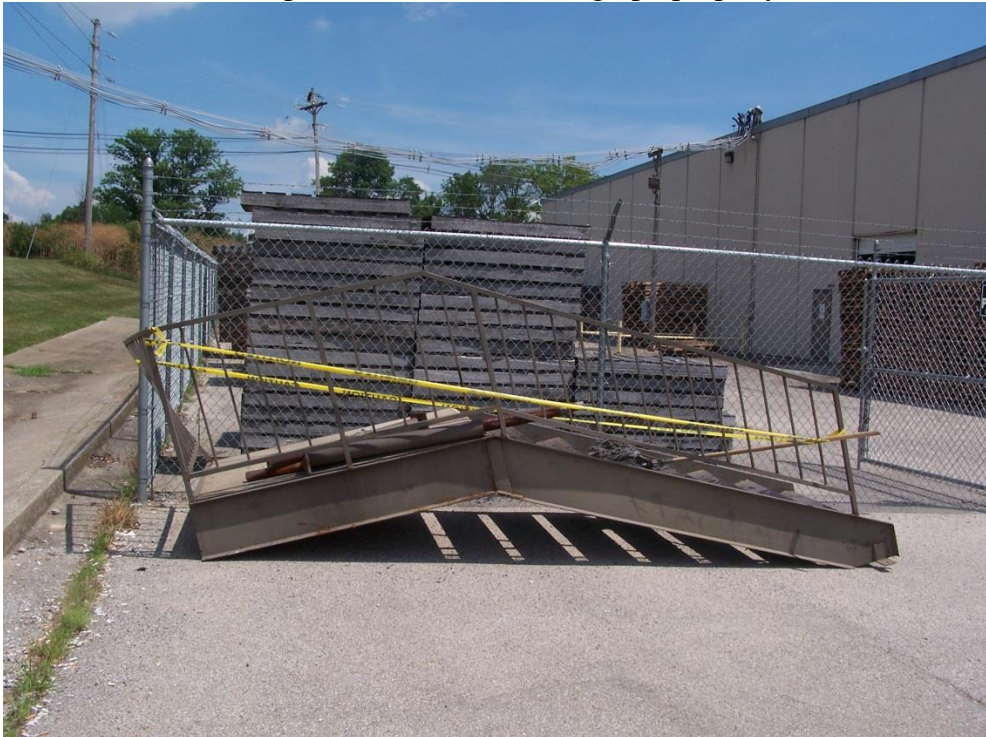
Co-workers of Laborer 1 revealed that it was his habit to take a break outside underneath a small metal stairway in the loading dock area during his lunch break each day. This location gave him privacy and was relatively quiet, but this area was near the loading docks and was surrounded by concrete, metal and vehicles in motion. Employers should provide safe and protected areas for employees to take breaks and require that employees use the designated break areas when on the property for breaks. Employees should refrain from taking breaks in areas that are inherently unsafe. At the factory where the incident occurred, there were two designated break areas, one indoor and one outdoor under a tree next to the employee parking lot.

The metal stairway which had been attached to the building under the door. Laborer 1 was reported to take breaks under this structure. Photograph property of KY FACE

Recommendation No. 1: Employers should establish policies requiring employees to use the safe break areas that are provided.

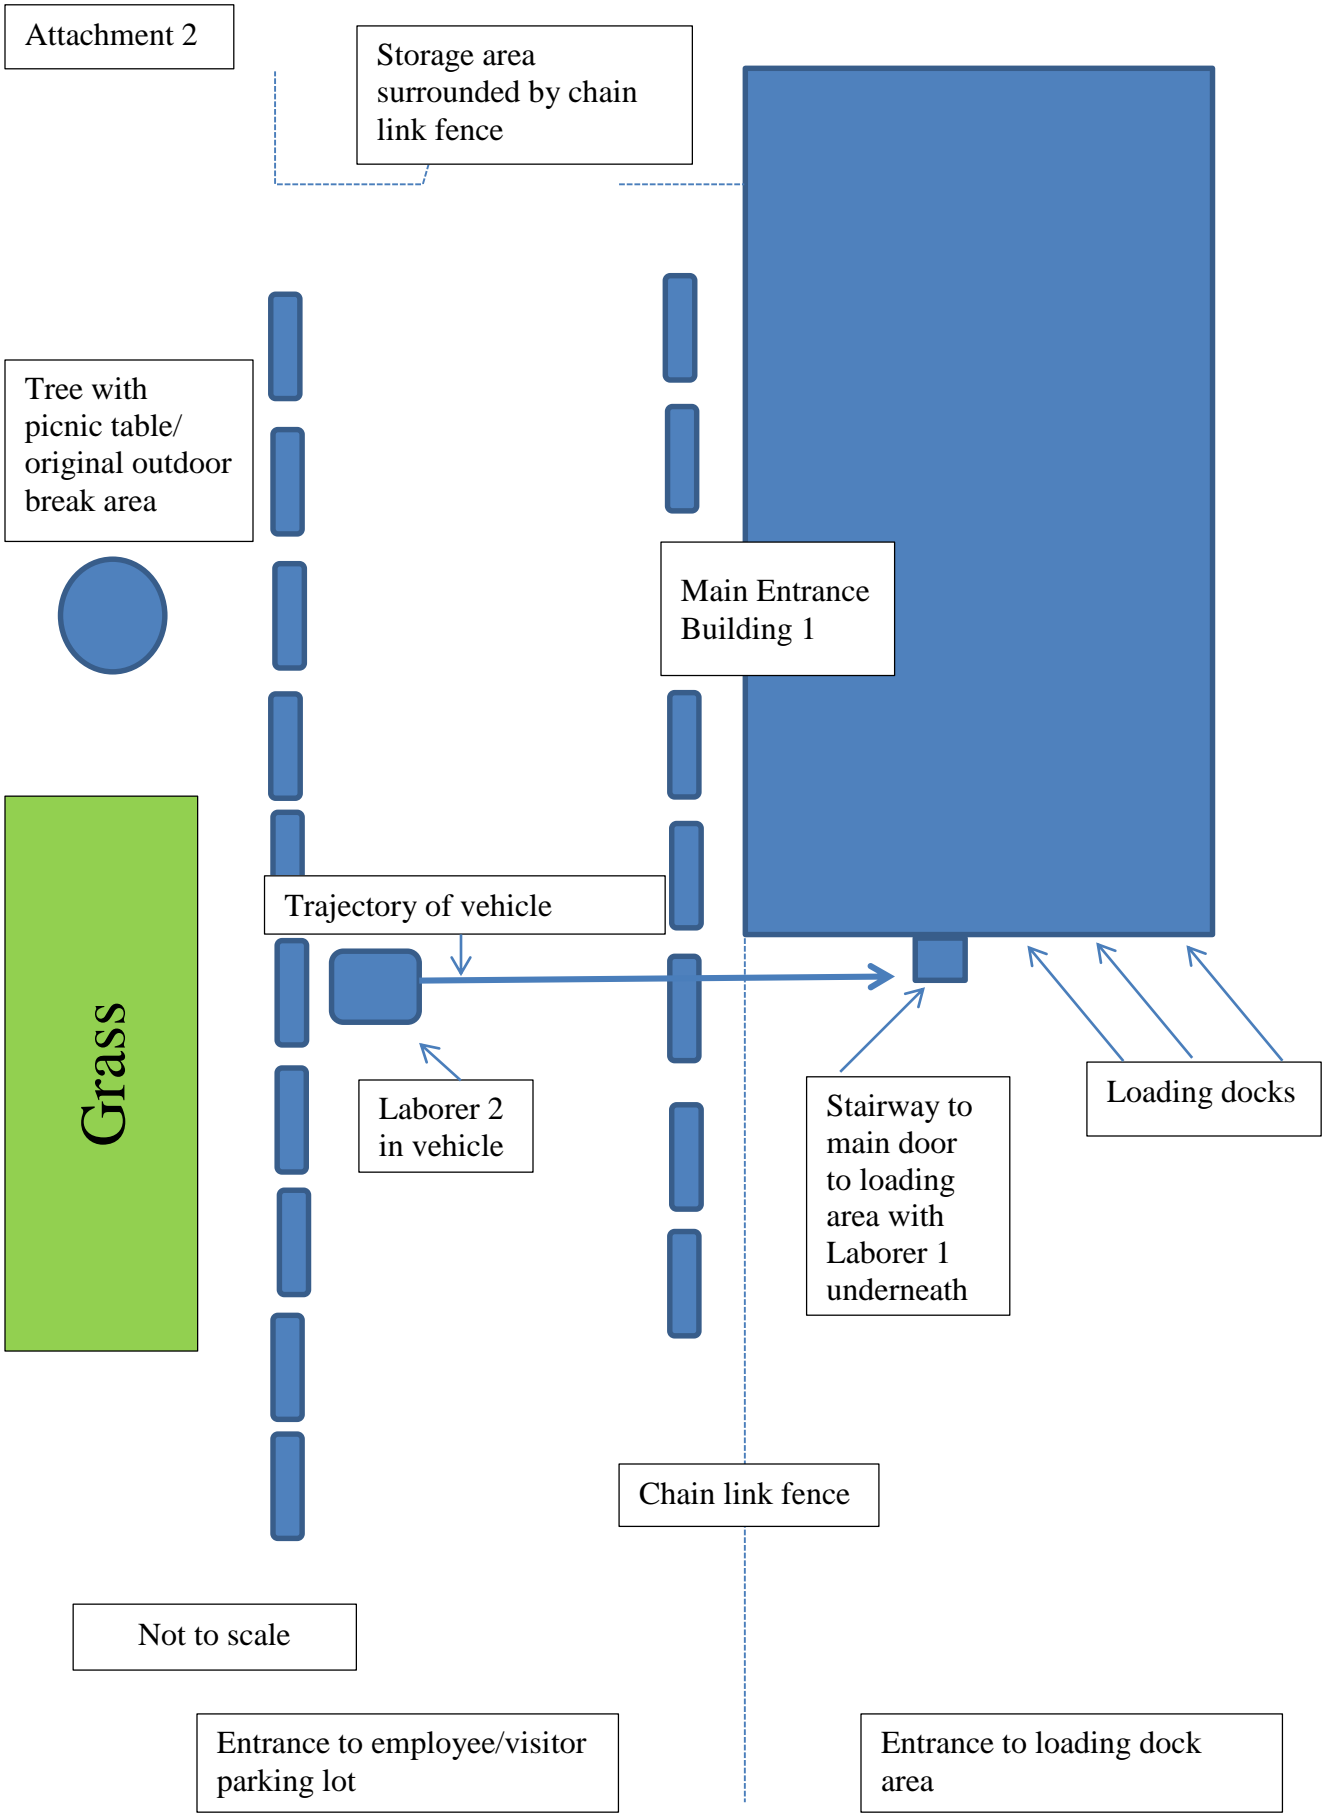
On a sunny summer day shortly before noon, a 29-year-old male factory laborer (Laborer 1) left his workstation to take a lunch break underneath a small metal stairway in the loading dock area. Coworkers revealed that it was the habit of Laborer 1 to take a nap or make cell phone calls outside under this metal stairway during his lunch break each day. The part of the loading dock area where the laborer was taking his break was separated from the employee parking lot by a chain link fence. The distance from the fence to the metal stairway was approximately 30 – 35 feet. On the day of the incident, another laborer (Laborer 2) entered her car with a friend to go out for lunch. She started her car, engaged it in reverse, and proceeded to back out of her parking space which was directly in line with Laborer 1 sitting underneath the stairway (See Diagram - Attachment 2).
