Occupational Fatality Report

Municipal Police Officer Fatally Injured When Struck by a Backing Dump Truck – Massachusetts

Release Date: June 18, 2014
Investigation: # 12-MA-016-01

Massachusetts Department of Public Health
Occupational Health Surveillance Program

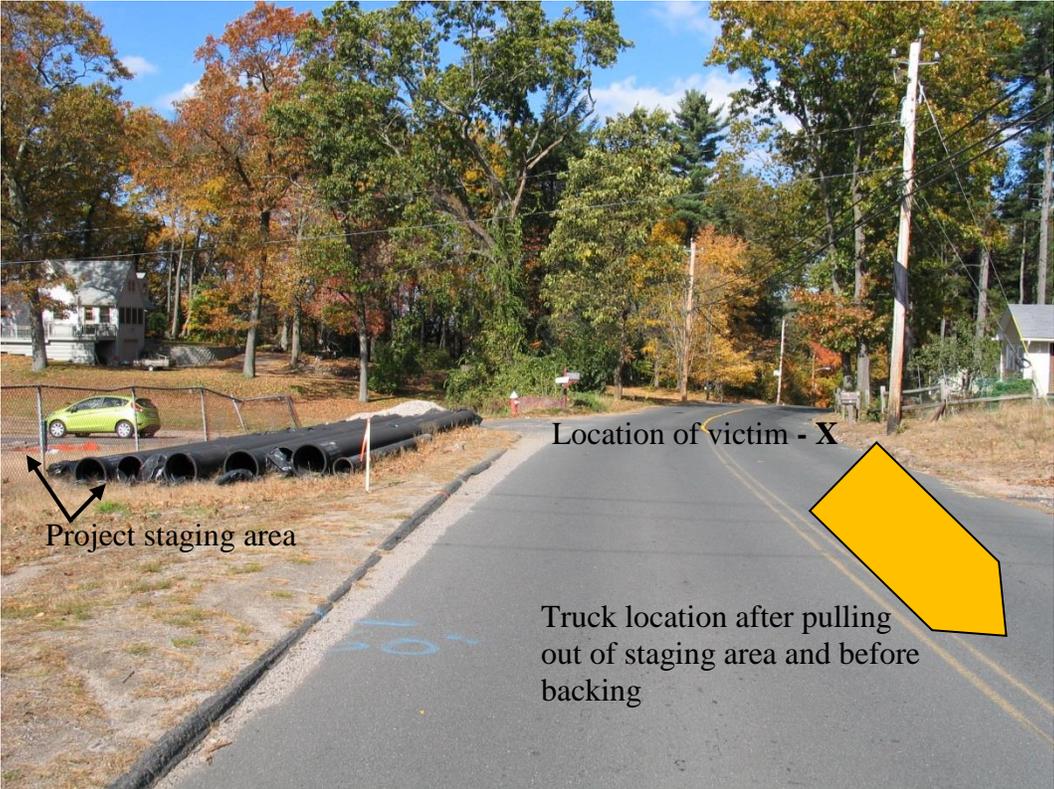
Figure 1 – Incident location looking north

The incident occurred on a rural residential roadway within a municipality incorporated as a city. The roadway was comprised of asphalt and had two lanes; a single northbound lane and a single southbound lane (Figure 1). The speed limit for the roadway was an un-posted 30 miles per hour (MPH) residential area. The roadway's markings consist of double center yellow lines separating the single northbound and southbound travel lanes. There were no painted white fog lines along the roadway edges. The width of each lane varied from 12 feet to 15 feet depending on the location along the roadway.

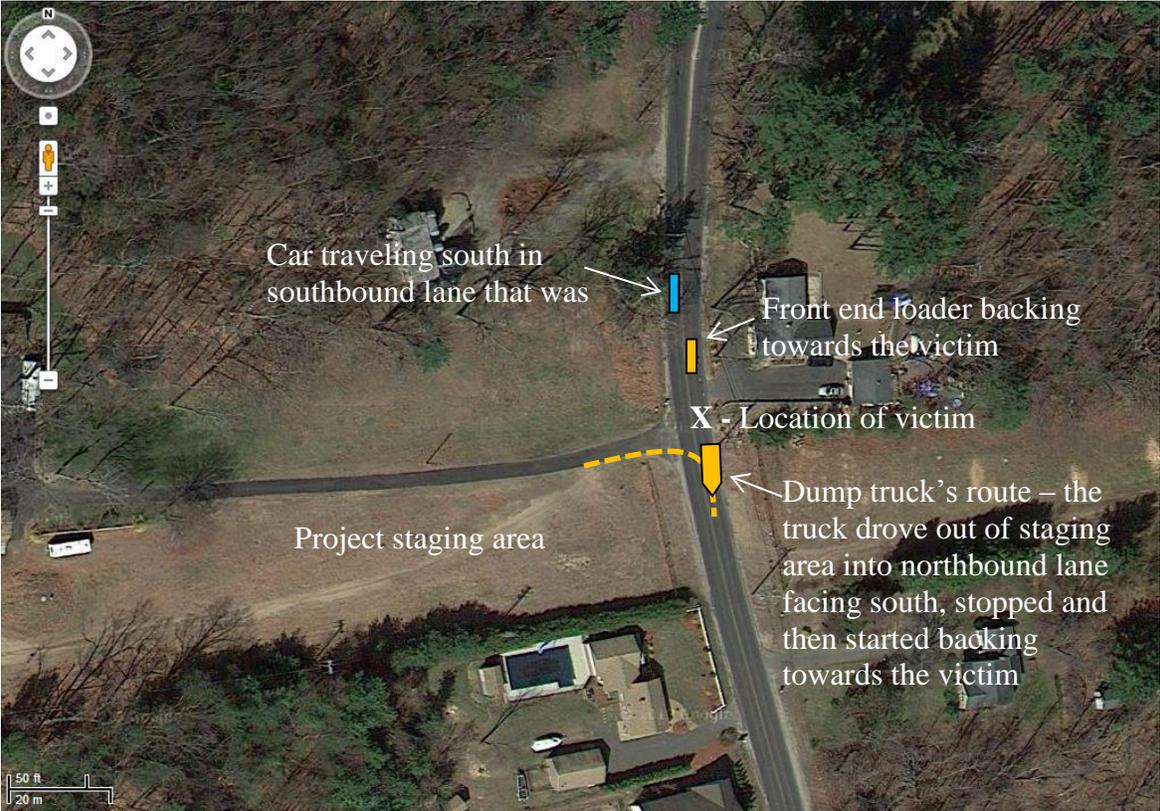
Figure 2 – Aerial view of the incident location

line replacement project. At the northern end of the incident location, the roadway curved to the east and declined while heading north (Figure 2).

The dump truck involved in the incident was parked in the construction project staging area prior to the incident. The dump truck drove out of the staging area in the forward direction and one of the officers performing a traffic detail was directing the truck. As the dump truck exited the staging area it pulled into the closed northbound travel lane facing south and then stopped. At this point the victim was standing behind and had his back to the dump truck concentrating on directing the oncoming traffic traveling in the southbound travel lane (Figure 2).
