FATALITY ASSESSMENT AND CONTROL EVALUATION

Mechanic Electrocuted when a Mobile Light Tower Contacted Powerline Case Report 12NY018

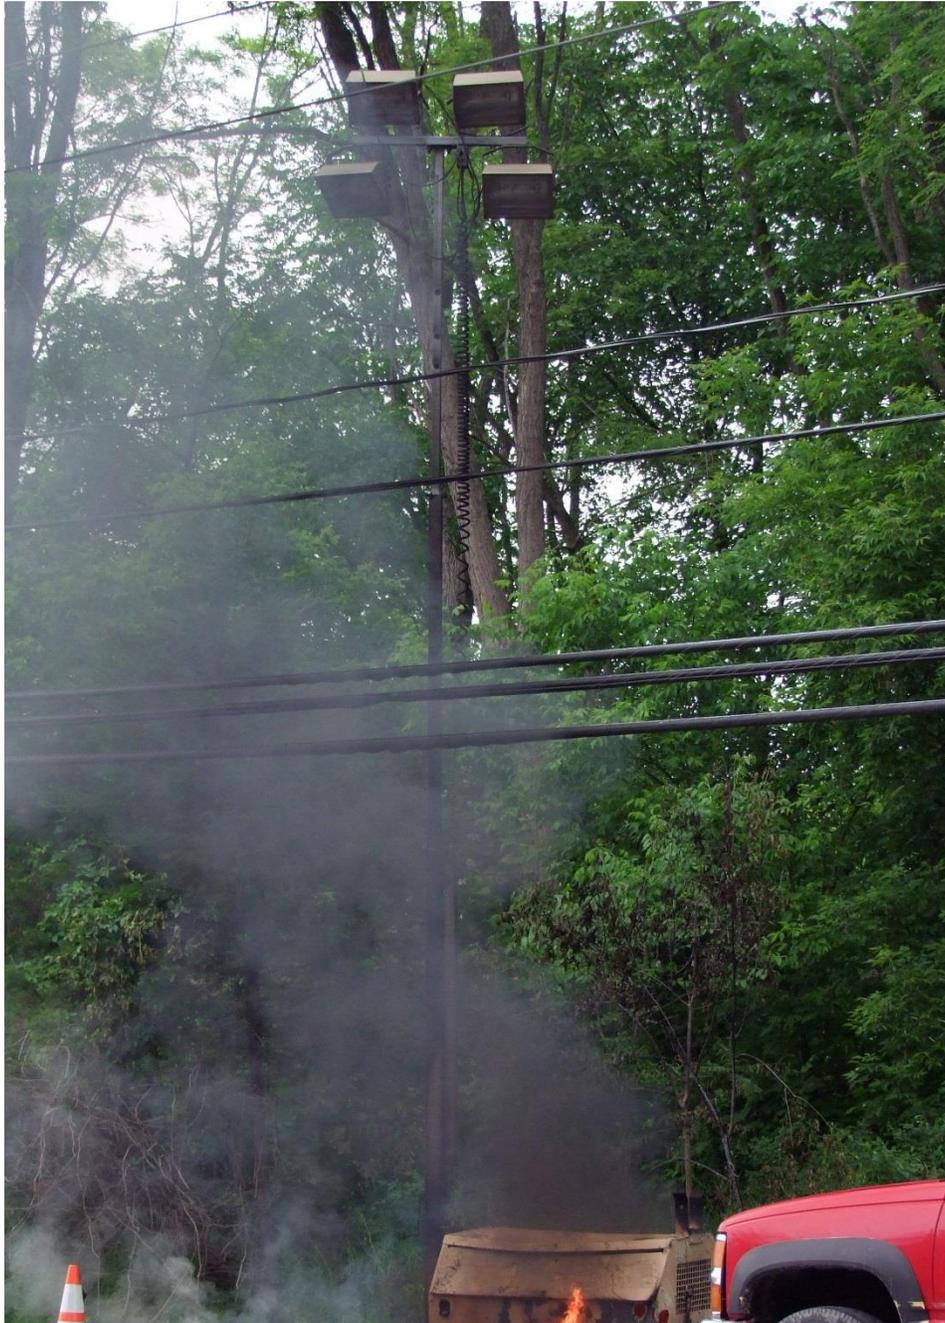
Photo 1. The mobile tower contacted a 7,620-volt powerline causing a fire and an explosion at the road construction site (photo courtesy of the town police department)

At the time of the incident, the victim was working alone on the roadside while other employees were working at a staging area. The incident was not witnessed. The light tower was positioned off the pavement on the grass under a 7,620-volt powerline that was approximately 25 feet above the ground. To lower the tower from its upright position, the victim first had to crank winch B to retract the telescopic mast and then crank winch A to fold the tower from upright to the horizontal storage position. For an unknown reason, the victim extended the mast instead of retracting it. The lights came in contact with the powerline and the victim was electrocuted. The electric current ignited the diesel fuel in the tank causing an explosion and setting the light tower on fire. The other workers heard the explosion and rushed to the site. They called 911 to summon emergency services. The police and fire department responded within minutes. The fire department had to wait for the power company to off the electricity before fighting the fire. It took approximately an hour to extinguish the fire. The victim was pronounced dead at 10:25am at the scene. The immediate cause of death was severe high voltage electrocution with thermal burns.

The manufacturer in this case required an overhead clearance of 40 feet for setting up the light tower. The maximum height of the tower was 30 feet. Therefore, the minimum safe distance was ten feet. The minimum safe distance was not maintained since the height of the powerline was approximately 25 feet and the tower was placed directly underneath the powerline.

Recommendation #1: *Employers should conduct a thorough jobsite survey to identify hazards including overhead powerlines and implement appropriate control measures prior to placing mobile light towers.*

Discussion: A jobsite hazard survey and evaluation should be performed by a competent person prior to placing mobile light towers at a construction site. Energized powerlines in proximity to a work area constitute a serious safety hazard. The hazard survey should identify: 1) the location and height of all overhead powerlines, 2) equipment to be placed under or near the powerline and the size (maximum height) of this equipment, 3) tasks to be performed underneath and in proximity to an overhead powerline, and 4) workers who are to perform those tasks. Once potential hazards are identified, appropriate control measures should be developed and implemented.

Control measures should be taken to maintain a minimum safe distance between powerlines and mobile lighting equipment. If the minimum safe distance cannot be maintained, the employer should make arrangements with the power company to de-energize the powerlines or otherwise protect the powerlines from contact.

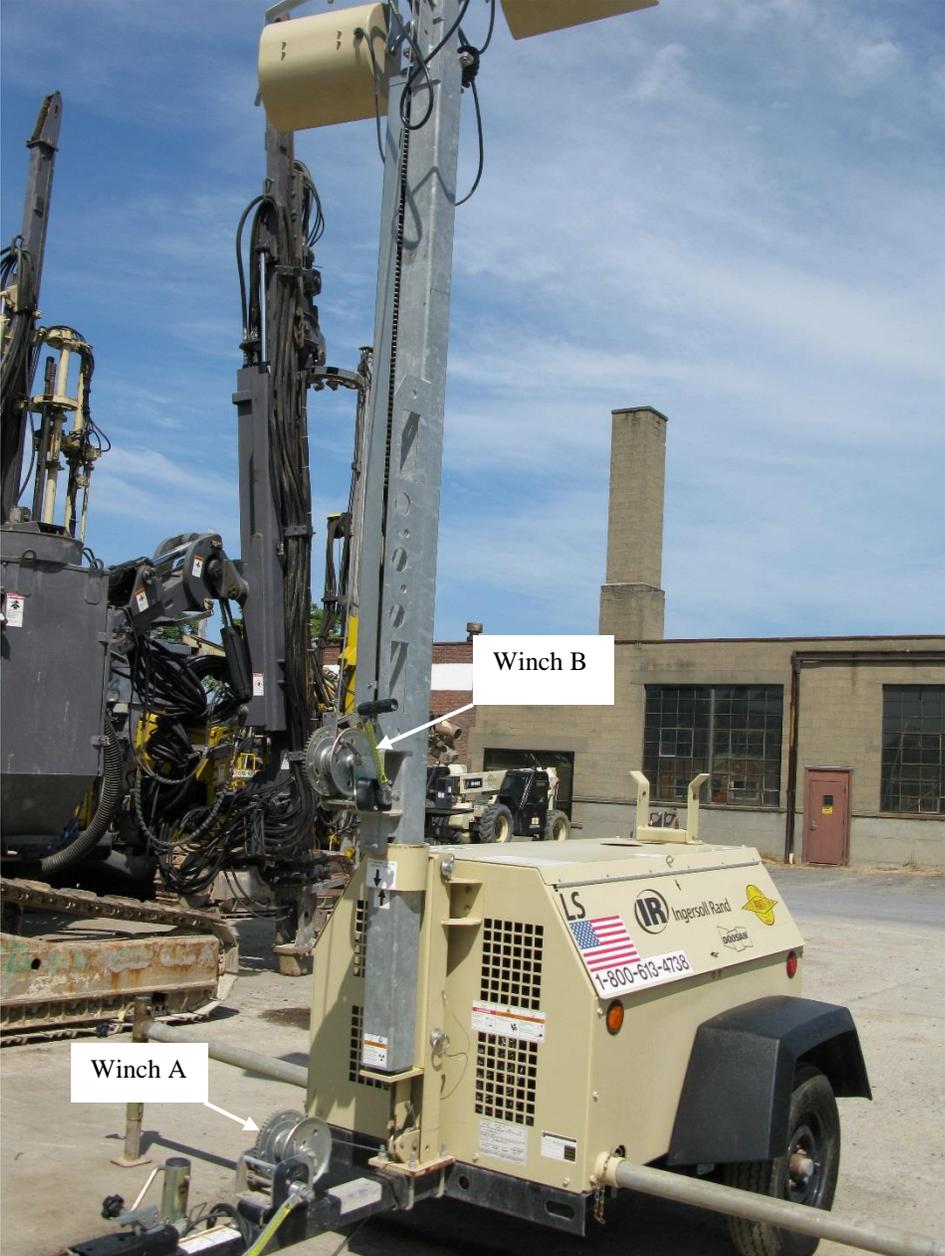
Photo 2. A Doosan mobile light tower Model LightSource, the same model as the one in the incident.

The mobile light tower was manufactured by Doosan Ingersoll Rand (Model: LightSource) and powered by a 4.6L diesel engine (Photo 2). The fuel capacity of the engine was 27 gallons (102 liters) and would allow lighting to be maintained for up to 52 hours. The light tower had four 1,000-watt metal halide lamps mounted on a telescoping mast made of galvanized steel. The telescopic mast could extend to 30 feet high with a 360° rotation and could be locked in position. The manufacturer stated in the Operating & Maintenance Manual: “*Danger: DO NOT raise or position light tower under electrical powerlines*”. There was a sticker on the tower warning the users of the electric shock hazard associated with positioning the light tower under powerlines (Photo 3).

The position and height of the tower was controlled by two hand winches (A and B). Winch A raised the tower from a horizontal position to an upright position and winch B extended (or retracted) the light tower (Photo 2). There was a yellow sticker on both winch handles stating that turning the handle clockwise would raise the tower and turning handle counter-clockwise would lower the tower (Photos 4). However, the Tower Operating Instruction posted on the tower did not specify which direction to turn the winch to raise or extend the tower. It simply stated that “operate winch A to raise tower” and “operate winch B to extend tower” (Photo 4).

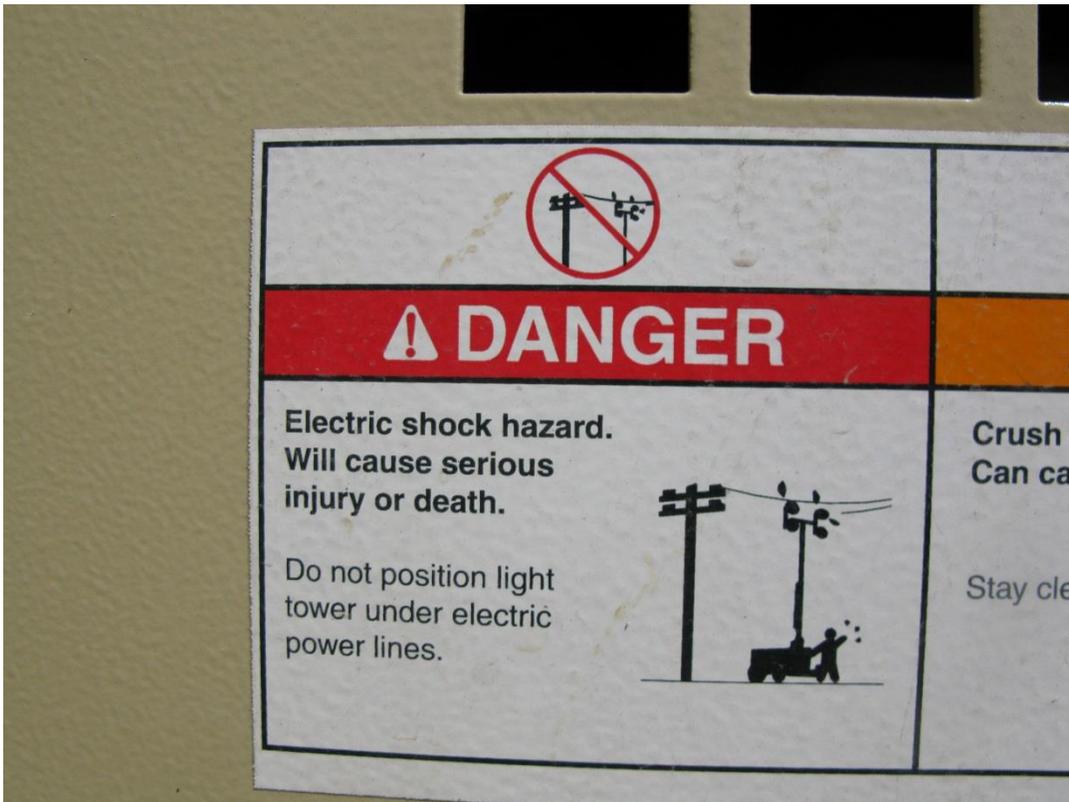
Photo 3. A manufacturer’s sticker on the Doosan light tower warned of the electric shock hazard associated with positioning a light tower under powerlines.

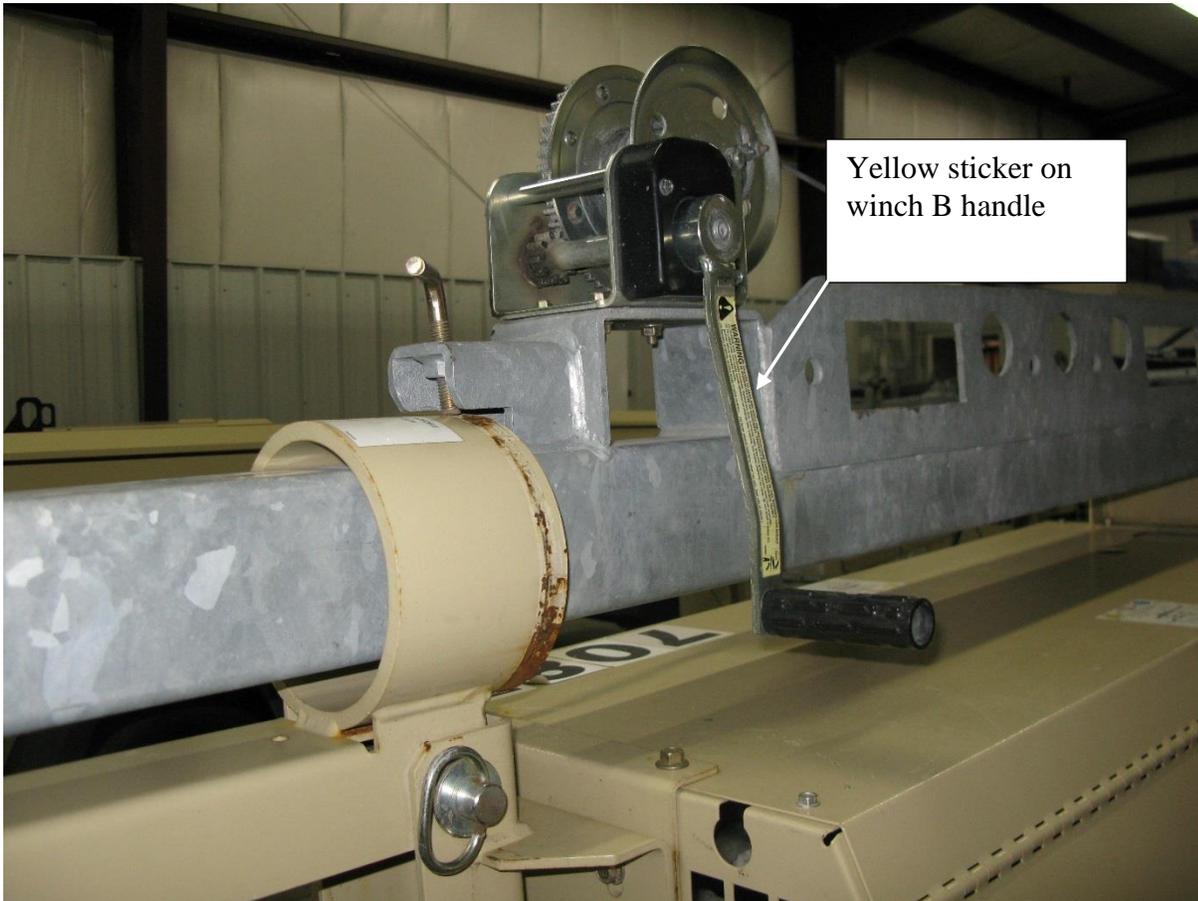
Yellow sticker on winch B handle

Photo 4. The yellow sticker on winch handles stated that “to raise load, turn handle clockwise” and “to lower load, turn handle counter-clockwise”.
