## Fatality Investigation Report

OR 2012-18-1

# Experienced Journeyman Machinist Killed While Operating an Engine Lathe

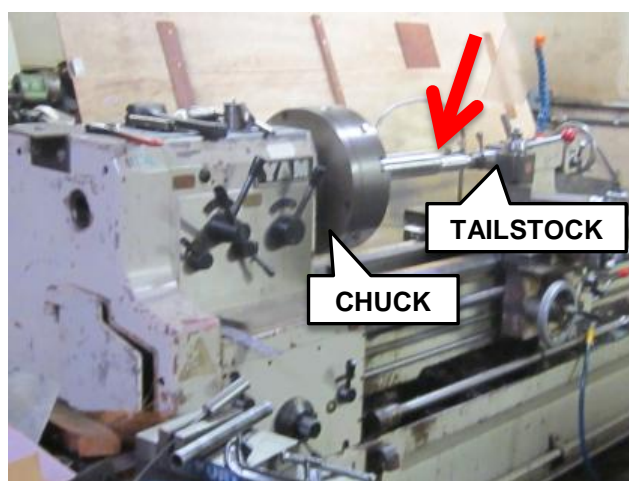
The engine lathe where the event occurred. The arrow indicates where the victim became entangled.

- The OR-OSHA investigator believed that the victim's loose fitting cut-off sweatshirt was the first point of entanglement with the work piece. The most common causes of death and injury from metal lathes include entanglement of clothing in moving parts, being hit by loose objects on the lathe (e.g., chuck keys, tools, metal shavings) and being struck by a part that has not been adequately secured (see reference Work Safe Victoria, September 2010). To prevent entanglement, recognized accepted practices include prohibiting loose clothing, jewelry, gloves and unsecured long hair around rotating equipment.

#### **Recommendation #1: Employers should establish, communicate and enforce a clothing policy specific to the work environment and particularly for machine operators.**

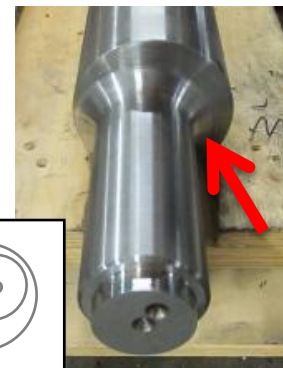
On the day of the incident the machinist was operating an engine lathe turning an eccentric shaft. These shafts have offset centers, as shown in the photograph of a finished product with a schematic drawing of the part face. Because of the offset centers, the surface of one end of the shaft rotates around the lathe centerline during the machining operation. During the OR-OSHA interview with the shop foreman, he indicated that these shafts required the use of emery cloth or file handled by the operator to smooth the transition of the radius of the two centers. Eccentric shafts of varying lengths were produced by the employer for vibratory equipment.

ABOVE: A finished eccentric shaft. Arrow indicates the transition of the radius of the two centers. The black and white drawing is a face schematic of the shaft end.

When examining the work piece that the machinist had been turning, the shop foreman stated that the rough surface could grab clothing or gloves. He also indicated that he would have set the spindle speed to no more than 330 rpm. The settings on the lathe indicated a spindle speed of approximately 590 rpm when the incident occurred. This speed may have caused machine vibration and greater air turbulence similar to a fan intake increasing the potential for entanglement with loose clothing.

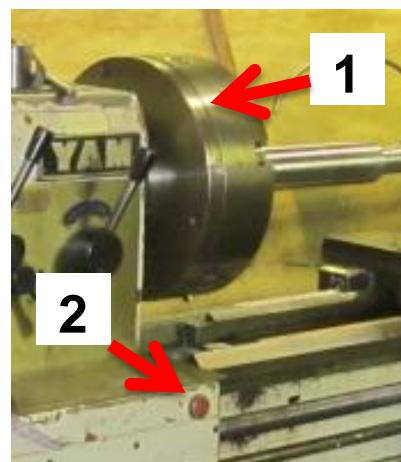
ABOVE: (1) Lathe involved in the incident with unguarded chuck and (2) red “inch” (or jog) button.

- Job hazard analysis is especially critical when there are legacy machines with varying hazard controls. These job hazard analyses should be used to create SOPs that would eliminate and/or control the hazards. The investigation revealed that there were several engine lathes in the shop. The engineering or regulatory standards at the time of manufacture or country where manufactured were likely different. For example, the machine involved in the incident had a red button that was not an emergency stop whereas another engine lathe had two red emergency stops. Current OSHA regulations or ANSI Z535.1-1998 do not specify which machine parts require color-coding. However, a standard interpretation (see reference OSHA, Standards Interpretation) states, that the “employer has the responsibility to evaluate the machine and determine if any portion needs to be color-coded.” In this particular case employees assumed that the red button on the engine lathe was an emergency stop. Training, labeling, or changing the color of the button after a job hazard analysis would have corrected the mistaken assumption that the “inch” button was an emergency stop. After the incident the employer painted the brake bar red, covered the “inch button” and had begun the process to add an emergency stop on the lathe involved in the incident.

- During routine preventive maintenance it might have been discovered that the red button was not an emergency stop. Preventive maintenance can also ensure controls for recognized hazards are installed consistently across similar equipment. Manufacturers of equipment and aftermarket safety equipment should be consulted for the type of controls.

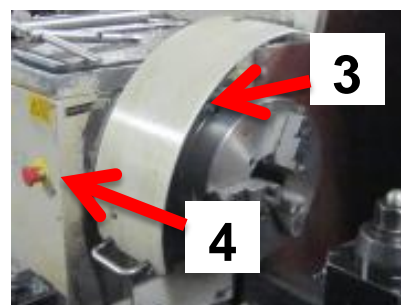
The shop where the incident occurred had different models of engine lathes with different safety features. The engine lathe involved in the incident was manufactured in Taiwan and believed to have been manufactured 40 years ago. Another shop lathe was manufactured in England in 1996. The safety features for the recognized lathe hazards (e.g., rotating chuck) were different. For example, an interlocking chuck guard was a component of the newer lathe while there was no chuck guard for the older lathe. In addition, whereas the red button on the newer lathe was an emergency stop, it was not on the older lathe. The manual indicated it was an “inch” (could be a translation of jog) button. Pushing and holding this button in causes the lathe to rotate. Releasing the button stops the lathe. This control is used for checking tool set-ups before machining the work piece. Multiple employees thought the red “inch” button on the engine lathe was an emergency stop. Quickly stopping this machine was accomplished by stepping on a foot-operated brake bar, located just above floor level and extending along the front of the machine.

BELOW: (3) Lathe manufactured in England also on site with interlocking chuck guard and (4) red “emergency stop.”

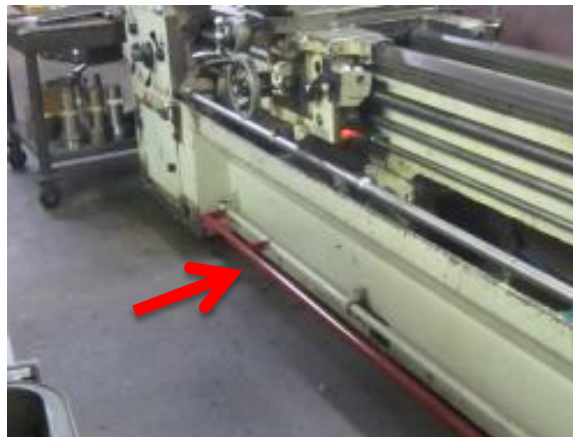
While doing so his own arm was repeatedly struck by the eccentric shaft until his cry for help summoned the manager who upon arriving at the scene immediately stepped on the brake bar, stopping the machine.

Brake bar on the engine lathe, which was painted red following the incident

**Recommendation #5: Employers should implement preventive maintenance and inspection processes for hazardous machines. Where necessary, employers should install, adjust, label and/or repair appropriate controls (e.g., machine guards, emergency stops).**
