FROM: California Fatality Assessment and Control Evaluation (CA/FACE) Program

SUBJECT: A Supervisor Dies When He is Decapitated by a Rope That Was Pulled Into a Wood Chipper

SUMMARY
California FACE Report #12CA001

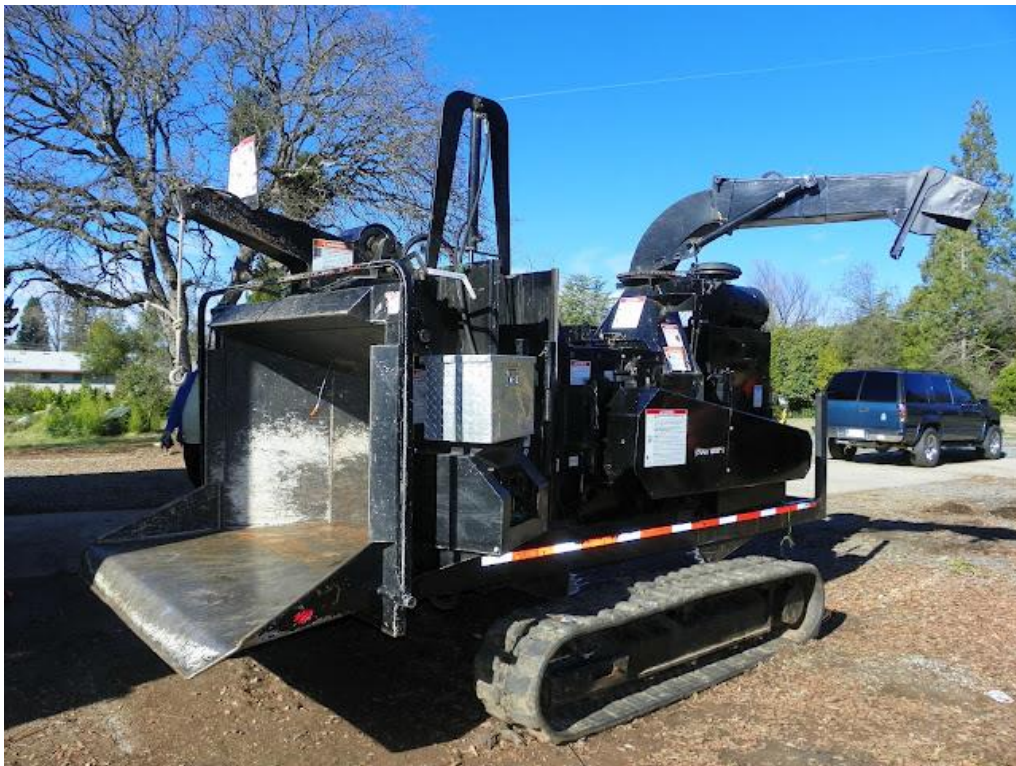
The wood chipper involved in the incident was a Bandit Model 1890 that was purchased new in 2004 (see exhibits 1-4). This was a self-propelled track-mounted chipper with reversing auto feed rollers, hydraulic swivel discharge, and a remote control for portable operation. The wood chipper also included a hydraulically controlled rope winch mounted above the feed table (see exhibit 4).

Exhibit 1. The right side of the wood chipper involved in this incident.

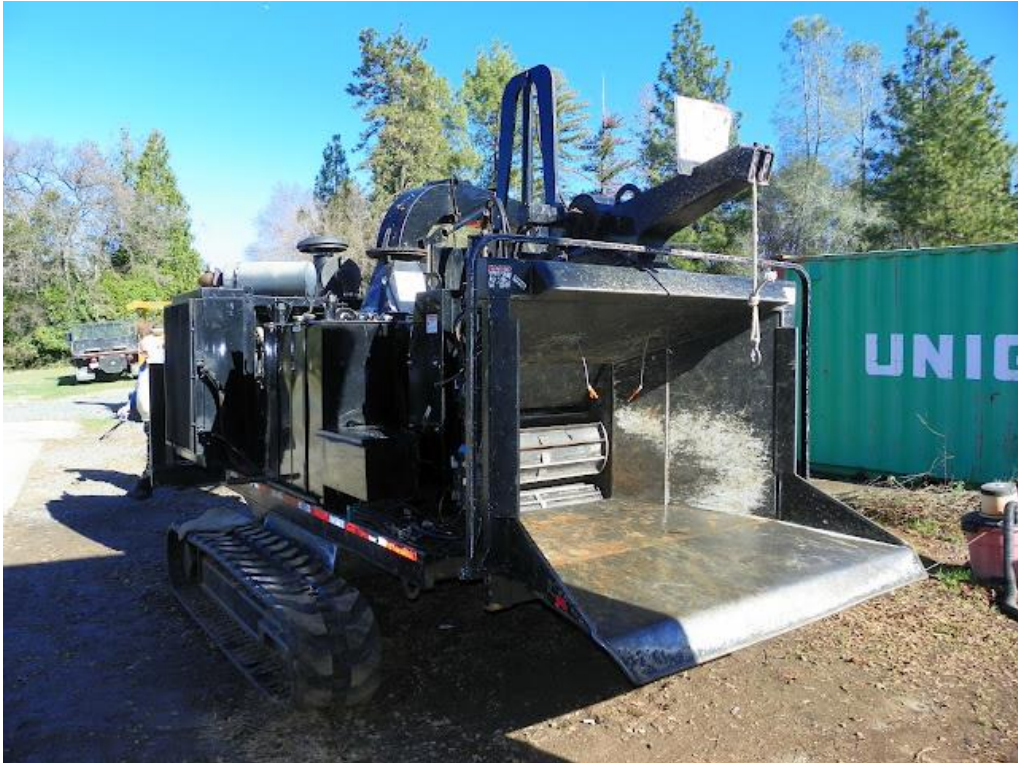
Exhibit 2. The left side of the wood chipper involved in the incident.

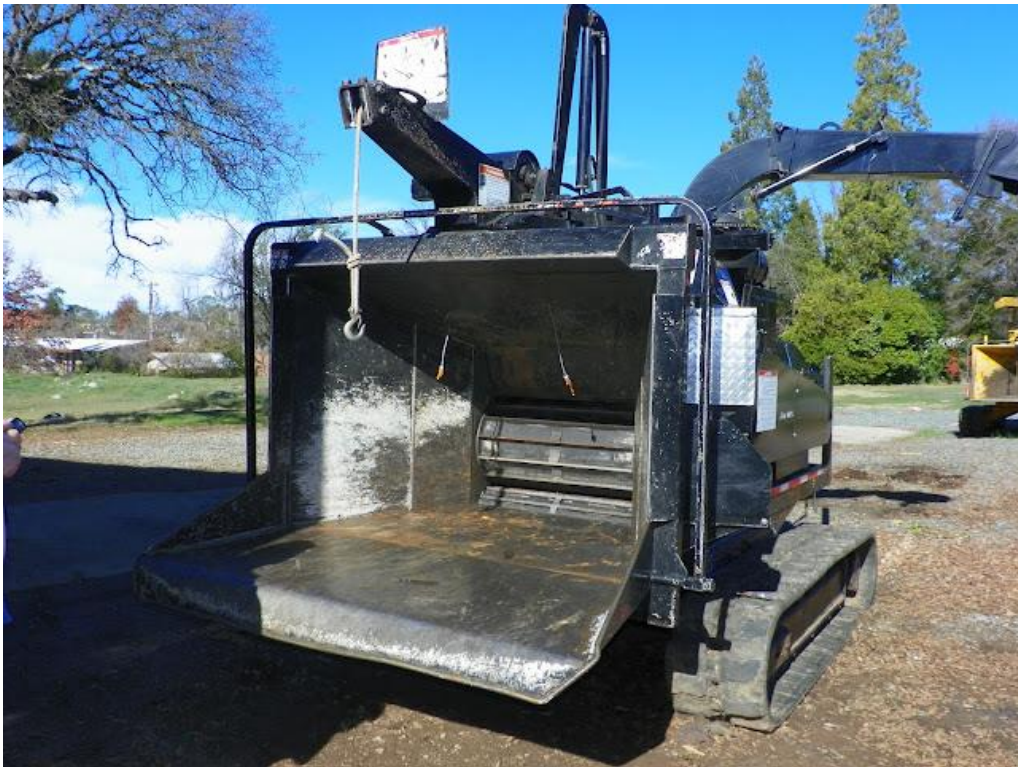
Exhibit 3. The wood chipper feed table and feed rollers.

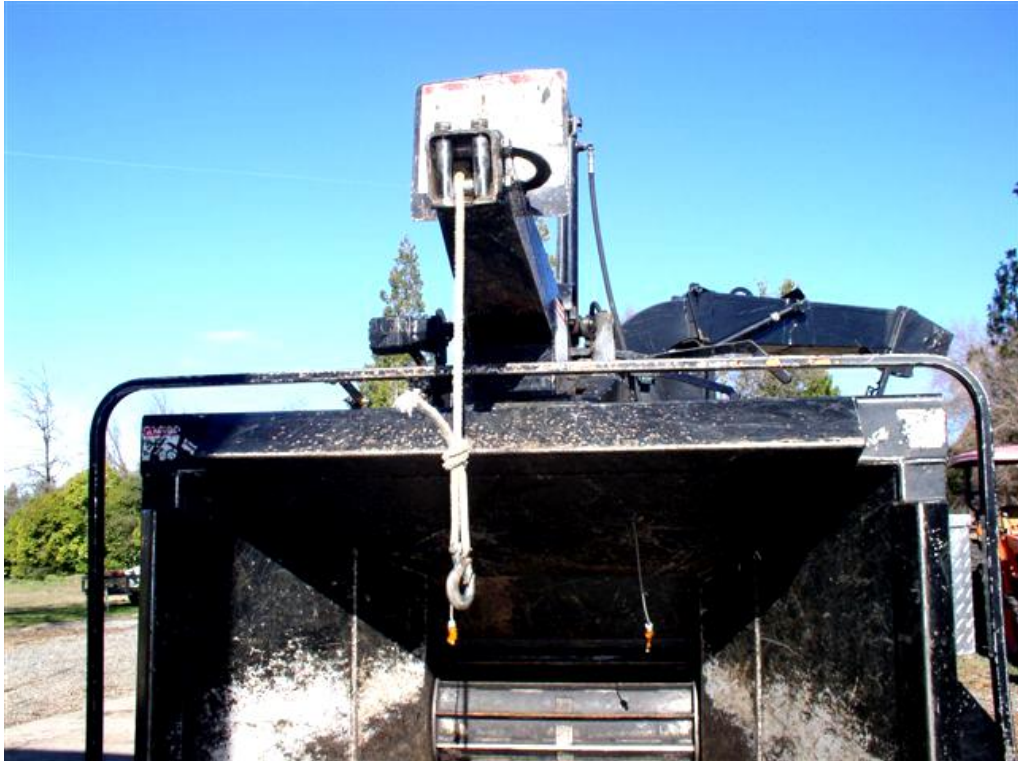
The work process involved cutting trees and brush, cinching cut limbs and brush into bundles with a rope, and dragging them up the steep incline by a second rope from the wood chipper-mounted winch. The wood chipper was controlled and operated by a remote control that the victim wore around his waist. After the bundles of cut limbs and brush were dragged to the wood chipper, the rope was supposed to be removed from the bundle before the branches were fed into the chipper.

Exhibit 4. The rope winch on the wood chipper used to pull tied bundles of brush and cut branches up to the feed table.

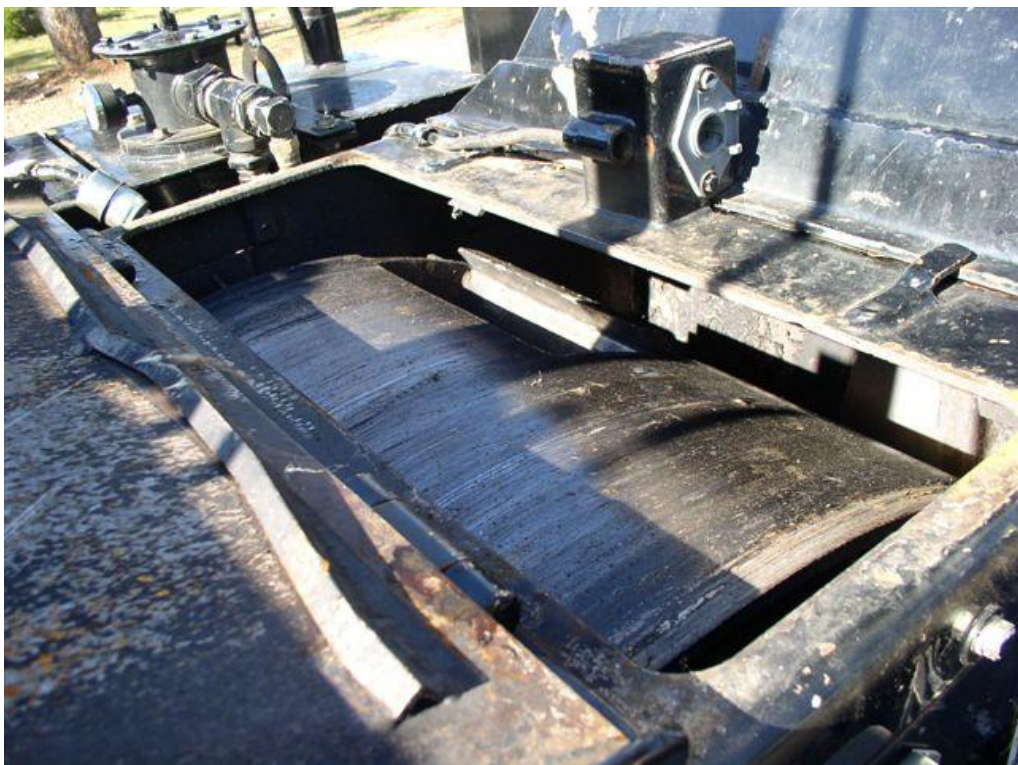
Discussion: In this incident, a co-worker cinched a bundle of brush with a rope and used the winch to drag it up the hillside to the chipper. While feeding the brush into the chipper, one end of the rope entered the chipper and wrapped around the chipper's drum, pulling the rope taut, entangling the victim, and decapitating him. Although ropes serve a useful purpose in the tree trimming and brush clearing business, they should always be removed from the point of operation of chippers before chipping begins and never used to feed material into the wood chippers. To prevent such incidents, all cut branches and brush should be placed in piles and inspected prior to being fed into wood chippers to ensure that they are free of any unwanted object(s) that might cause personal injury. Had the material been placed in piles and inspected prior to being fed into the chipper, the rope may have been removed from the bundle thereby preventing this incident.

Exhibit 5. The wood chipper's drum that the rope was wrapped around.

Recommendation #1: Ensure that cut tree branches are placed in piles and checked for unwanted objects before being fed into wood chippers.

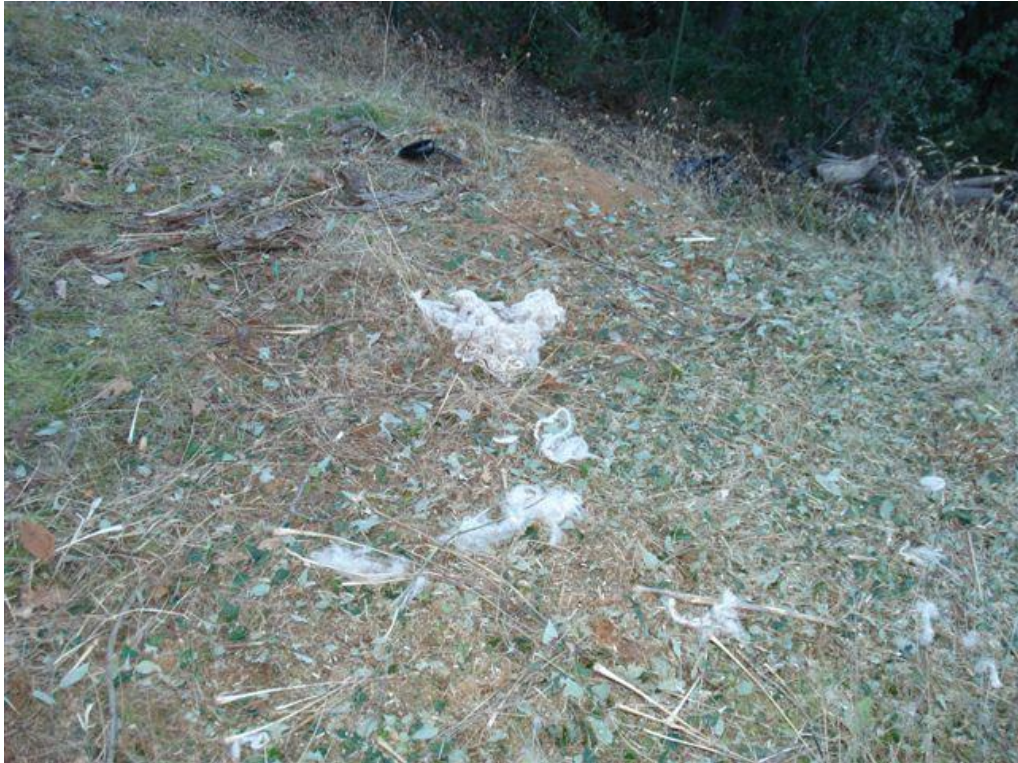
Exhibit 6. Portions of the frayed rope after it went through the wood chipper.

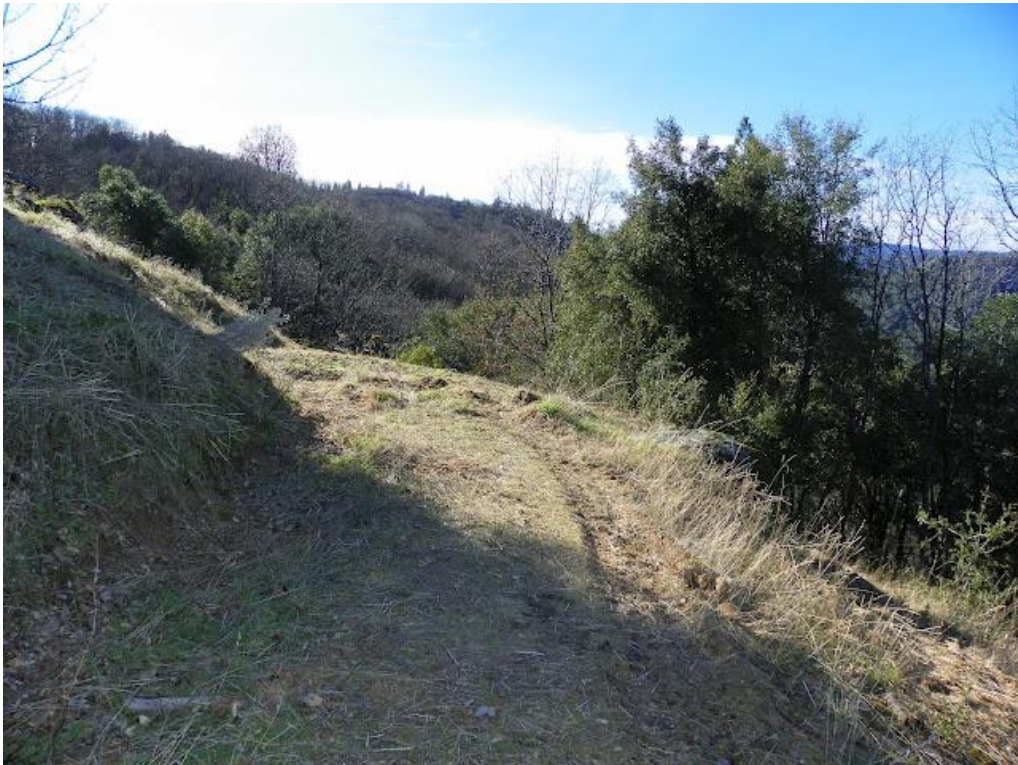
Exhibit 7. The location in the back of the house where the wood chipper was parked.

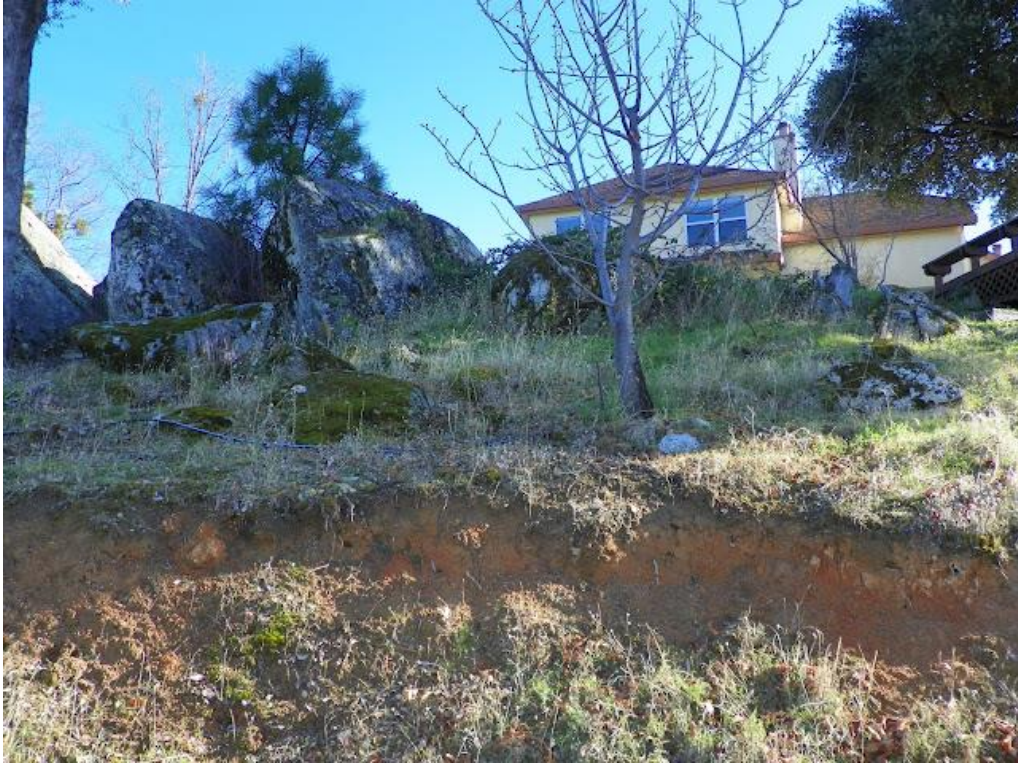
Exhibit 8. The back of the residence where the wood chipper was located.

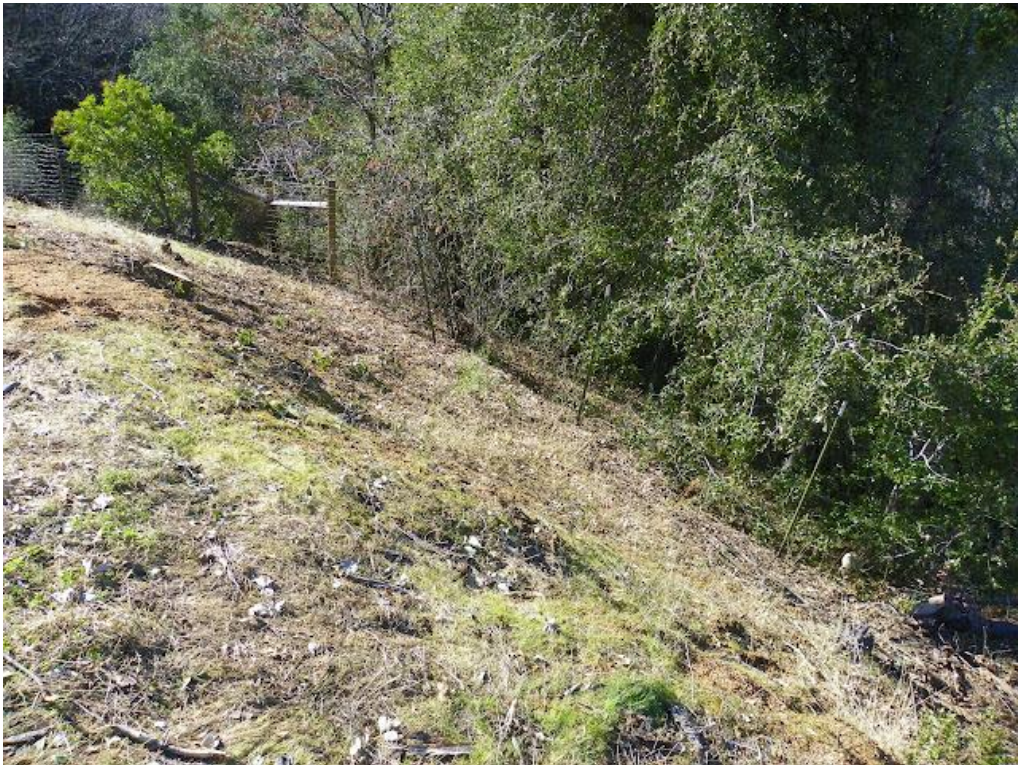
Exhibit 9. The steep hillside where the employees were working.

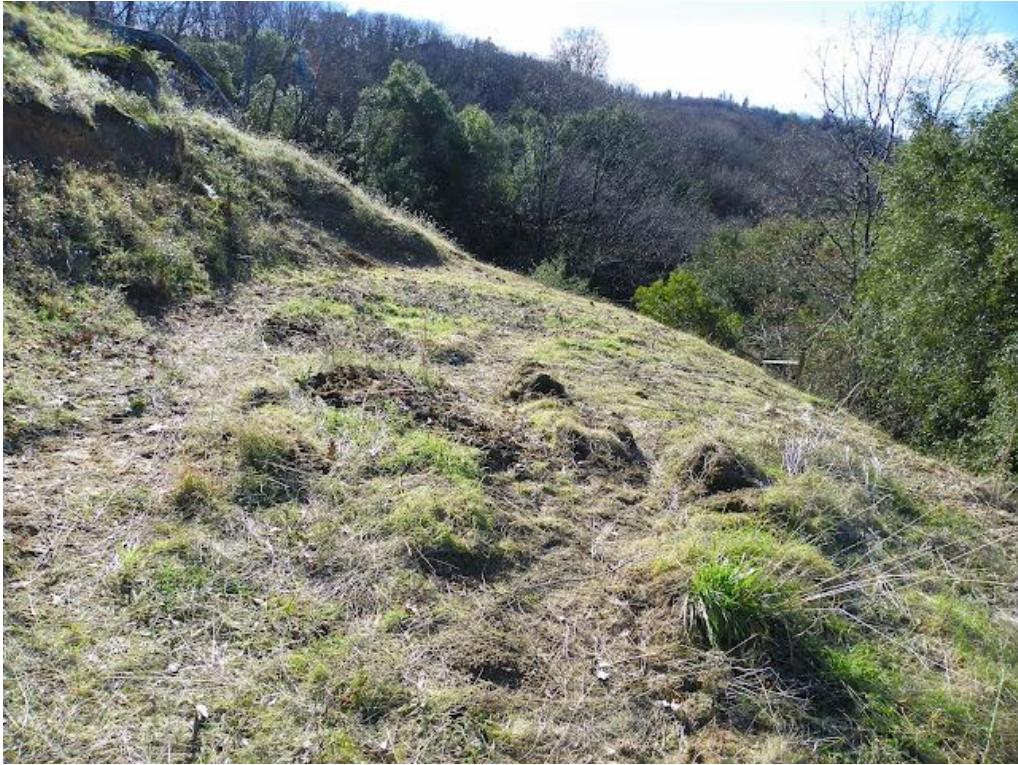
Exhibit 10. The incident scene showing the topography of the land.
