## Occupational Fatality Report

### Mechanic Crushed When the Dozer He Was Lowering Shifted and Fell off the Jack - Massachusetts

Release Date: March 12, 2015  
Investigation: # 13-MA-002-01

Massachusetts Department of Public Health  
Occupational Health Surveillance Program

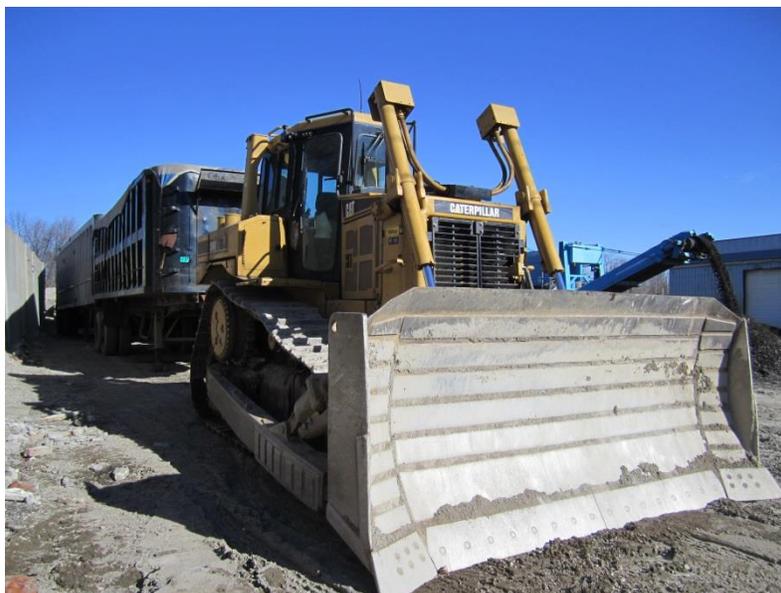
The machine involved in the incident was a track-type tractor (dozer) that had been manufactured in 2006. The company purchased the dozer in the same year it was manufactured (Figure 1). The dozer was equipped with an enclosed cab and an elevated sprocket undercarriage. The dozer had an operating weight of just over 44,200 pounds.<sup>1</sup> The dozer was 10'6" high, 8'8" wide, and 12'8" long without an attachment. The victim was replacing the dozer's right front track adjuster at the time of the incident. The defective track adjuster was under warranty by the manufacturer, but the labor cost to replace the part was not covered with the warranty. Therefore, the company was going to remove the defective track adjuster and send it to the manufacturer. Then the manufacturer was then going to send a new track adjuster to the company to install.

**Figure 1 – The track type tractor (dozer) involved in the incident**

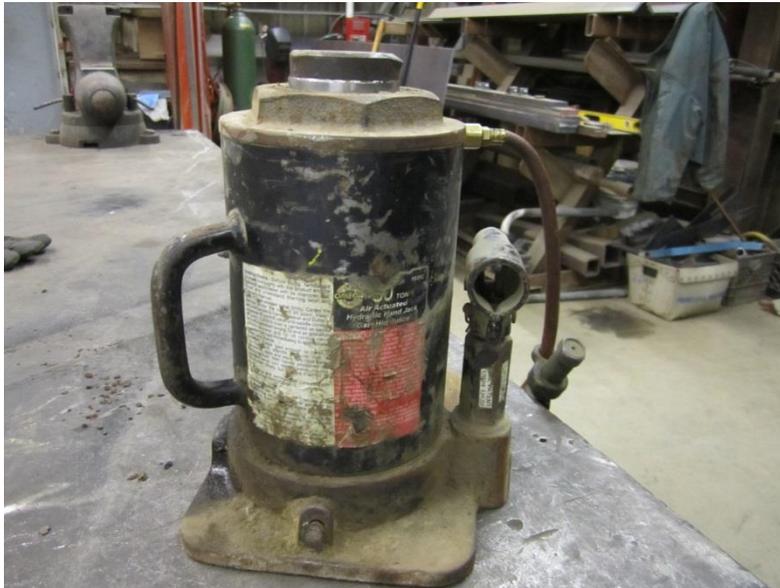
To perform the repair, the dozer had to be lifted to remove the dozer's weight from the track. A 30-ton air actuated hydraulic bottle jack was used to raise the dozer (Figure 2). The bottle jack had a lifting capacity of 60,000 pounds and a maximum lift height of 18 inches. The base of the bottle jack was 10 ¼ inches long by 8 ¼ inches wide and the diameter of the saddle, the point of contact between the jack and the load being raised, was 2 ½ inches.<sup>2</sup> The jack had a warning label but it was no longer in readable condition. The company had the operating manual for the jack and the warning labels were included in the manual. The warning labels included that work should never be performed under or around a load supported only by the hydraulic jack. In addition, the operating manual included two warnings that were specific to this type of incident. These warnings were to ensure that: 1) all tools and employees are clear before lowering a load and 2) employees never place any portion of their body under a load while it is being raised or lowered.

**Discussion:** In this case, the warning label on the bottle jack was worn and no longer legible. While housekeeping was not the root cause of this fatality, if the warning label had been visible the employees might have been reminded of the hazards associated with using the bottle jack. As mentioned above, the warning label included that work should never be performed under or around a load supported only by the hydraulic jack.

**Figure 2 – The 30-ton bottle jack being used during the incident**

Routine inspections of the bottle jack could have previously led to the observation and replacement of the worn warning label. In addition, the visual inspections would include looking for any abnormal conditions such as excessive wear, cracked welds, and damaged, loose or missing parts. If any of these or other conditions are observed, the jack should be immediately tagged and removed from service until it is repaired. OSHA also requires that all jacks, which are constant or intermittently used at one locality, to be inspected once every six months by the manufacturer or an authorized repair facility.

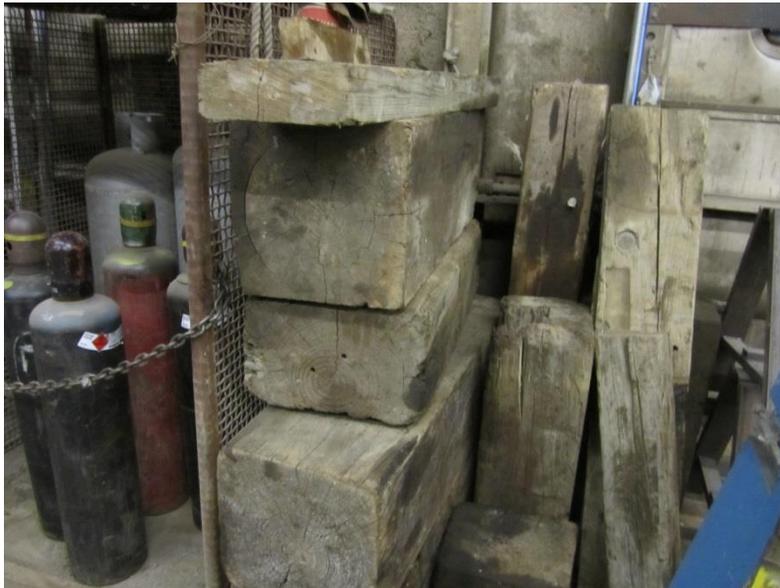
One of the first steps performed during the replacement of the track adjuster was to remove the dozer's blade attachment. The 30-ton air actuated hydraulic bottle jack was used to raise the dozer and 12x12x4 oak blocking was used as cribbing to secure the raised dozer. Once the cribbing was in place, the jack was removed from underneath the dozer. While waiting for the new track adjuster to arrive, the dozer remained raised and supported by the cribbing inside one of the garage bays (Figure 3).

In this case, the dozer was raised by the bottle jack and then lowered onto cribbing in the form of oak blocks placed in a cross pattern underneath the dozer.<sup>3</sup> The dozer remained supported on the cribbing throughout the repair process. Once the dozer was ready to be lowered, the bottle jack was used to raise the dozer and the cribbing was removed. While lowering the dozer an issue was encountered and the victim then went partially underneath the dozer while it was only being supported by the bottle jack to try and observe the problem. At this point, prior to going underneath the dozer, the cribbing should have been put back in place to ensure the dozer was stable. A quicker alternative would be to use jack stands instead of cribbing. If jack stands are used, employers must ensure that the jack stands are rated to support the weight of the intended load. In addition, jack stands should only be used when the task is being performed on a hard level surface.

**Figure 3 – The oak block cribbing being used during the incident**
