MIFACE INVESTIGATION REPORT #13MI102

SUBJECT: Airport Manager Killed When Homemade Drag Struck Him While Smoothing a Runway

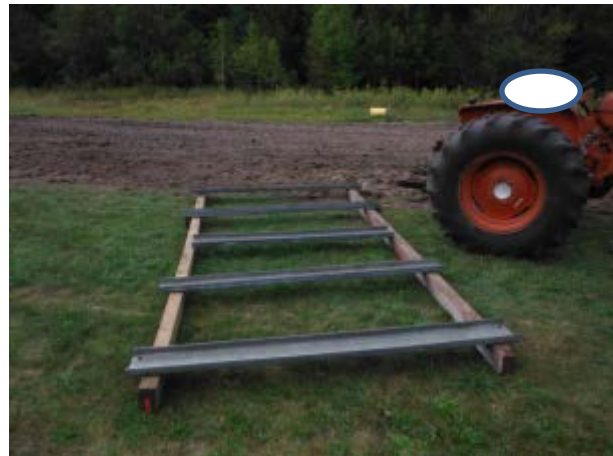
Figure 1. Overview of incident scene. Drag had been positioned on ground from upright position against rear of tractor

The decedent was found slumped over on the seat with an injury to the top of his head. A possible scenario is that the decedent noted dirt clods building up on the front channel iron and placed the tractor in neutral to get off the tractor and clear the clods. Prior to getting off of the tractor, the tension on the chain to the driver's left caused it to break, and the drag to flip upward toward the decedent, striking him on the top of his head. Emergency response moved the drag to the position as shown in Figure 1 for their safety and to avoid further injury to the decedent.

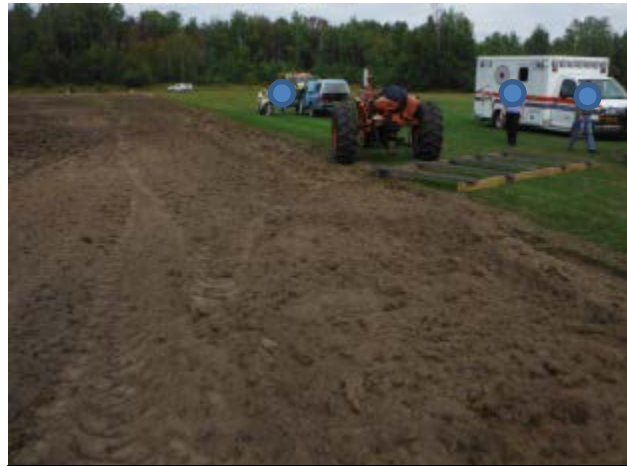
The north end of the runway was uneven. The dirt area where he was working was approximately 75 feet wide. On the other side was the runway. The decedent had previously used the tractor and had disced this dirt area adjacent to the runway. At the time of the incident, he was in the process of leveling it. The terrain was described as damp/moist and was rutted from the disc activity.

Figure 3. Overview of incident scene looking north.
