MIFACE Investigation Report #13MI136

SUBJECT: Dump Truck Driver Entangled in Dump Box Power Take Off Driveline

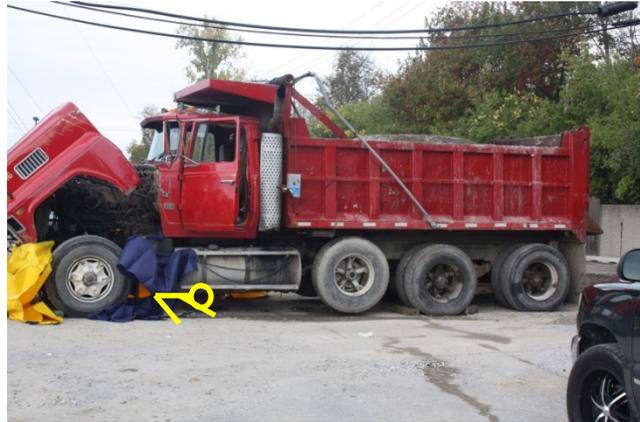
Figure 1. Decedent’s dump truck and position of decedent at incident location

- Truck not turned off and PTO rotating when he went underneath the truck
- PTO driveline not shielded

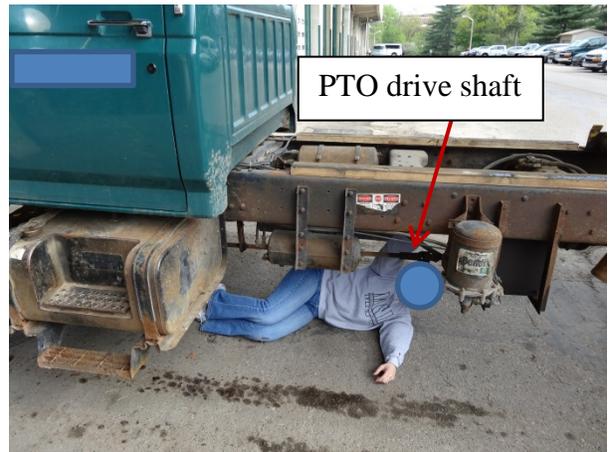
With the truck running and PTO activated, the decedent went under the truck to try to ascertain the problem. A possible scenario was that he was attempting to determine if there were loose cable connections (used to raise and lower the dump box) at the “gear box” controlling the hydraulic valves (See Figures 2 and 3 re-enactment).

Figure 2. Re-enactment of position of decedent as shown in the police pictures

As he was reaching up, his clothing contacted the spinning drive shaft and wrapped around it, pulling his neck against the driveline, and choking him. At some point, the truck stalled. At approximately 9:35 a.m., the individual who had subcontracted his services arrived at the incident site. He walked over to the truck, noting it was stalled, and called the decedent’s name while tapping on the truck. When the decedent did not answer him, he looked under the truck and saw the decedent. He immediately called 911.

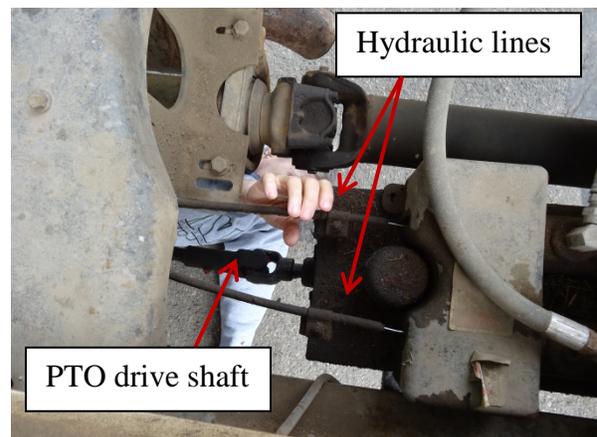
Figure 3. Re-enactment scenario of decedent’s activity
