MIFACE INVESTIGATION REPORT #13MI149

SUBJECT: Truck Mechanic Pinned By Truck's Sway Bar and Link

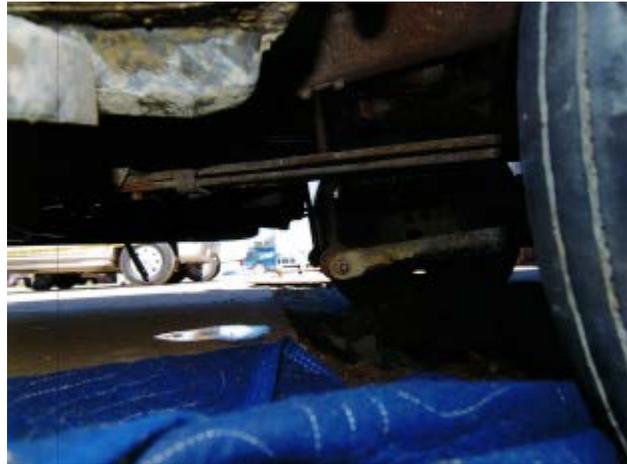
Figure 1. Picture of sway bar/linkage, passenger side, decedent's work area

brake. No wheel chocks were used to prevent truck movement. At some point while lying on his back working under the truck, the truck moved backward, with the front wheels entering a 5-inch deep dirt trench. The truck's sway bar and link to the rear of the front axle fell on the decedent's chest, pinning him against the cement (Figure 1). A building employee had left approximately one hour earlier and had noted the truck running. When he returned, the truck was still running, so he looked under the truck. Seeing the decedent, he screamed for help. Emergency response was summoned. A jack was used to raise the truck. The decedent was transported to a local hospital and declared dead.

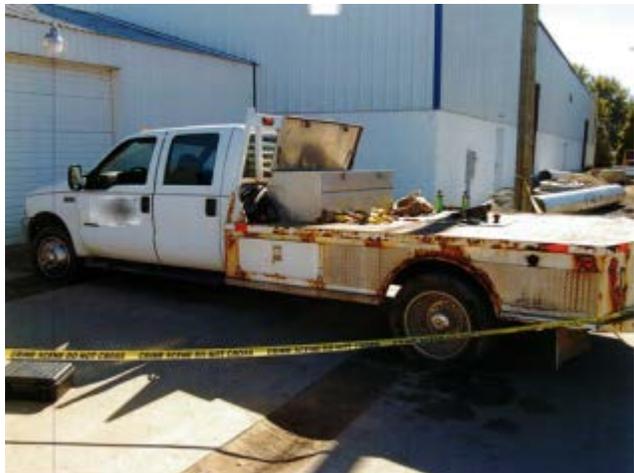
Figure 2. Truck involved in incident. Truck facing east, front wheels in trench

At approximately 9:30am, the friend drove the truck to the back of the auto parts store, parking the truck facing east (Figure 2). There had been two newly created trenches near the building due to the removal of concrete. The trench located a few feet from the building was approximately three feet wide and approximately five inches deep. The second trench was approximately 19 ½ inches wide, was concave in nature, and was located approximately 14 feet away from the building. There was a slight pavement decline from the building toward the center of the property to allow for water drainage. The decedent's friend parked the truck with the truck's front wheels over and several inches past the easternmost trench, in front of an overhead door to allow for more space under the truck for the decedent to work. The friend placed the manual transmission in park and turned the ignition key to off. The work plan did not include jacking the truck up from the ground.

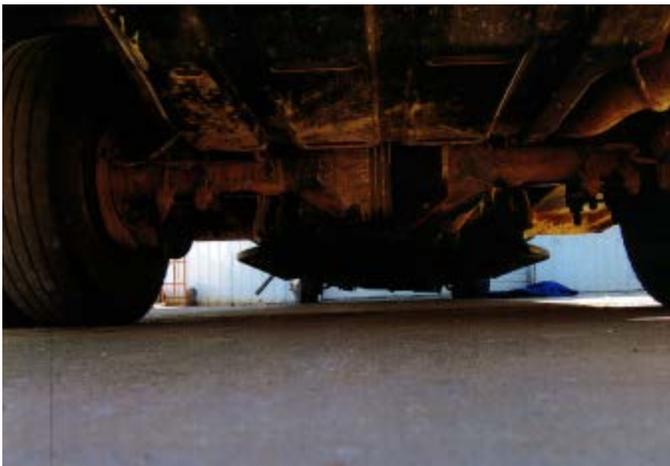
Figure 3. View of undercarriage and distance between sway bar and linkage and cement

For reasons unknown, while he was under the truck, the truck rolled backward four to five inches and fell down hard as the tires entered the five inch deep dirt trench. The ground clearance on the driver's side of the vehicle near the front bumper (minus the plastic air dam) and lower fender area measured approximately 12 inches. Police personnel measured 5¼ inches from the compacted earth near the west edge of the trench to the bottom of the sway bar where it connected to the passenger side sway bar link. A second measurement from the concrete west edge to the lower passenger side leaf spring was measured at approximately 9 inches.

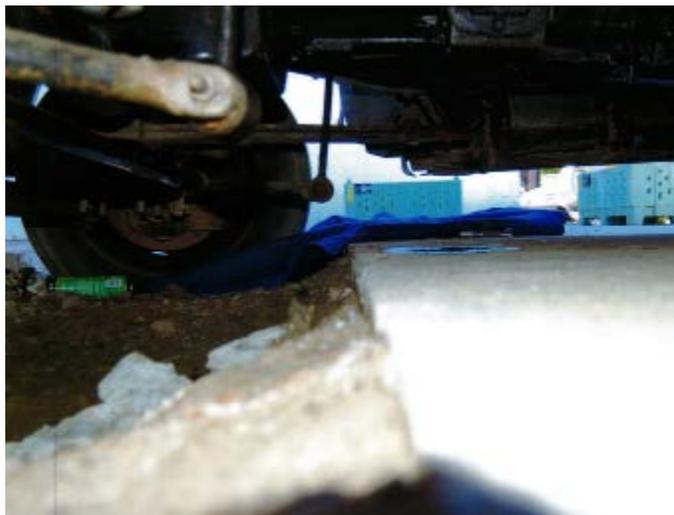
Figure 4. View of incident area looking from driver's side.
