Heavy Equipment Mechanic Dies when an Elevated Dump Truck Tag Axle Pins Him to the Concrete Floor

Incident Number: 13KY041

Kentucky Fatality Assessment and Control Evaluation (FACE) Program

Subject: Mechanic Dies when an Elevated 1800 lb. Tag Axle Pins Him to the Concrete Floor.

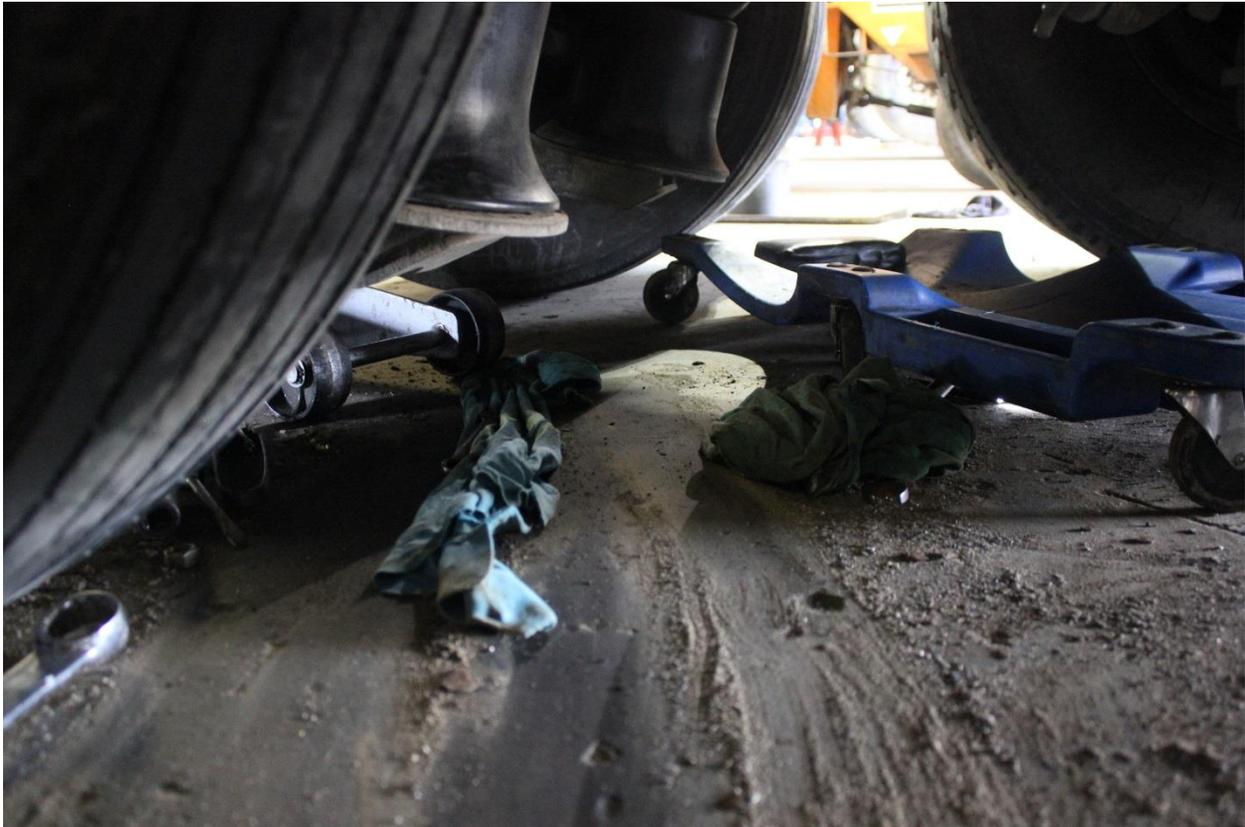
On September 19, 2013, at approximately 4:28 p.m. a 58-year-old heavy equipment mechanic was replacing an air bag on a tri-axle dump truck. The victim was under the truck and axle, which was resting on a hydraulic floor jack. While the victim was under the axle, he inadvertently placed his hand on the jack causing the floor jack to lower and pin him between the axle and the concrete floor. At 4:48 p.m. the shop security camera shows the victim's fellow mechanic return to the shop after he finished repairing a truck he was working on. He returned to the shop where the victim was working, to get ready to leave for the day. He yelled for the victim but received no answer. The mechanic observed the victim's legs and called out his name again, with no response. The mechanic walked around the truck to the passenger side and observed the victim's left hand on the handle of the jack. The mechanic removed the victim's hand from the jack and shook him without getting a response. He yelled for other employees to dial 911 for assistance. The victim's head was pointed toward the jack which was on the front side of the tag axle. The victim was lying on his right side with 1/3 of his body on the creeper. The mechanic started jacking the jack but it would not move. He then turned the handle and the jack started elevating. Once the axle was lifted off the victim, another employee pulled the victim out from under the truck on the creeper. Employees trained in first aid and CPR started CPR and put an AED device on the victim and placed a call to EMS at 4:51pm. EMS and the Sheriff arrived six minutes after the call was placed, and the victim was transported via ambulance to the hospital. After being crushed by the dump truck, the victim succumbed to his injuries due to compression asphyxia on September 21, 2013 at 1:50 am.

Recommendation No. 1: Employers shall ensure that employees using jacks must crib, block, or otherwise secure the loads immediately after they have been raised.¹
