Auto Technician Mistakes Handicapped-Accessible Accelerator Pedal for Brake Pedal and Fatally Pins Co-Worker

Incident Number: 14KY001

**Kentucky Fatality Assessment and Control Evaluation (FACE) Program
Incident Number: 14KY001
Release Date: June 30, 2014
Subject: Auto Technician Mistakes Handicapped-Accessible Accelerator
Pedal for Brake Pedal and Fatally Pins Co-Worker**

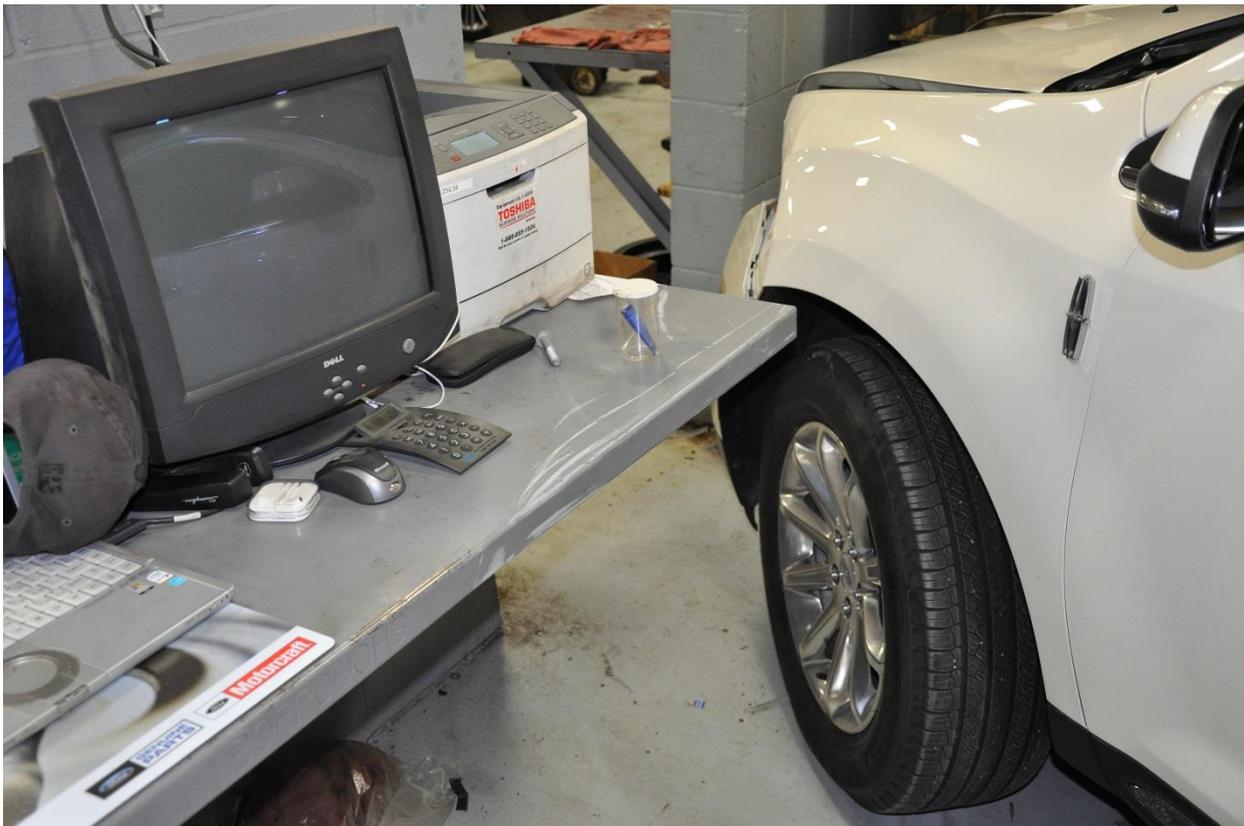
The incident scene was a service bay area of an automobile dealership. The service bay area and the administrative area where serviced-related computer work was performed were all located together. The Administrative area was in front of the bays where vehicle servicing was performed, without any barriers and the employees sitting there had their backs toward the service area.

Desk area where victim was working

Recommendation No. 2: All duties and other tasks not involving the driver of the vehicle, should be performed in an area away from or barricaded from contact with vehicles being serviced.

While service technicians are also doing administrative work on their computers, it is highly recommended that for any task not involving the driver of the car the work area should be away from the area where the vehicles are being serviced or barriers/ guardrails should be installed to protect them from incidents of this nature in the future. If this is not possible, then an administrative procedure should be developed for the technician to clear the area in front of and behind the vehicle before moving the vehicle.

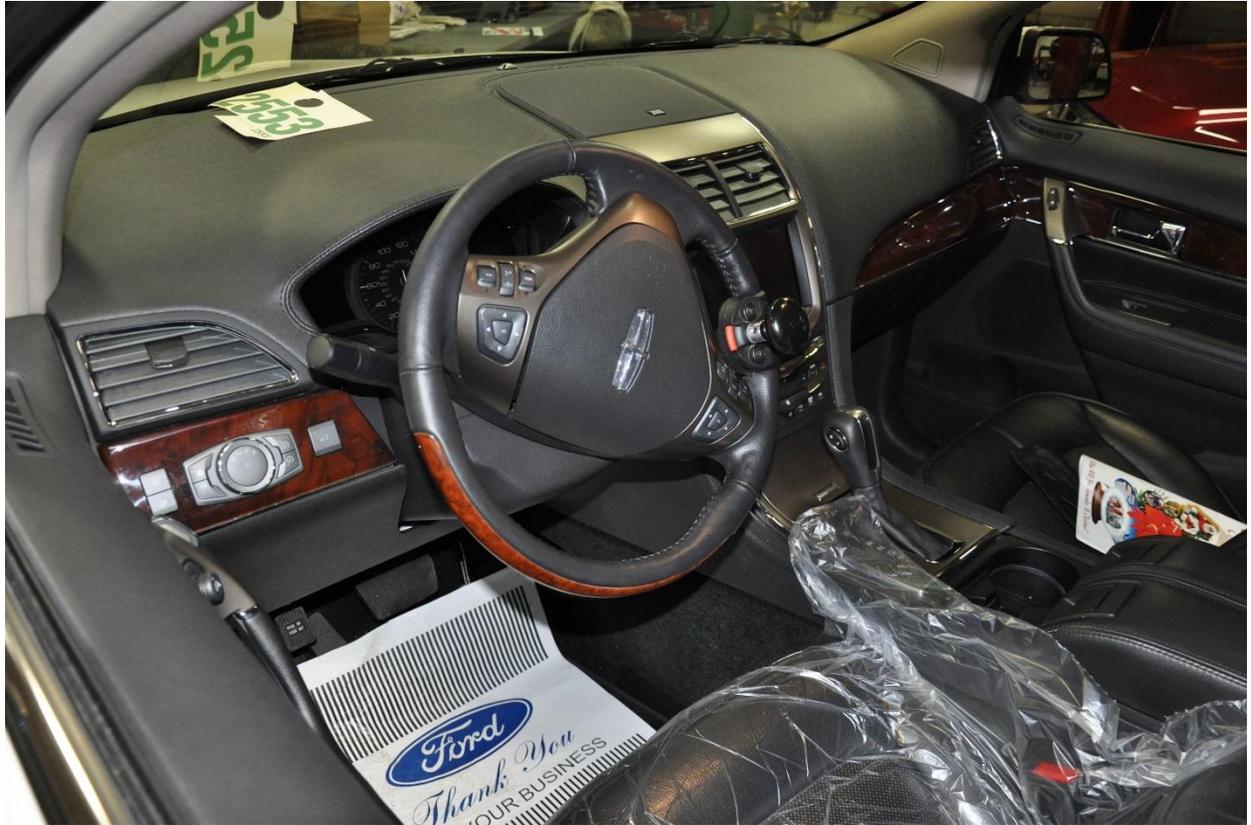
Another scenario, noted in the second photograph, the paper mat is covering the handicapped foot pedal. This could have played a factor into the incident, hiding the fact there was a handicapped pedal and surprising the technician. This is another reason why the warning sticker is necessary.

Inside the handicapped vehicle

sticker should be posted on the dash where a new driver would see it telling them to remove the pedals or explaining the operation of the pedals. This particular manufacturer does include these stickers to be placed on the dash with each of their products sold as a warning to untrained drivers. The authorized installer of the equipment should mandate these stickers be placed in the vehicle for safety reason.

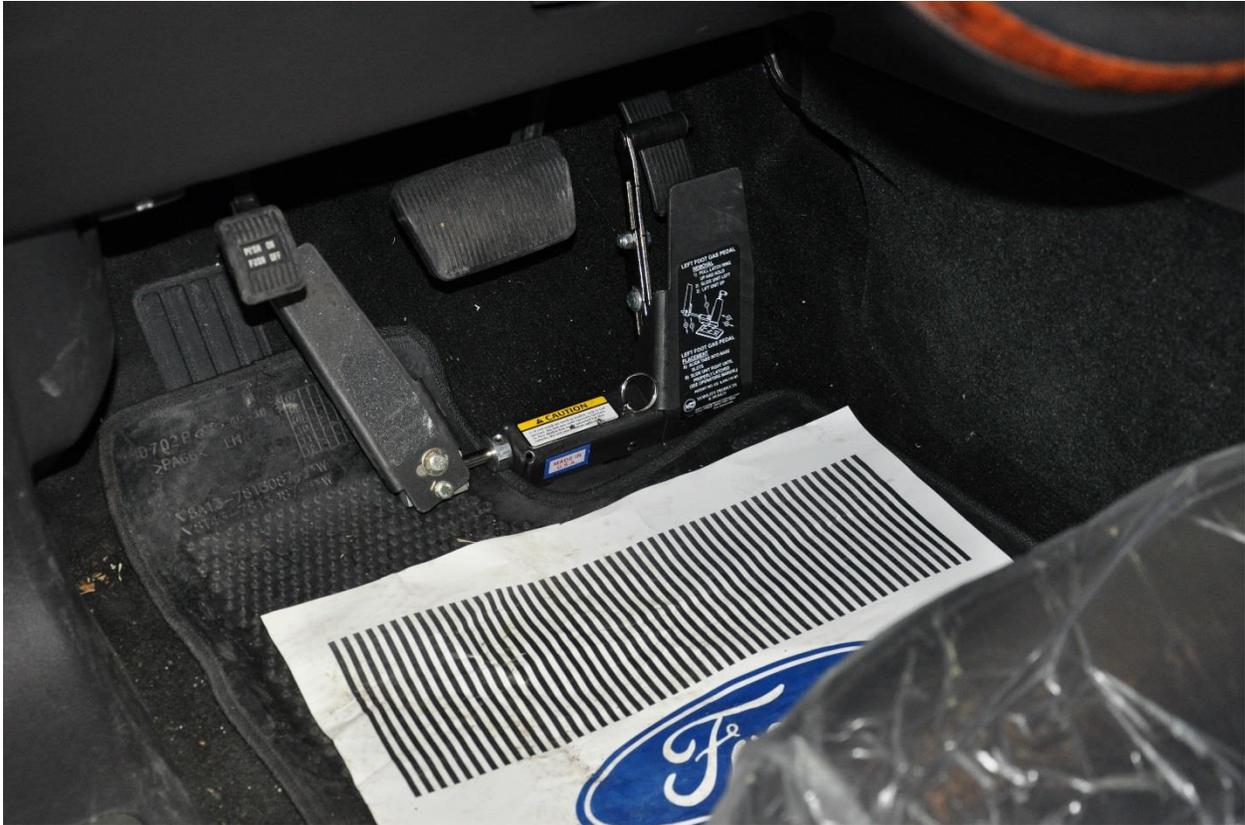
Monday, January 6, 2014, a 50-year-old Master Technician and married father spoke to another technician about work that needed to be done to a 2009 Lincoln MKX that was accessible for a handicapped driver with a left-foot accelerator made for people who have lost the ability to use their right foot. The left foot gas pedal was purchased from Mobility Products & Design and was model number 3545. This model type is easily removable. To remove the left-foot accelerator you lift the key ring on the LFGP (left foot gas pedal) assembly and while lifting and holding the key ring up, slide the lockout base to the left. When the assembly begins to move, release the

Interviews with the employees discovered there was a prior handicapped vehicle that came in for service and the handicapped equipment was removed prior to the technician's operation of the vehicle. However, this time, the handicapped equipment was not removed even though the technician was not trained to operate handicapped equipment. It is unknown why the handicapped equipment was not removed and a warning sticker was not on the dash board of the vehicle.

Handicapped break and accelerator pedals

Recommendation No. 1: Based on manufacture's recommendations, service technicians should detach unfamiliar handicapped accessible equipment if untrained to use the special equipment before operating the vehicle.

Manufacturers' mobility products and design installation and the owner's manual specifically warns that the operation of a motor vehicle with a handicapped accessible adjustable accelerator and brake pedal may result in serious bodily injury, death and/or property damage. The owner's manual also states that the left foot gas pedal can be quickly attached and is to be used by TRAINED OPERATORS ONLY. The manual states that it can also be quickly detached. Also, since it's not uncommon for technicians to not take the time to read the manual, a warning
