Hispanic Laborer is Crushed by Gantry Roller Press While Retrieving a Dropped Hammer

Incident Number: 14KY012

Kentucky Fatality Assessment and Control Evaluation (FACE) Program
Incident Number: 14KY012
Release Date: August 6, 2014
Subject: Hispanic Laborer is Crushed by Gantry Roller Press While Retrieving a Dropped Hammer

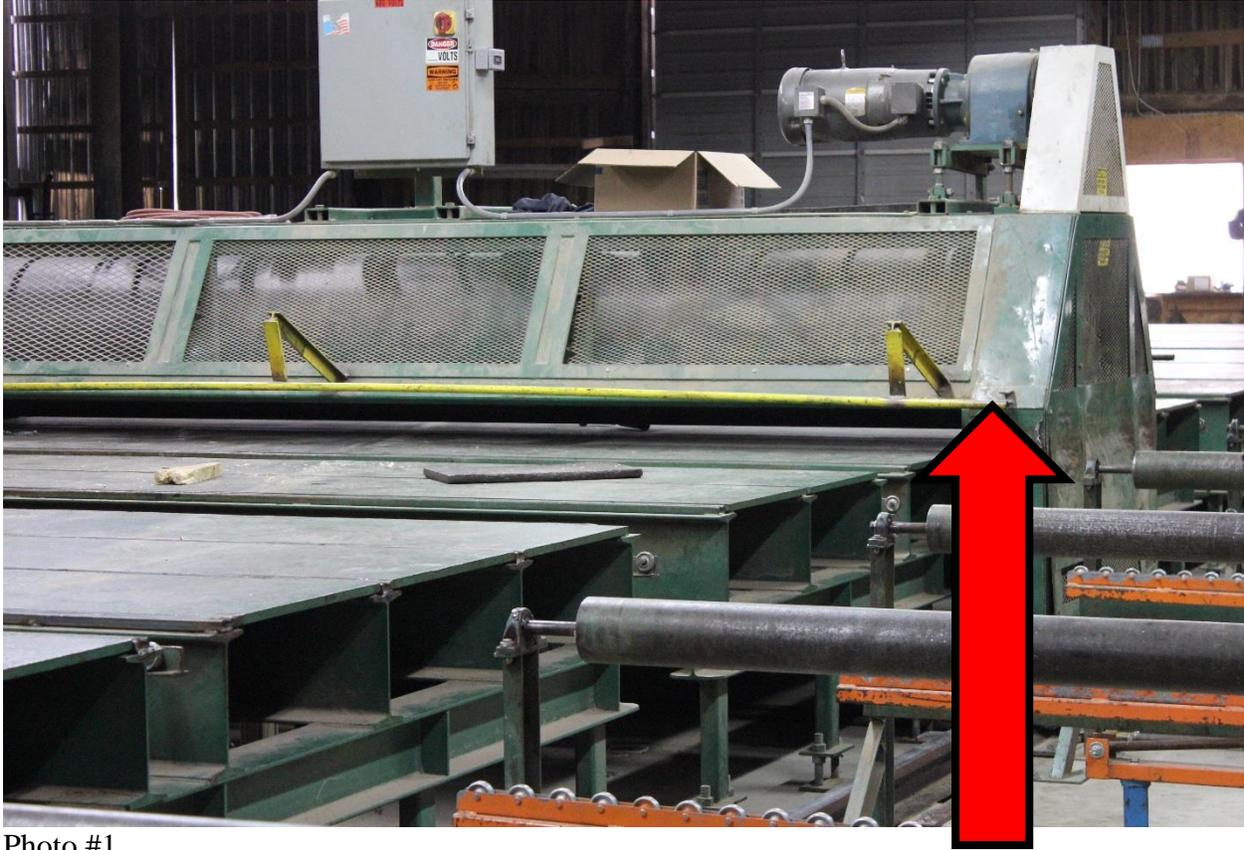
Photo #1

The scene was located in a manufacturing warehouse type structure. A gantry press which stretched from the front to the rear in an east to west direction was approximately 104 feet long by 20 feet wide by 15 feet tall. The roller followed a rail on both sides which was 2 $\frac{5}{8}$ inches wide, with a 35 inch tall by 14 $\frac{1}{2}$ foot wide by 103 $\frac{2}{3}$ feet long table which ran below the roller. Pneumatically lifted rollers were spaced equally, approximately every 80 inches along the table. The legs of the table had an opening between each leg of 17 $\frac{1}{2}$ inches high and the opening between the legs spanned the length of the table and were 27 inches wide at the base plates and 31 inches wide between each leg. The guard observed was an interlock style that was operated by a bar that stretched the length of the roller carriage. The bar did not attach to the lower portion of the carriage. (See photo 1.)

The arrow indicates the interlock, style guard and where the guard bar should be extended to stop equipment when it encounters interference while in motion. Photo courtesy of KY OSHA.

Recommendation No. 2: Manufacturers should consider the redesign of the roller carriage guard to extend the guard and prevent the roller press from contacting employees or other objects in its path.

The interlock style guard that stretched the length of the roller carriage should be extended to stop the machine when it engages something in its travel path. An extended guard would have stopped the machine when it came into contact with the victim and shut off the machine. 29CFR 1910.212 (a)(1): Requires one or more methods of machine guarding to protect the operator and other employees in the machine area from hazards such as those created by point of operation, ingoing nip points, rotating parts, flying chips and sparks. Examples of guarding methods are barrier guards, two hand tripping devices, and electronic safety devices.

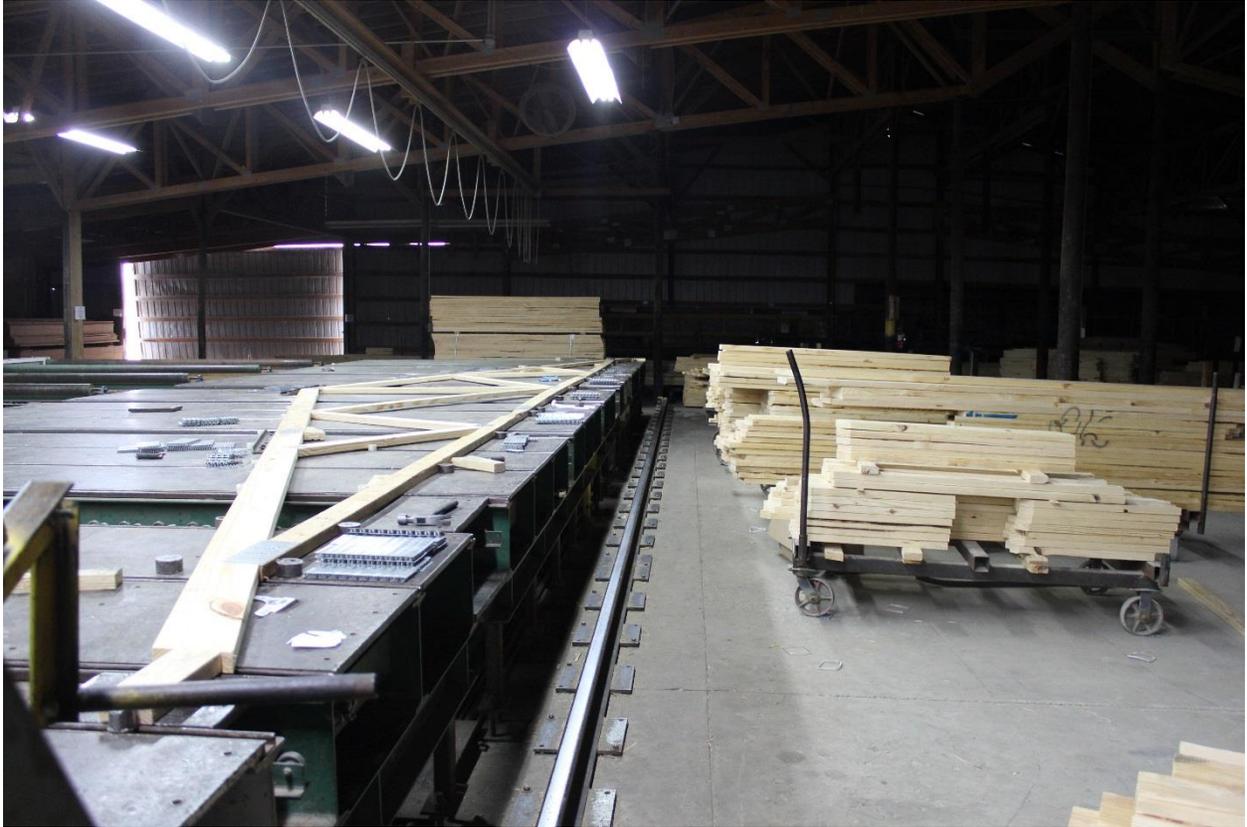
Photo #2 shows the truss being built. Photo courtesy of KY OSHA.

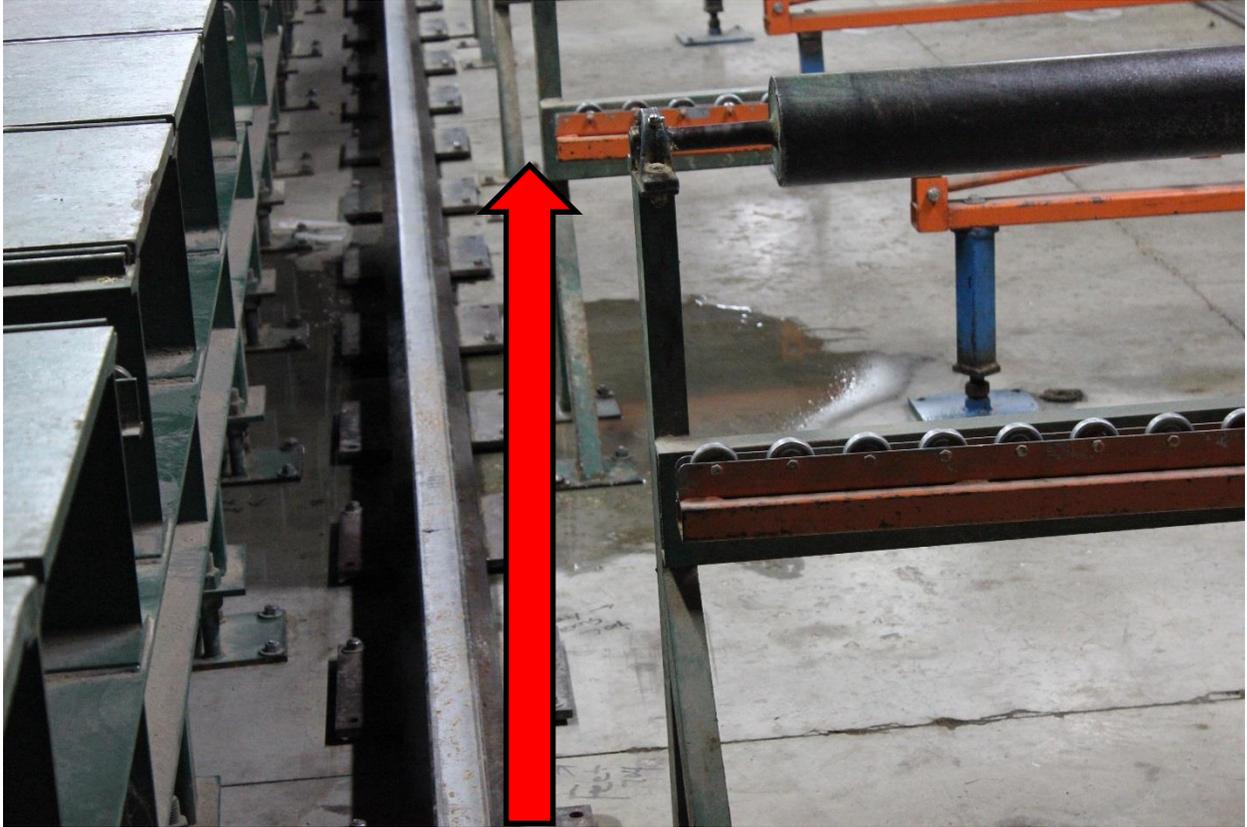
While investigating the scene, the detective of the Sheriff's department and the coroner came to the conclusion the victim had dropped the hammer he had been using to set the trusses and had gone down to retrieve it. This placed the victim in the direct path of the rolling gantry press. A hammer was found alongside the victim which led to this conclusion. Witnesses could not confirm this conclusion since no one saw the victim prior to the incident, but there would have been no other reason for the victim to be in that area of the press.

Photo #3 shows the area where victim was crushed. Photo courtesy of KY OSHA
