Temporary Electrician Helper Steps into Unguarded Elevator Shaft and Dies

Incident Number: 14KY039

**Kentucky Fatality Assessment and Control Evaluation (FACE) Program
Incident Number: 14KY039
Release Date: September 28, 2015
Subject: Electrician Helper Steps into Unguarded Elevator Shaft and Dies**

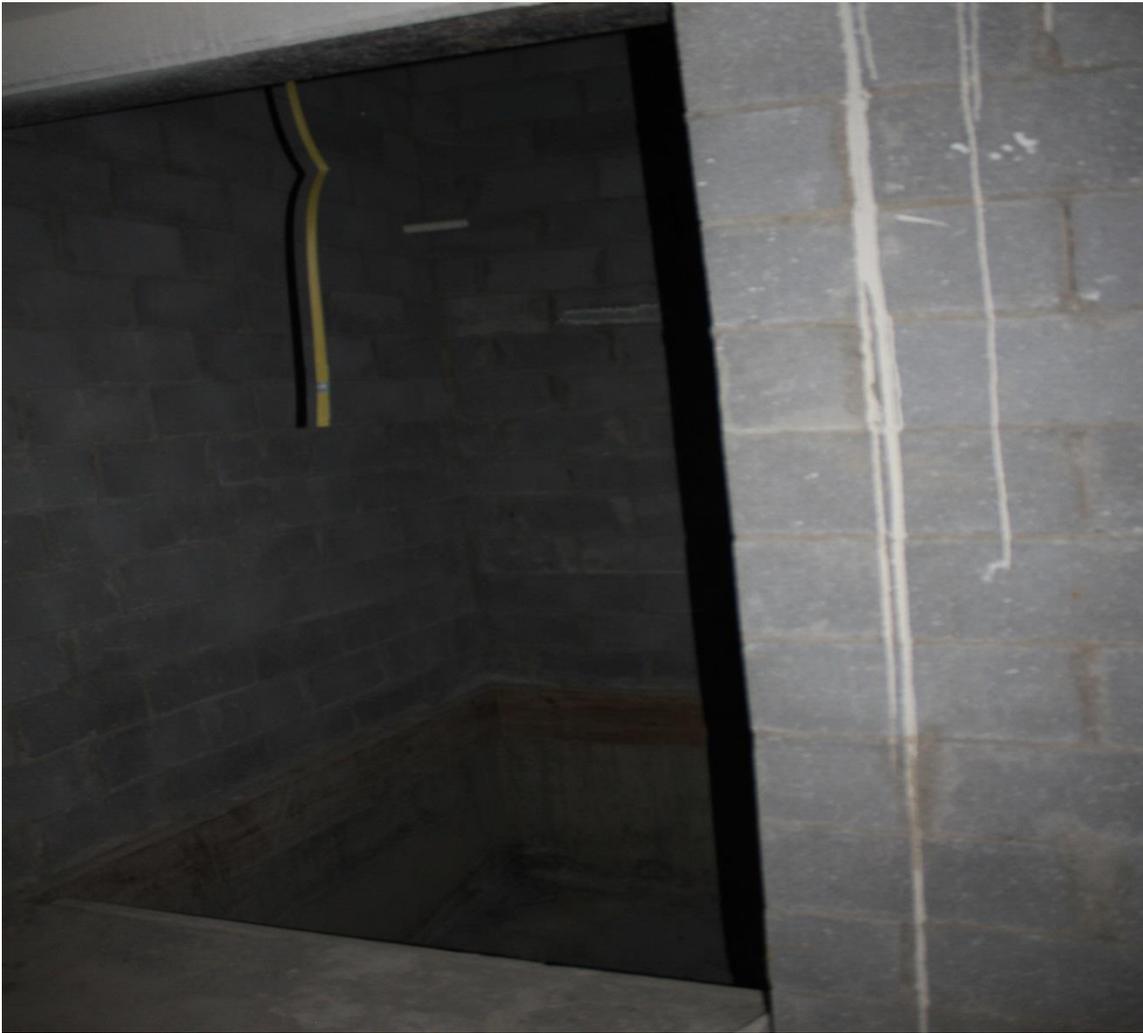
The scene was a commercial construction (four-story building) site. The elevator had yet to be installed, and the shaft opening was left open with no safety guards in place. The victim was laying out light fixtures to be installed in the second floor hallway by the elevator shaft. There was no lighting in or around the elevator shaft locations on the first and second floors. Footprints were observed on a small dusty pallet located in the passageway outside the 2nd floor elevator shaft, indicating that employees had to walk over the pallet to navigate through this crowded area.

Recommendation No. 1: Employers should guard all open areas where falls could occur.¹

In this incident, the elevator shaft was not guarded. In compliance with OSHA 1910 standard for walking and working surfaces, employers must place guards around all openings where falls could occur. All exposed sides must be guarded following the standards.

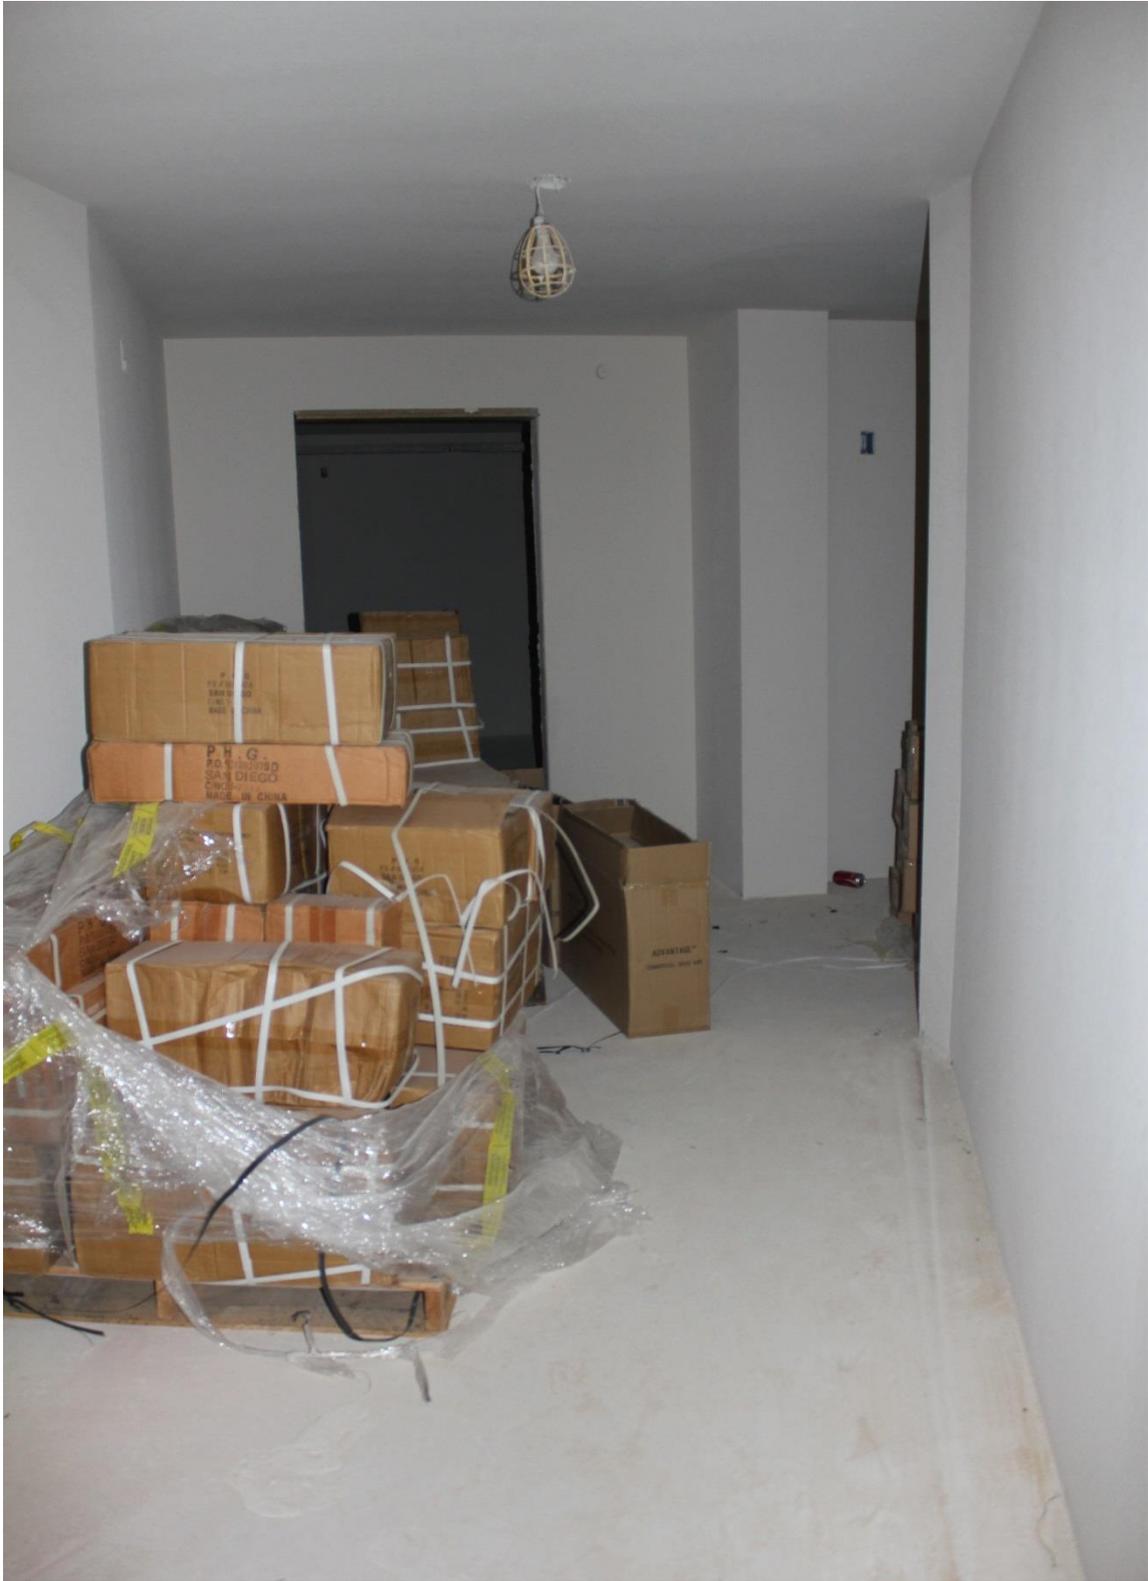
The victim's cart, work belt, hardhat, safety glasses and light fixtures were found on the second floor hallway outside the 2nd floor elevator shaft. There were two pallets directly placed outside the opening of the 2nd floor elevator shaft with the plastic encasing the pallets. It was concluded that the victim fell 13 feet and 8 inches from the 2nd floor elevator shaft opening to the bottom of the elevator shaft.

Pallets and boxes cluttering the hallway work area.

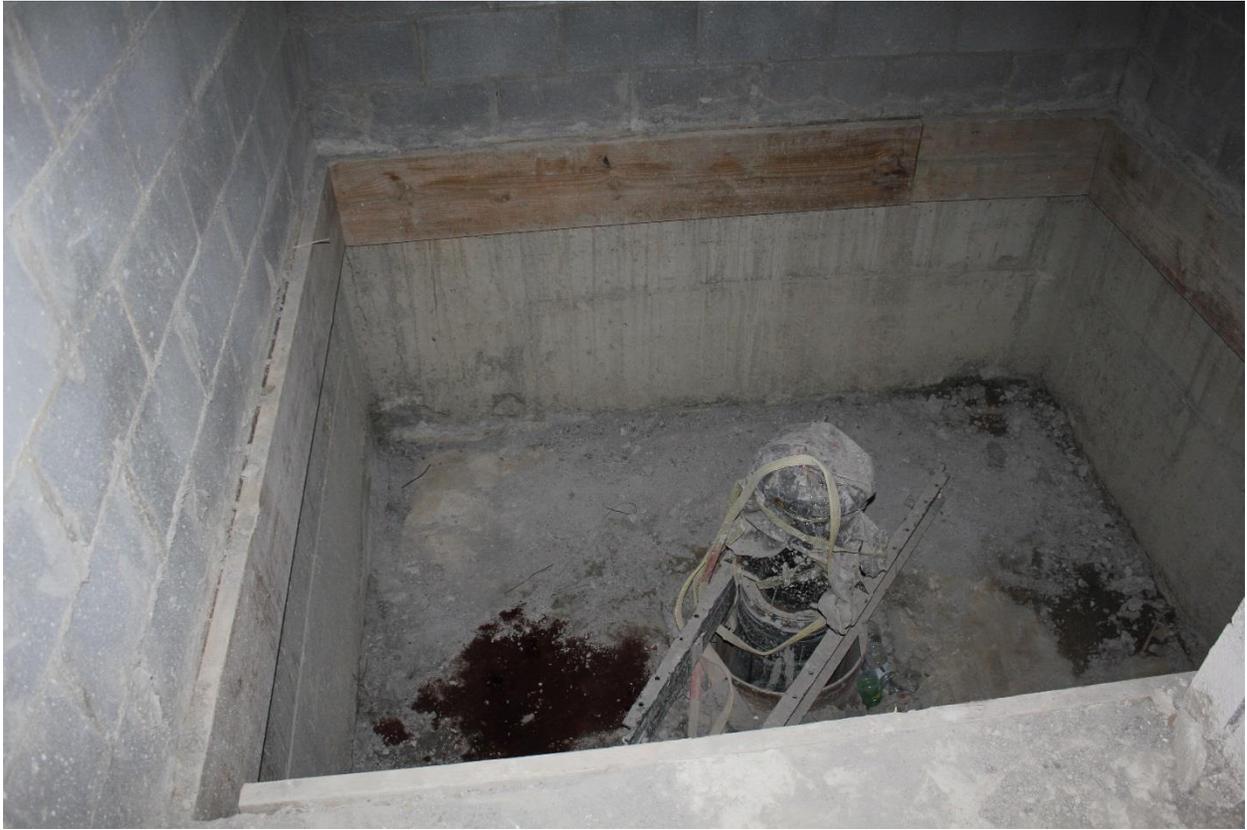
First floor landing inside elevator shaft where the victim landed. Photo courtesy of KY OSH
