**Firefighter is Electrocuted After Contacting Overhead
Power Line
Incident Number: 14KY049**

Kentucky Fatality Assessment and Control Evaluation (FACE) Program
Incident Number: 14KY049
Release Date: August 12, 2015
Subject: Firefighter is Electrocuted after Contacting Overhead Power Line.

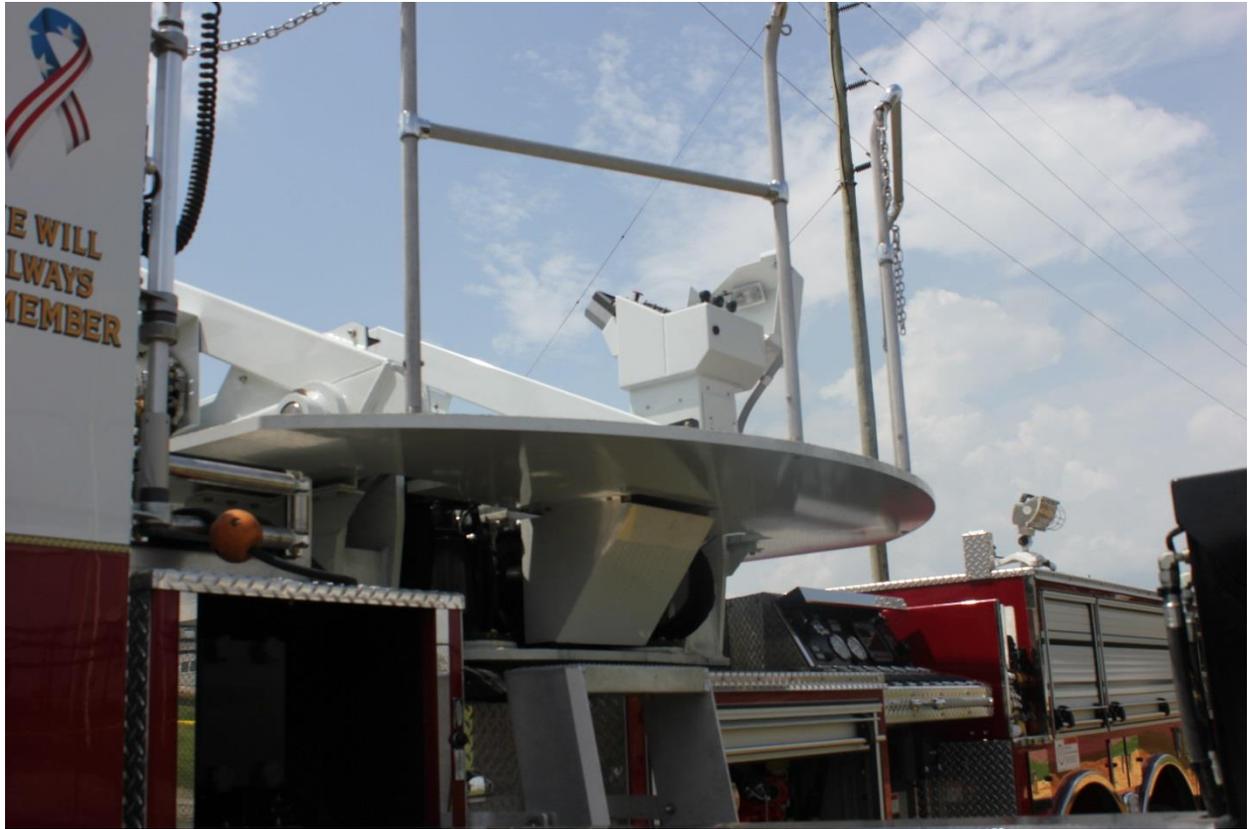
Firefighter 4 noticed a ball of fire that shot out from under the truck and a flash at the turntable. Firefighter 3 walked away from the truck, thinking that a hydraulic line incident was responsible for the flash. However, as firefighter 3 walked toward the truck he heard firefighter 2 in the bucket with firefighter 1, yelling that the Captain (firefighter 1) was down and needed help. Firefighter 3 looked up and saw firefighter 1's wrist engulfed in flame. Firefighter 1 stood in the bucket, appearing dazed. He braced his hands on the back of the basket and moved his head to the right. As he moved his head back to the left, he hit the power line a second time. There was a bright flash around his head and he slumped over the bucket and hung by his ladder belt. Another flash was observed at the same time from under the turntable and a second fireball shot out from under the truck. Firefighters 3 and 4 radioed the incident, and requested emergency medical services.

Photo of the turntable.

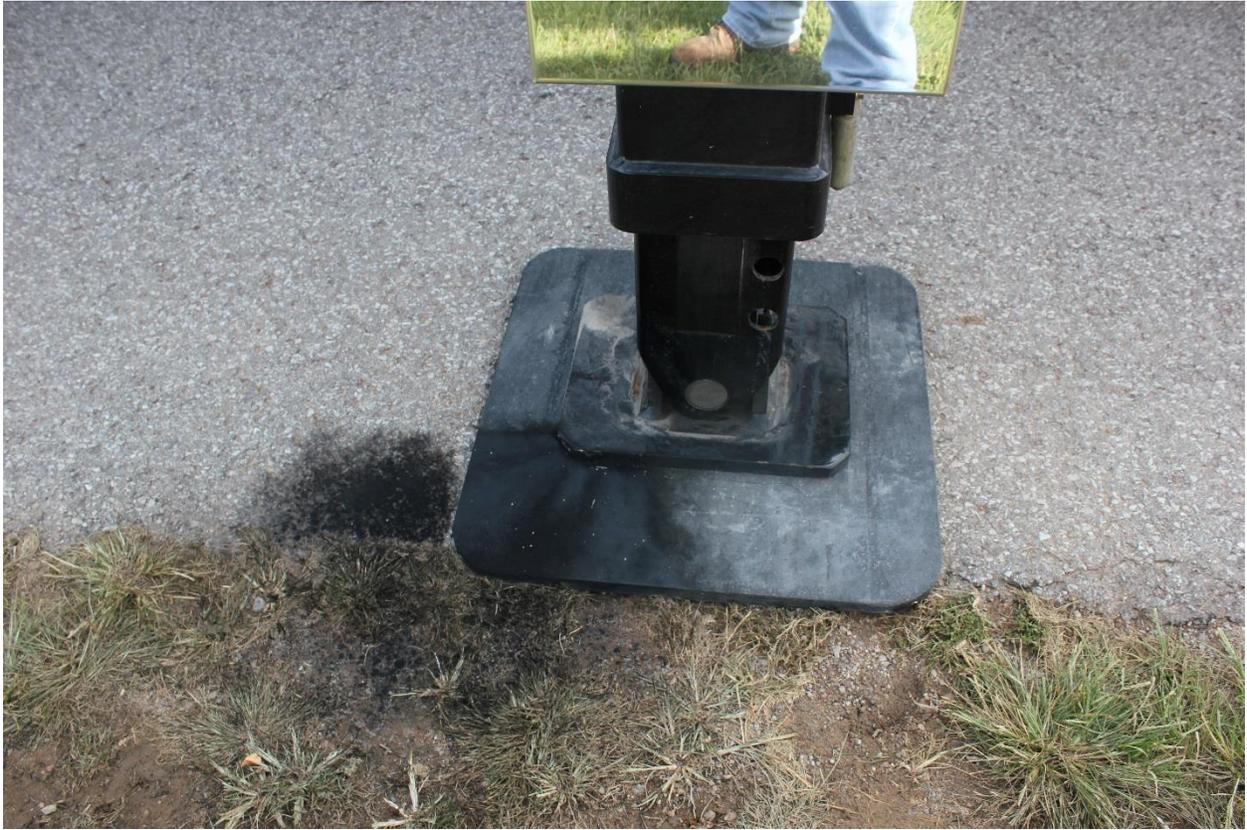
Photo of outrigger where arc occurred.

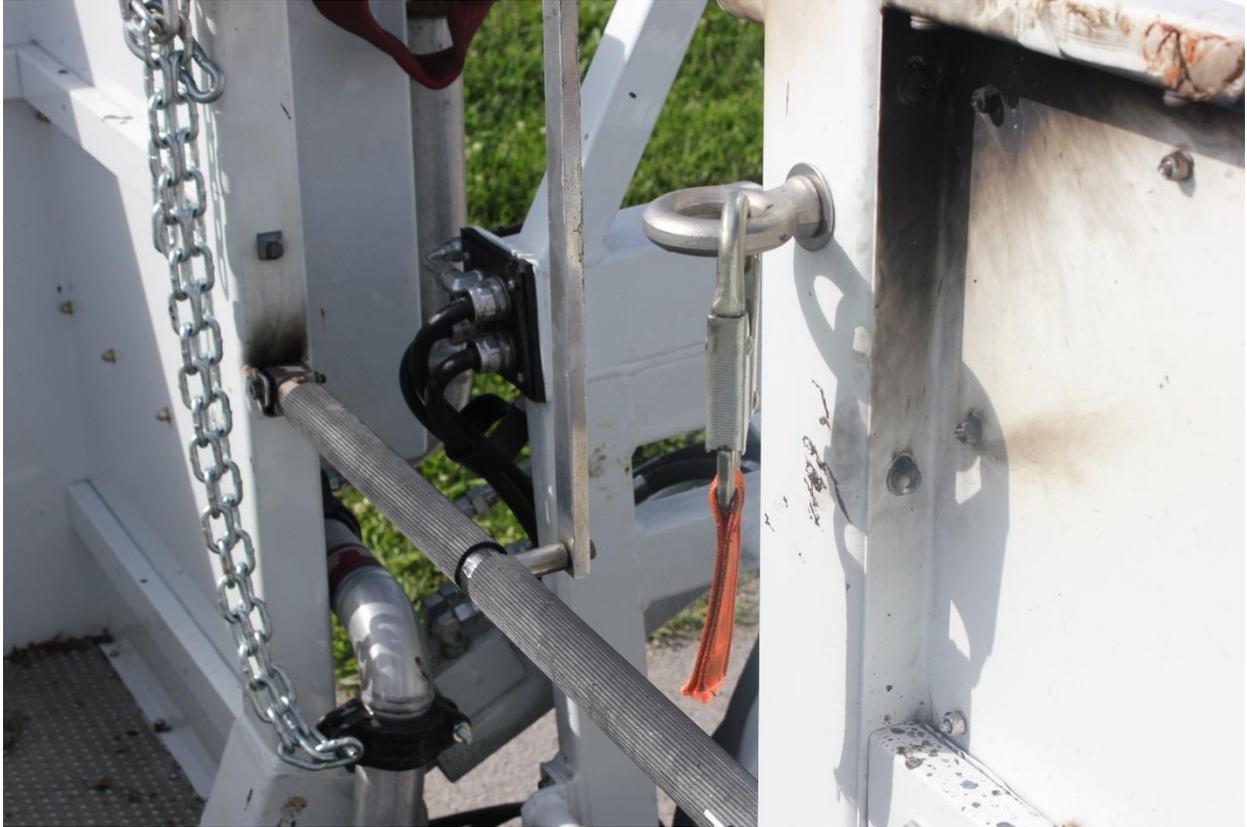
Firefighters 1 and 2 entered the bucket of the tower truck and proceeded to raise the bucket to the position necessary to spray the water. Firefighter 3 was on the turntable of the truck, opening the valves to access the water. Firefighter 4 was in the back of the truck watching the university film crew tape the band members' introduction. The firefighters in the bucket were not wearing helmets or protective footwear but both were wearing ladder belts.

Photo of inside bucket and ladder belt that was cut

The helmets worn by firefighters are certified to NFPA 1971-2013 or NFPA 1951-2013 standards and will protect them up to 20,000 volts. Had the firefighter worn this type of helmet, he may have reduced his electrical shock hazard. Also, footwear to protect against electrical hazards may have reduced the risk.

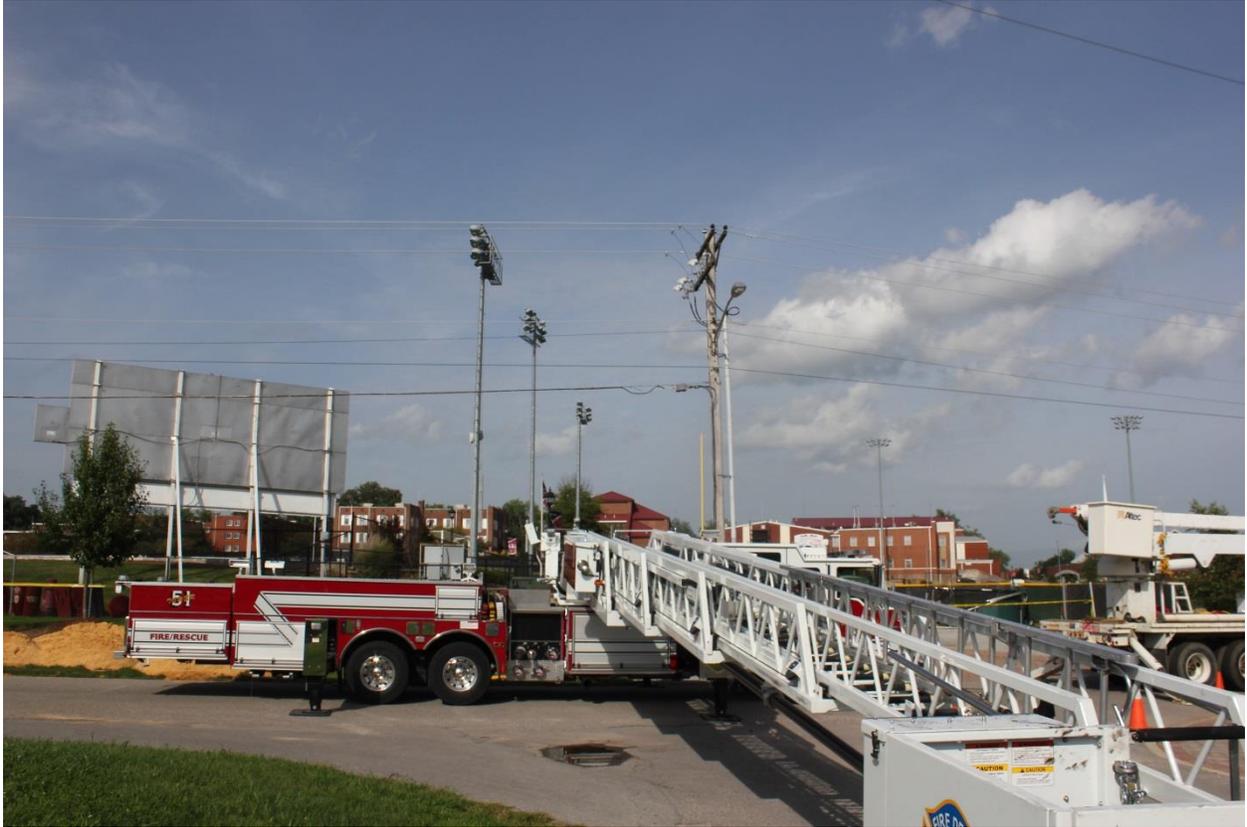
A tower truck was parked at an intersection on a university campus. Overhead power lines were present at 40 feet 6 inches above the ground with a voltage of 69kV.

Firefighter 4 removed pins from the front driver's side outrigger while firefighter 3 stood at the pump panel to open the main drain to the pump, close the main streamer from the hydrant, and close the aerial discharge valve. As firefighters 1 and 2 were docking the bucket, a witness, (a fifth firefighter who was there as only a spectator) noticed the tower ladder move inward and upward instead of outward and down. Before the witness could yell a warning about the power lines, the head of firefighter 1 struck the powered electrical line, sending a charge through the tower truck.

Photo of tower apparatus and electrical lines

Recommendation No. 1: Whenever possible, avoid operating tower trucks where overhead power lines are present.¹

Overhead power lines create a hazard and should be avoided whenever possible. The best practice in this case would have been to move the disease fundraising event to an empty flat parking lot or open field.²
