Occupational Fatality Report

Municipal Foreman Killed When Struck by a Backhoe Loader Outrigger While in an Excavation - Massachusetts

Release Date: March 30, 2016
Investigation: # 14-MA-003-01

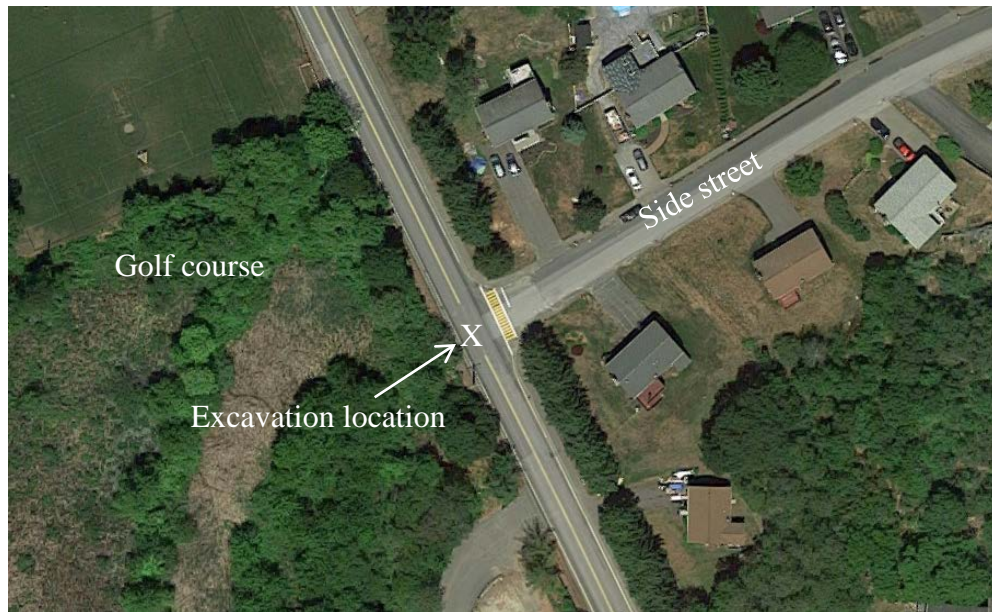
The incident occurred in a suburban area that was mostly made up of a residential neighborhood with single family homes, municipal playing fields and a golf course (Figure 1). The roadway where the incident occurred was an asphalt roadway that primarily ran north and south. The roadway had two travel lanes, one for each direction. The travel lanes were approximately 12 feet wide each and were separated by painted solid double yellow lines. The outer edges of the lanes had painted solid white fog lines followed by a two foot wide paved shoulder and then granite curbing. The east side of the northbound travel lane had a paved sidewalk and the west side of the southbound travel lane had a grass sidewalk. Both sidewalks were about six feet wide. The posted speed limit for this street was 30 miles per hour. The roadway was relatively straight and flat in this area.

Figure 1 – Aerial view of the T-shaped intersection where the incident occurred

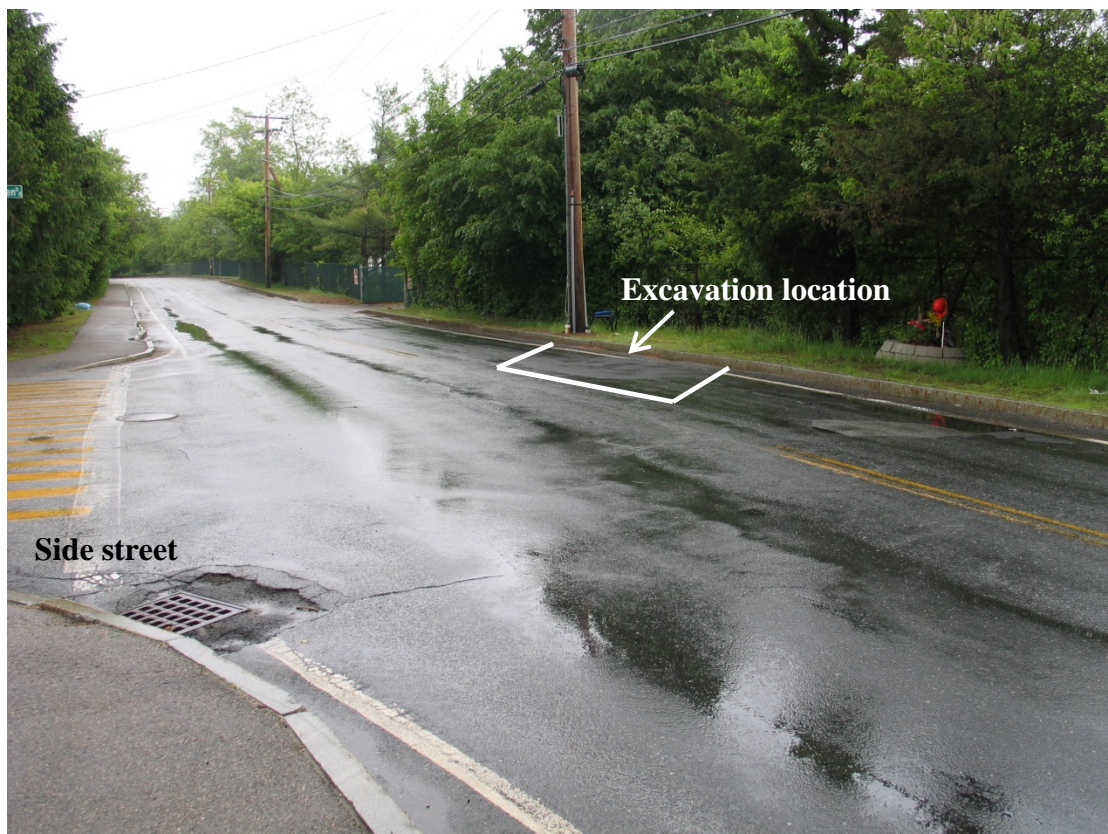
The incident occurred at a T-shaped intersection with a residential side street that intersected the main roadway from the east (Figure 2). The side street was asphalt, had one lane for both directions of travel

Figure 2 – Roadway view of the T-shaped intersection with excavation location outlined

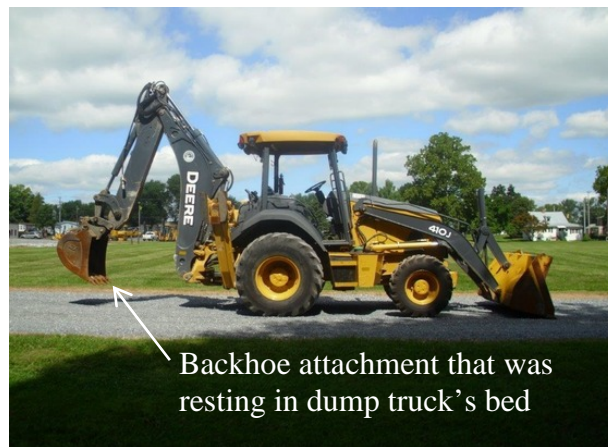
The machine involved in the incident was a backhoe loader that was purchased new by the town in 2008. One end had a loader attachment and the other end of the machine had a backhoe attachment (Figure 3). There were two outriggers (stabilizers) at the end where the backhoe attachment was located. The backhoe loader's dimensions were 9.3 feet high to the top of the cab, 7.7 feet wide with outriggers stowed, and 13.3 feet wide with the outriggers extended. The backhoe loader had an operating weight of about 15,000 pounds.

Figure 3 – Backhoe similar to the one involved in the incident

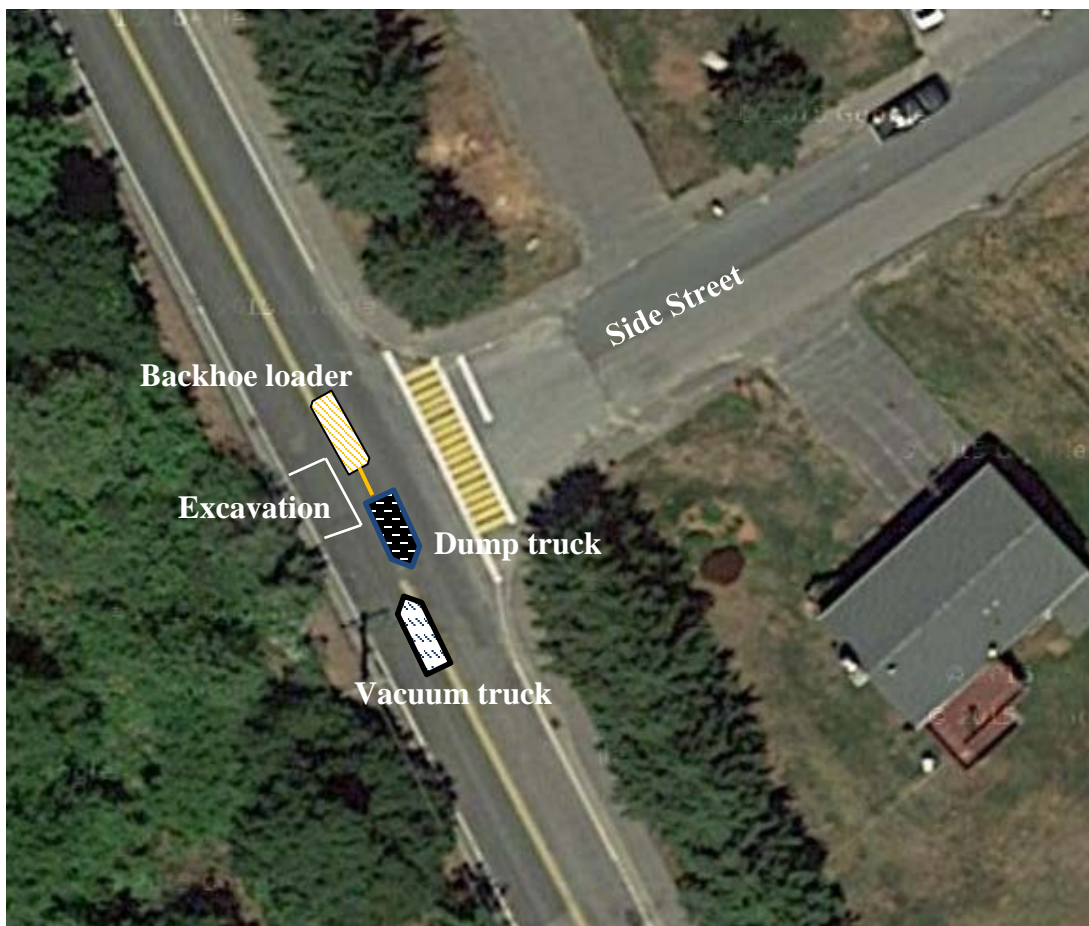
The work crew arrived at the work site location with the backhoe loader, dump truck, and a vacuum truck (Figure 4). They also brought a light tower to illuminate the work area, due to it being dark outside. The work crew estimated the break location and excavated a hole that was approximately ten feet long by six feet wide and five feet deep to locate the break. The excavated hole was located in the T-shaped intersection southbound travel lane, directly across from the side street. The backhoe section of the backhoe loader was used to excavate the hole and was positioned in the southbound travel lane just north of the hole. The backhoe loader's outriggers were in use and extended while digging the excavation and at the time of the incident. The dump truck was positioned next to and immediately east of the hole. This position placed the dump truck over the painted solid double yellow line and partially in the northbound travel lane. The light tower was located to the west of the hole. The vacuum truck was positioned in the southbound travel lane just south of the hole to control the water level in the excavation. The northbound travel lane was kept open during the repair process and a town police officer was on site with a police car conducting traffic control as part of a traffic detail.

The dump truck was on site to contain the spoil pile; the soil excavated from the hole was placed in the dump truck's dump bed. Once the excavation was completed, the backhoe loader's backhoe bucket attachment was placed inside the dump truck's dump bed and the backhoe loader operator remained inside the cab. Then four water department employees, including the victim, climbed into the excavation to find the leak. They discovered that a one-inch plug had let go, causing the leak. The four workers started to conduct the repair to the pipe. Due to the cramped working area around the excavated hole,

the dump truck was parked close to the excavation edge. It was reported by water department personnel that the working foreman asked that the dump truck be moved because it was in the way and there was concern it was parked too close to the excavation edge. At approximately 7:15 p.m., the working foreman told the dump truck operator to quickly move the dump truck. The driver immediately climbed into the dump truck cab to move the truck forward in a southerly, direction. Due to the location of the vacuum truck, the dump truck, once moving, was going to have to be driven forward and to the left (east) to get around the front edge of the vacuum truck.

It appears that when the dump truck operator attempted to drive the truck forward, the truck did not move, resulting in the operator trying to accelerate more. Once the dump truck started to move forward, the backhoe loader was dragged with the dump truck due to the backhoe attachment being located inside the dump truck bed. As the backhoe loader was pulled in the forward direction (south), its outrigger that was extended to the west moved across the top of the excavation, striking the victim and one of the co-workers. The victim was then caught on the outrigger and was dragged up and out of the excavated hole and onto the roadway while the co-worker remained in the excavation. The backhoe loader continued to move forward, as the victim laid on the roadway between the excavated hole and the vacuum truck. Then the backhoe loader's extended outrigger struck and got caught on the right front tire of the vacuum truck and started to drag the vacuum truck. The vacuum truck was dragged approximately 4 feet to the south before the backhoe loader disengaged from the dump truck. The dump truck continued forward and then came to a stop about 240 feet from its starting location. The backhoe loader had been dragged approximately 38 feet while the operator was inside the cab.

Figure 4 – Roadway view of the T-shaped intersection with outline of vehicles and excavation location

Recommendation #1: Municipalities should ensure that when excavating equipment is not being used that the equipment is moved away from the excavation edge and all attachments are lowered to the ground before workers enter the excavation.

The hub of activity at work sites with excavations is typically around the location of the excavation itself. To help ensure the safety of workers on excavation sites, always move equipment that is not in use away from the excavation edge and lower all equipment attachments to the ground, even if the operator is going to exit the cab for only a short period of time.¹ In this case, if equipment was moved and attachments were lowered before workers were allowed to enter the excavation, the incident would not have occurred.

Recommendation #3: Municipalities should consider closing roadways when the work area is located in a roadway and there is limited space for the work area, and multiple large pieces of equipment are needed to complete tasks.

In this case, taking into consideration the location and the time of day, the section of roadway where the repair was going to take place could have been closed to traffic without major impact to the general public. The roadway closure could have been from the side street at the incident location north to the municipal public works department, and access to these locations could have been maintained. The one area that the public would not have had access to was the municipal playing fields, which were not being used due to the time of year. Closing the roadway would have provided the space needed to create a larger work site where equipment could have been easily located away from the excavation when not in use.
