OREGON FATALITY ASSESSMENT AND CONTROL EVALUATION

Fatality Investigation Report

OR 2014-1-1

Driver killed when ejected from logging truck

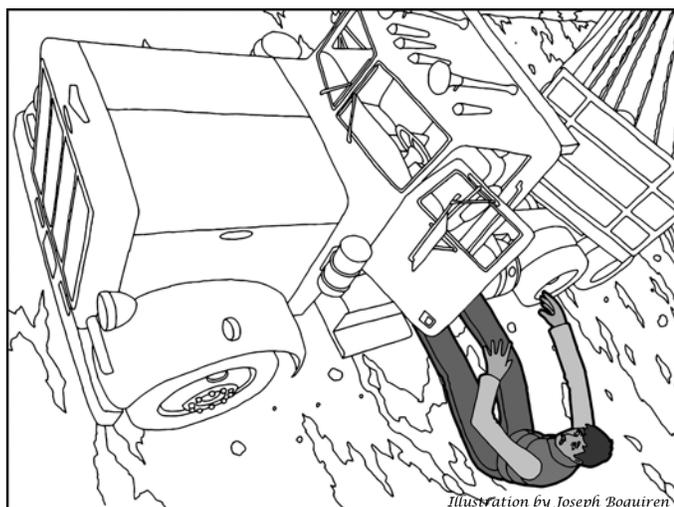
Figure 1. An illustration of the incident.

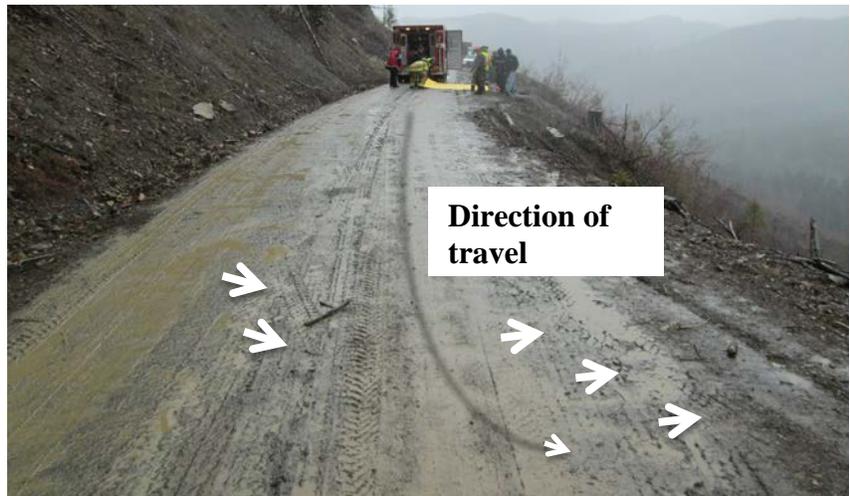
sharp drop off on the left side of the road, heading away from the landing. The right side was a steep embankment with a minor ditch between it and the road surface (see Figure 2).

Figure 2. White bold arrows point to the tire tracks on the road leading off the edge. White line shows the trucks direction of travel.

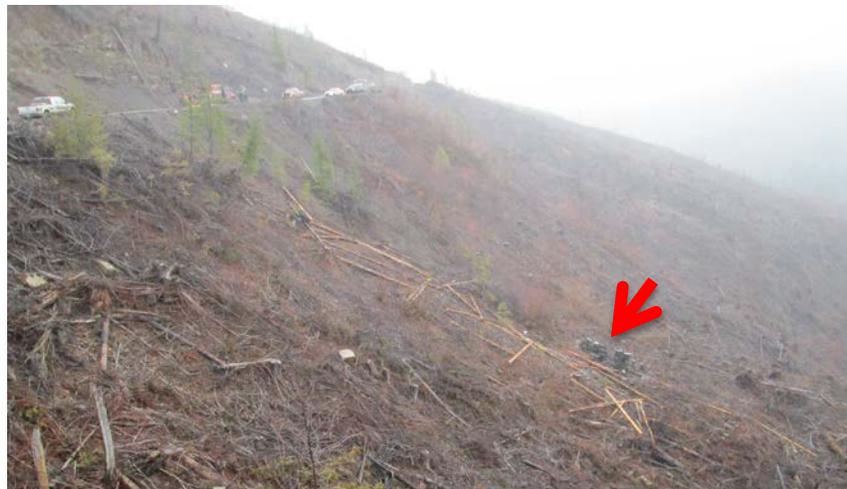
The driver and his truck were discovered below the log strewn slope. The truck was resting on a flat spot on the steep embankment, with the driver lying next to the drive wheels. It is speculated that the truck had rolled up to five times down the canyon wall. At some point during the tumble the driver was ejected from the cab and caught up in the debris rolling down the hill. It is unknown if the driver had attempted to jump from the truck or if he was ejected while not using his seat belt. The seat belt remained attached to the cab mounts but was not buckled. There was no damage to the belt or buckle. The seat belt was inspected later and shown to be fully functional. Additionally,

Figure 3. Photograph with red arrow showing where logging truck came to rest on the hillside.
