Truck Driver Falls from Tanker Truck to His Death

Incident Number: 14KY021

Kentucky Fatality Assessment and Control Evaluation (FACE) Program
Incident Number: 14KY021
Release Date: February 2, 2015
Subject: Truck Driver Falls off Tanker Truck to His Death

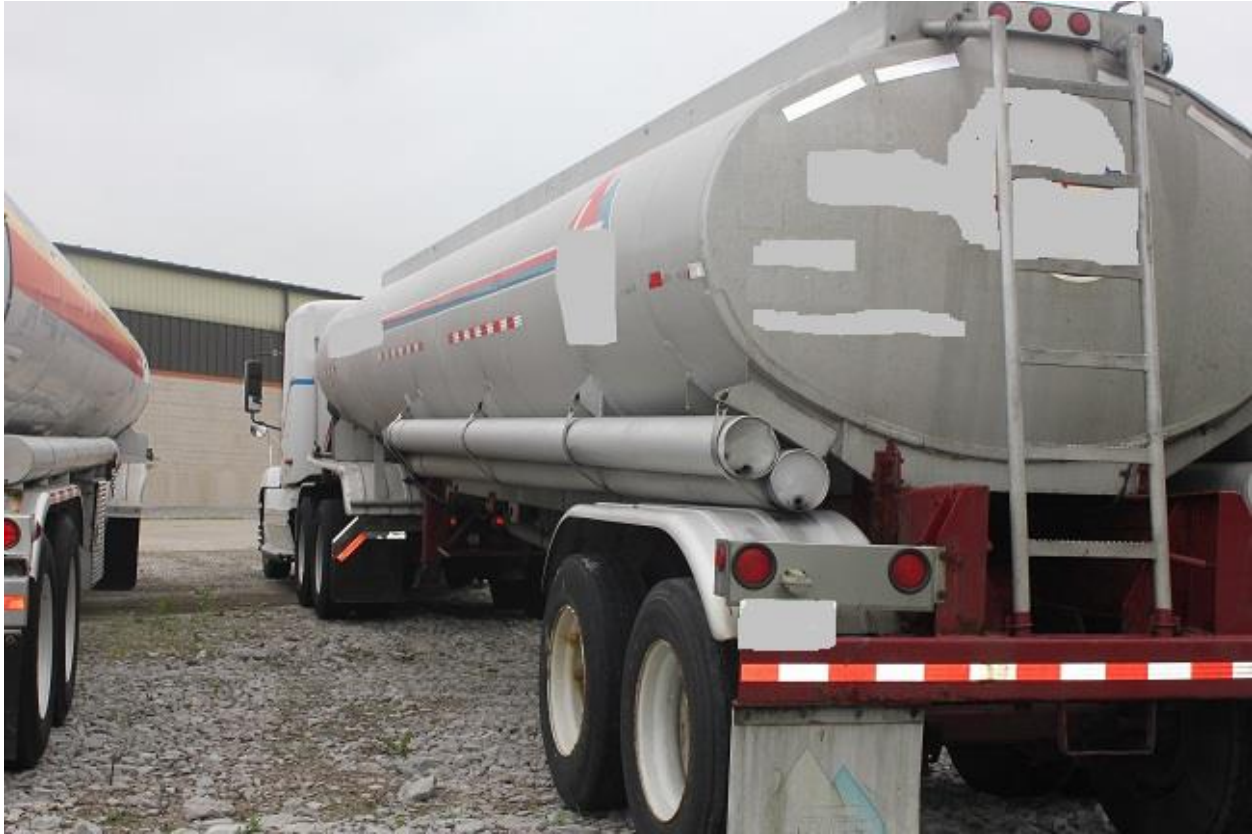
Photo 1: Tanker truck involved.

No one witnessed the incident, so it is unclear whether the victim slipped climbing or fell traversing the top of the tanker. It is also unclear whether the victim's type II diabetic disease contributed to this incident. The victim died from his injuries on May 15, 2014 at 7:08 pm.

Recommendation No. 1: Employers requiring employees to access the top of tankers must provide adequate fall protection.

In compliance with OSHA 29 CFR 1910.23 (c) (1), open sided floors or platforms 4 feet or more above adjacent floor or ground levels must be guarded by a standard railing as specified in paragraph (e) (3).¹ Manufacturers are now equipping tankers with bottom loading and automatic venting so that employees to negate the need for climbing on top of the tanker. The vapor vents automatically open during loading and unloading.

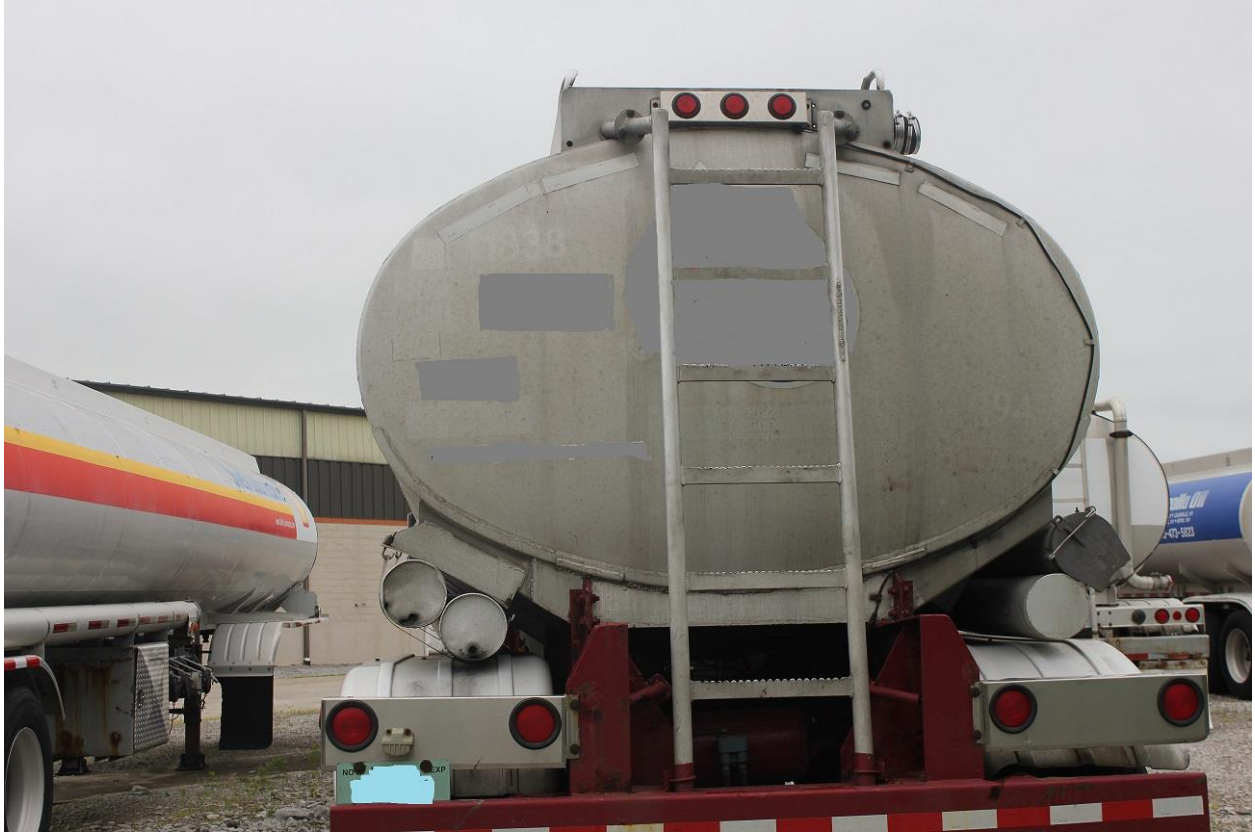
Part of the victim's training included learning the pump unloading procedure. This procedure contained detailed steps to unload and load the product, including venting the tanks. However, the procedure in the MC 3-7/DOT 407 did not contain any procedures for accessing the top of the tankers to vent the compartments.

Photo 2 Rear of tank with ladder to reach compartments for venting. Photo courtesy of KY OSHA

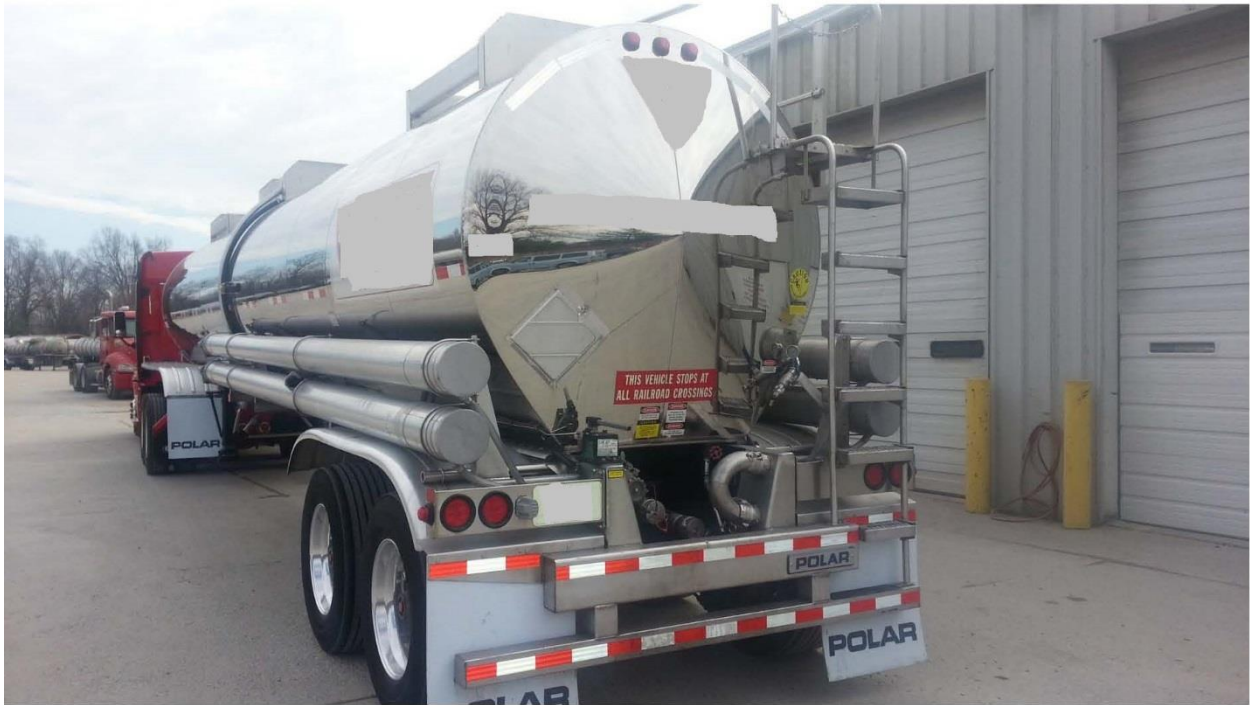
PROACTIVE SAFETY STANDARDS TAKEN FOR NEW EQUIPMENT ORDERED OVER THE PAST YEAR - DRIVER FALL PROTECTION.

Recommendation No. 2: Employers should consider equipping their tanker trucks with rail systems, shown in photos 3 and 4.

Recommendation No. 2: Employers should consider equipping their tanker trucks with rail guarding systems.

manufacturers that have a custom option of equipping the tanks with collapsible rail systems.² Photo 3 show the tanker with the rail guarding system collapsed for when the tanker is in transport. Photo 4 shows the tanker with the rail system in place, ready for access by workers climbing to the top of the tanker. Employers who order new tankers should consider making this mandatory on all their tankers.
