# Cell Tower Technician Dies after Antenna Array Falls and Decapitates Him

**Incident Number: 14KY032**

**Kentucky Fatality Assessment and Control Evaluation (FACE) Program**  
**Incident Number: 14KY032**  
**Release Date: August 17, 2015**  
**Subject: Cell Tower Technician Dies after Antenna Array Falls and Decapitates Him**

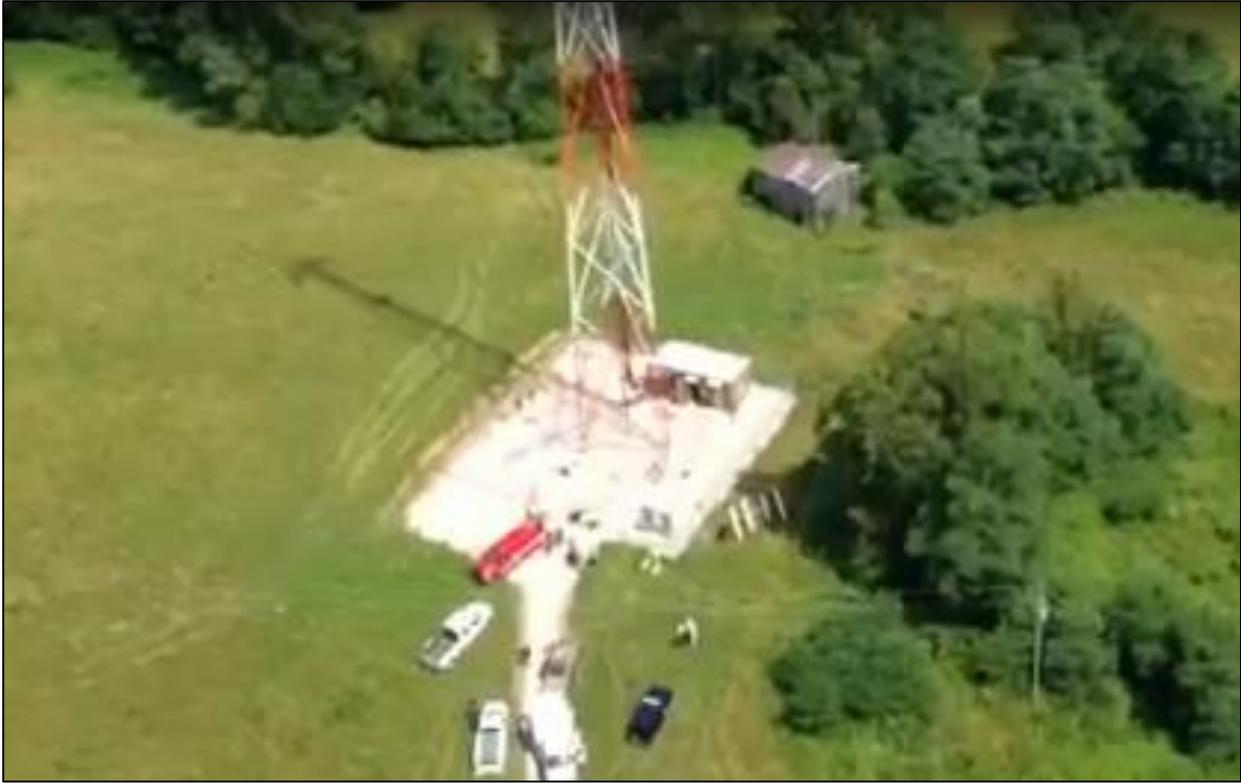
The victim and another tower technician, who had only been on the job for 8 days, climbed the tower to replace the antenna arrays (image 1). It is not known if the 8 day tower technician had previous experience. They worked steadily and replaced two of the three antenna arrays. They began replacing the third antenna array and had it raised above the victim. The victim was on the

Image 1  
Incident scene

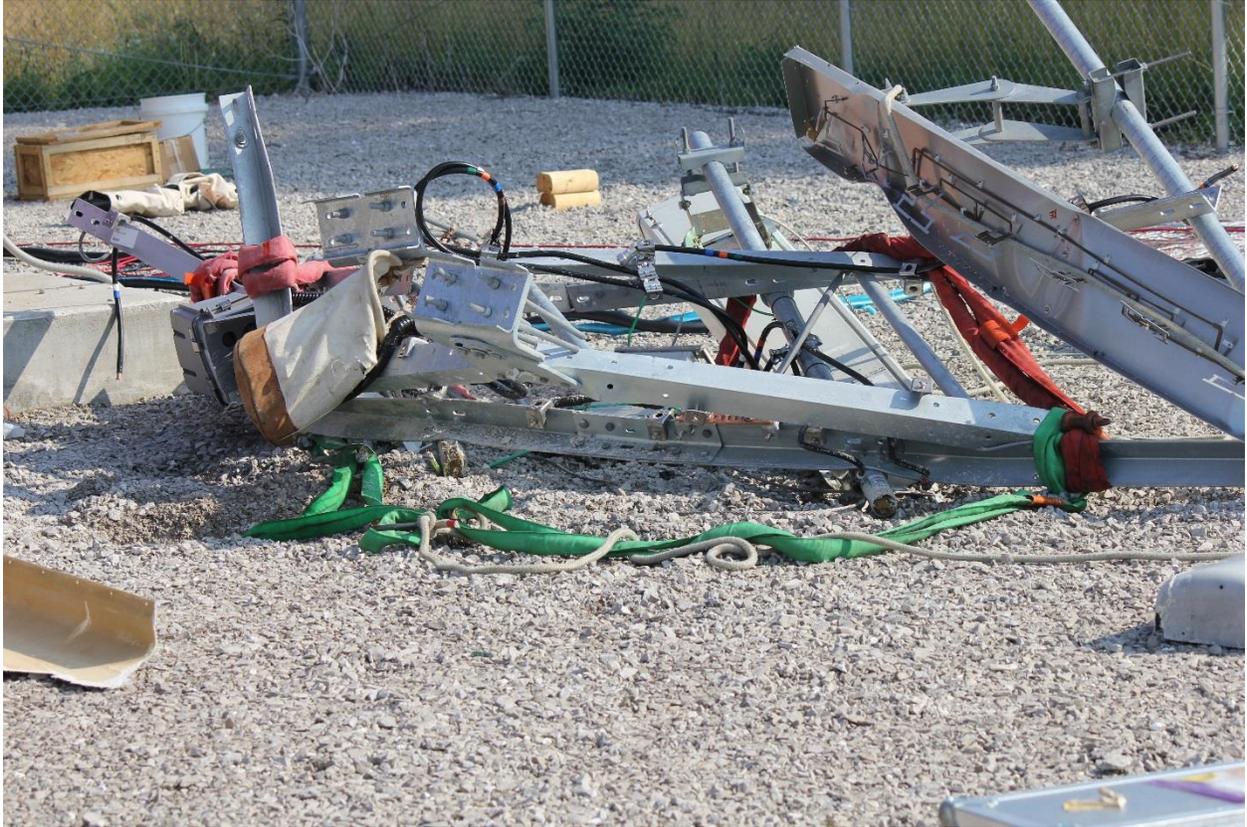
load bearing side of the tower at 242 feet above the ground. The other cell tower technician was on the opposite side at 217 feet. The antenna array was 15 feet above the victim on a McKissick “snatch block” pulley, model 419. Around 2:20 pm, the crew heard a loud pop. The supporting shackle had failed and caused the cable to snap. The antenna crashed down, striking three points on the tower, then the cables decapitated the victim and amputated his right arm between the elbow and shoulder. Two cell tower employees on the ground avoided being struck by the crashing antenna (image 2). When the cell tower technician on the opposite side of the tower saw the victim hanging from his fall protection equipment, he radioed the ground crew and asked them to call 911. The employees also requested that the power be turned off at an energized electrical line in contact with the broken cables.

Image 2  
Antenna array that fell

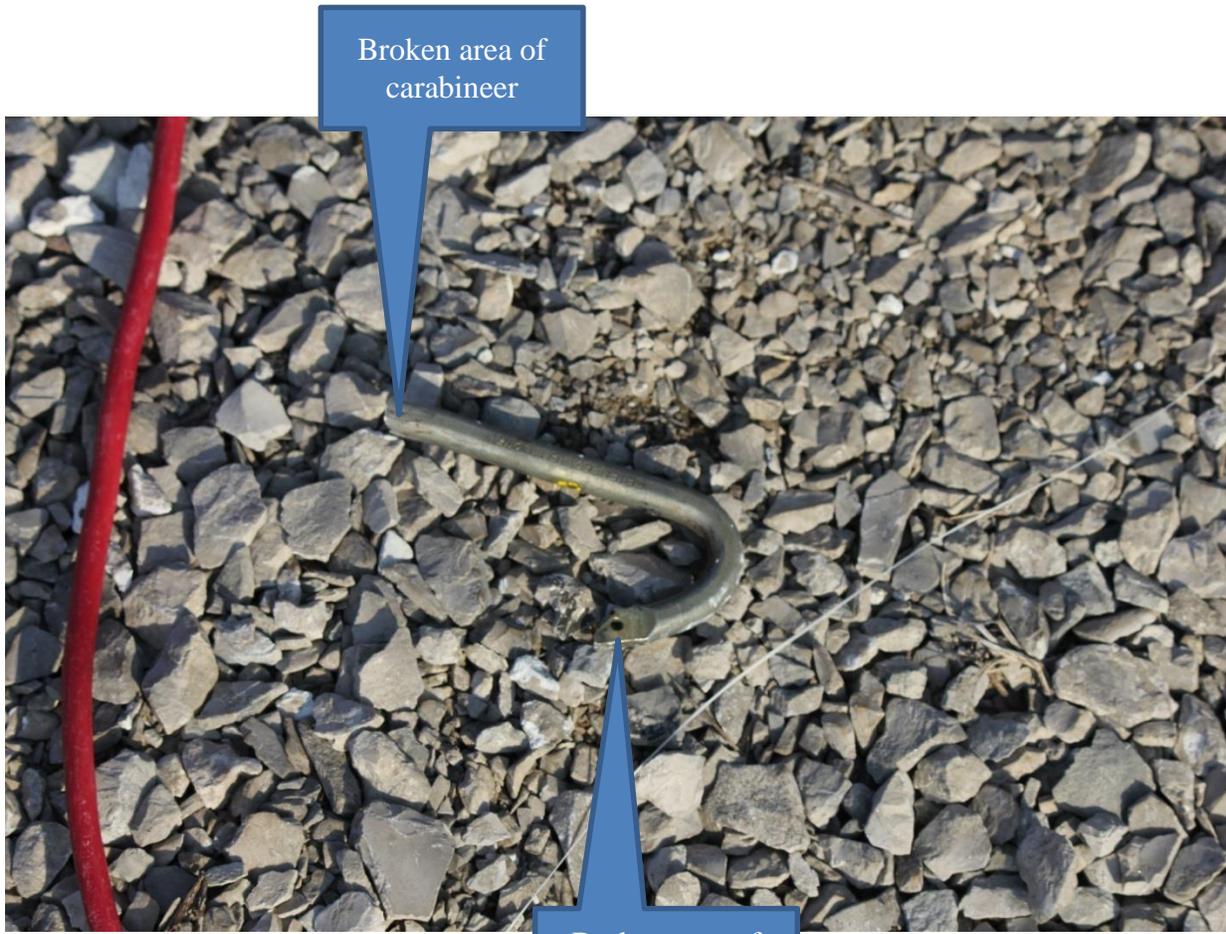
Search groups including KY OSHA, the company’s insurance carrier, and the sheriff’s department searched for the broken shackle for four days with metal detectors, but were unable to locate it. However, a shattered carabineer was recovered at the site the day of the incident, indicating that it could have been used on the winch in place of the shackle (image 3). This discovery could explain why the shackle was not recovered.

A four day search, which included metal detectors, did not produce the required shackle. The shackle is made from forged steel alloy, a metal that is very strong with a low failure rate. The shackle was not found onsite, but a broken carabineer was discovered the day of the incident. The carabineer did not originate from the fall arrest equipment, because the fall protection remained securely intact with the victim. The carabineer may have been used in place of the shackle, and used in the wrong spot.

Image 3  
Carabiner that was recovered on site

**Recommendation No. 4: Cell tower employers should ensure that antenna replacement equipment is used properly and according to manufacturers' recommendations.**

Employers need to stress that using the right equipment and taking the extra steps to do so keeps employees safe.

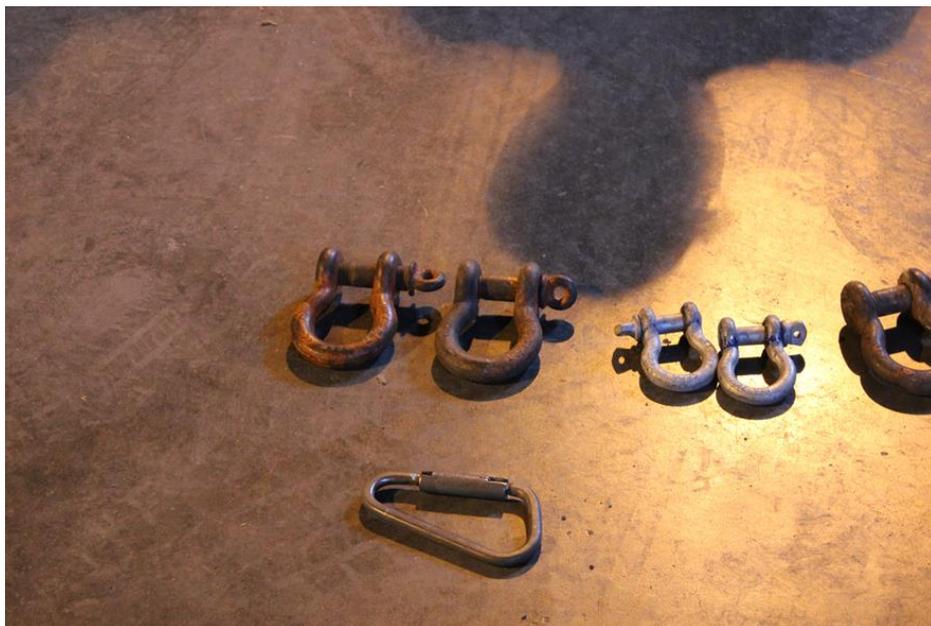
Image 4  
Undamaged shackle pins & carabiner

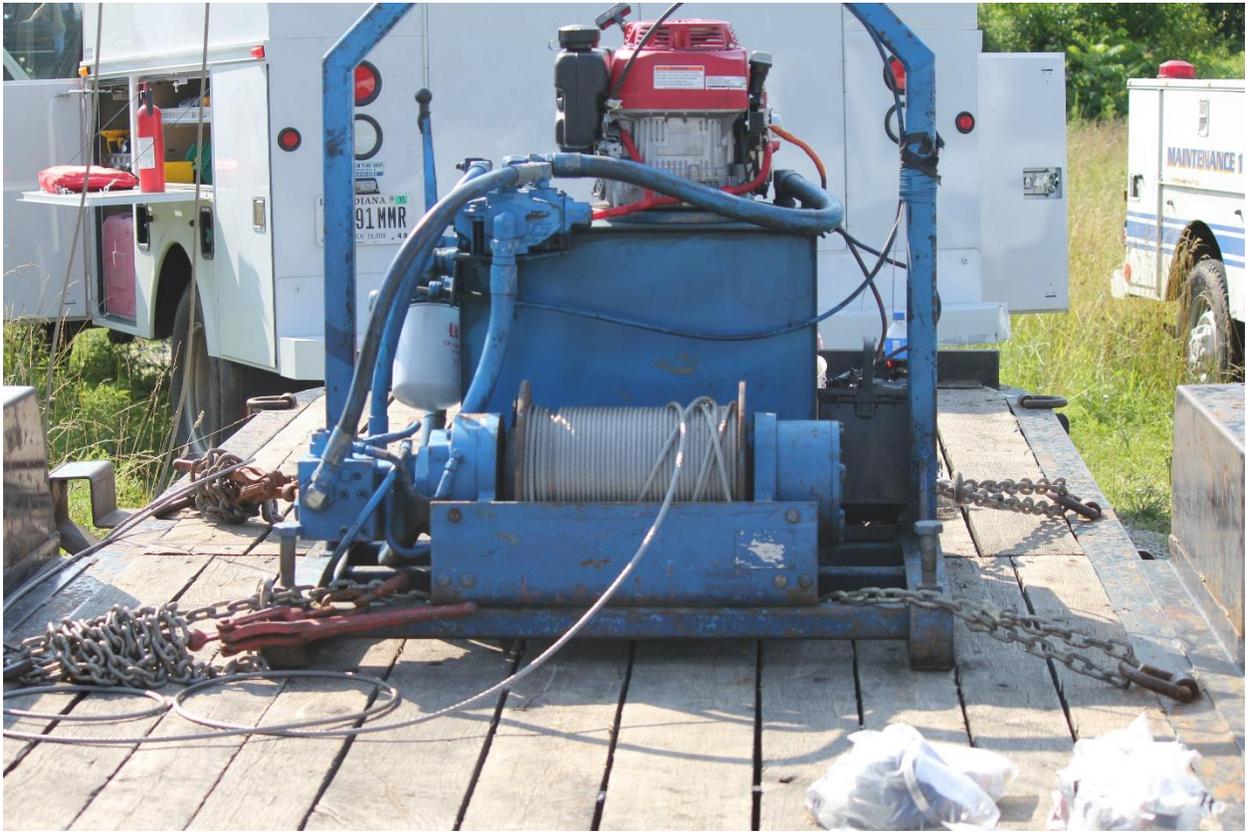
Each antenna array weighs 1800 lbs. and is routinely lifted to the destination point via a winch system. In this incident, the winch controls were based at a truck on the ground level, with a steel cable that reached from the winch controls to a pivoting point over which the antenna would be placed, and then down to the antenna itself. Routinely, the cable would be fastened to the antenna by a forged alloy shackle. The employer reported using a 5/8" shackle that would have provided a working load limit of 7000 lbs. and should have easily supported and not failed. However, there was evidence gathered at the scene to suggest that a carbineer was used in place of the proper shackle. A carbineer would not have been sufficient to support the weight tension from the winch system. A carbineer is a self-closing and self-locking connecting device for personal fall arrest or positioning systems. It must have a minimum breaking strength of 5,000 lbs. and the gate must withstand 3,600 lbs. of force in all directions without deformity, to meet ANSI X259.1 manufacturer's instructions.

Image 5  
Winch that was used
