**FATALITY ASSESSMENT AND CONTROL EVALUATION
PROGRAM (CA/FACE)**

**Lake Maintenance Worker Drowns while Removing
Weeds from a Golf Course Lake
Case Report: 15CA001**

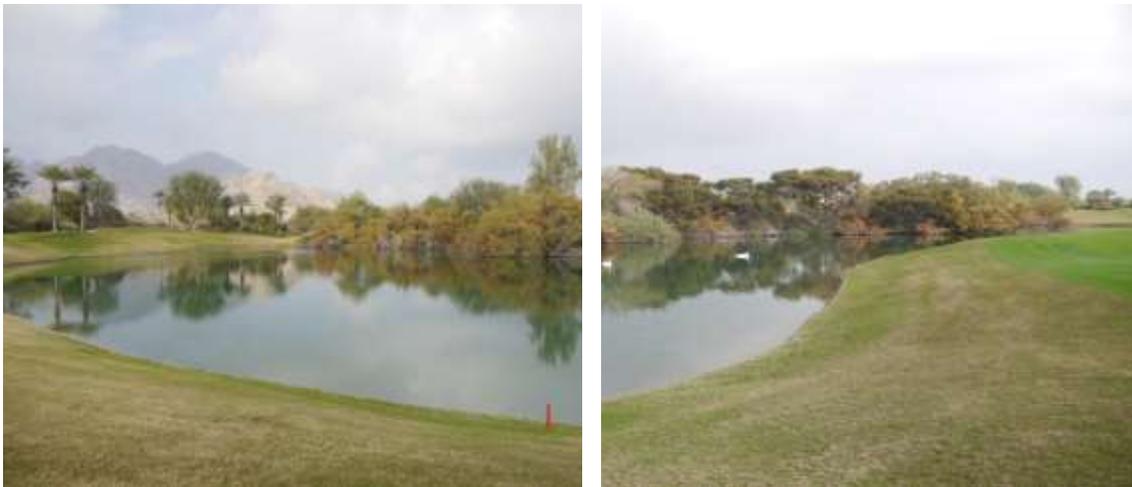
The incident scene was a 4.5-acre golf course lake (Exhibits 1 & 2). The lake served as an irrigation basin, receiving run-off water from an adjacent canal. Water from this lake flowed out through a pipe to another water feature on the course. Overgrowth of lake weeds and algae peak during the summer months. The lake was reportedly thick with weeds at the time of the incident.

Exhibits 1 & 2: View of lake where the fatality occurred (landscape view not to scale; photo taken when lake was free of vegetation).

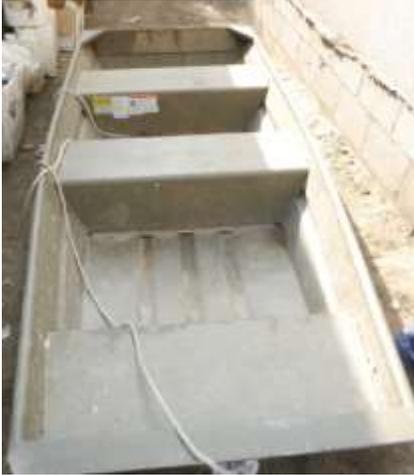
Exhibit 3. Boat used by victim

The victim was not wearing a PFD and there was no rescue equipment in the boat or onshore. Witnesses reported that the square-nosed boat that was being used that day may have contributed to the instability of the craft, leading up to the boat capsizing and the victim falling into the water. The boat involved in the incident was being used temporarily while their other boat was being repaired. The square-nose and shallow-hull design allows weeds to build up in front of the boat, impeding movement and requiring the boat operator to clear the weeds from the front of the boat, often from a standing position. Shifting one's weight in such a manner changes the center of gravity, decreasing stability. It was reported that the victim may have been clearing weeds from the boat's path when it overturned. There is inconsistent information as to whether the victim knew how to swim. During the CA/FACE interviews, the employer and

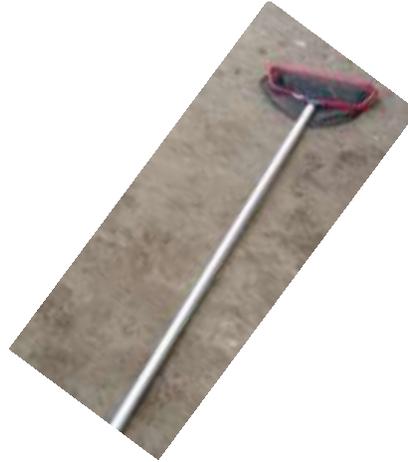
Exhibit 4. Poled net used for paddling the boat

Discussion: The victim was using a long pole with a net (skimmer) as a means for propelling the boat through the water. This pole and/or the rope used to corral the weeds may have become caught on weeds, or contributed to the instability of the boat, causing it to capsize. Employers should provide proper equipment for navigating non-motorized watercraft. Using proper equipment, such as strong and adequately sized paddles or oars, helps with controlling and navigating small watercraft safely.

Recommendation #5: Provide proper equipment for navigating small non-motorized watercraft.

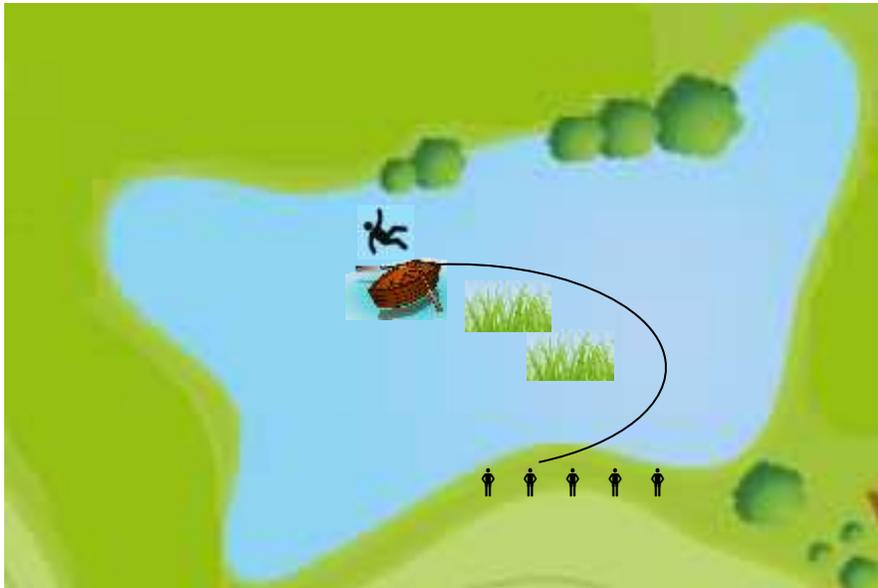
On the day of the incident, the victim was working from a small boat while “corralling” weeds from a golf course lake maintained by the victim’s employer. Corralling is an in-lake management method used for gathering floating weeds and moving them to the shoreline for disposal (Exhibit 5). During this procedure, a rope is attached to the boat and secured to the shore; the person in the boat takes the line out and surrounds the weeds in a large circular pattern and returns to shore. According to coworkers, the rope is allowed to sink to the bottom, at which time the workers onshore pull the rope, extracting (culling) the underwater weeds, and bringing them closer to the shoreline where they can then be raked onto the shore for disposal.

On the day of the incident, the victim started work at 5:30 am. Throughout the day, the victim had made multiple passes in the boat, corralling in the weeds. At roughly 1:45 pm, the victim set out alone in the row boat to make one last pass at corralling the lake weeds before ending the work day. Five co-workers, who were all relatives of the victim, remained onshore to help with the removal and disposal of the weeds. The victim was paddling the boat from a standing position, using the poled net that is pictured above (Exhibit 4). He was about 90 feet offshore when the boat overturned, causing him to fall into the water. The onshore workers saw the

Exhibit 5. Graphic depiction of corraling activity leading up to the fatal incident (not to scale).
