Granite Installation Company Owner Struck by Falling Granite Slab

Incident Number: 15KY020

Kentucky Fatality Assessment and Control Evaluation (FACE) Program

Release Date: October 6, 2015

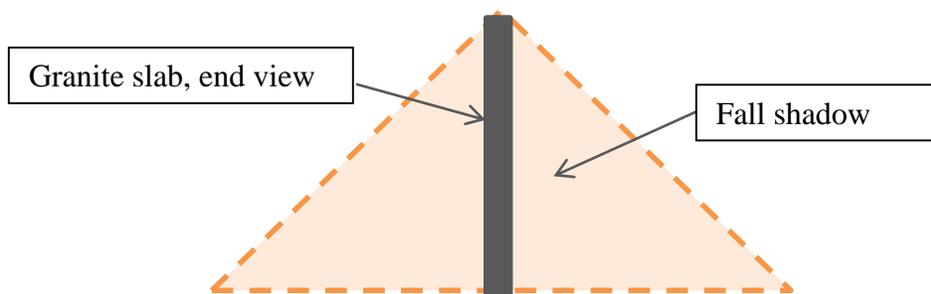
OSHA defines the fall shadow zone as “the area on both sides of the slab where the slab could land and topple if it were to fall.” The higher the slab is lifted from the ground, the larger the fall zone. Standing outside of the fall shadow at either end of the slab is the best practice to prevent being crushed or hit with the stone slab.

Recommendation No. 1: Employers should identify a fall shadow zone, and restrict employees from placing themselves in that zone, while stone is being loaded, unloaded or moved. ¹

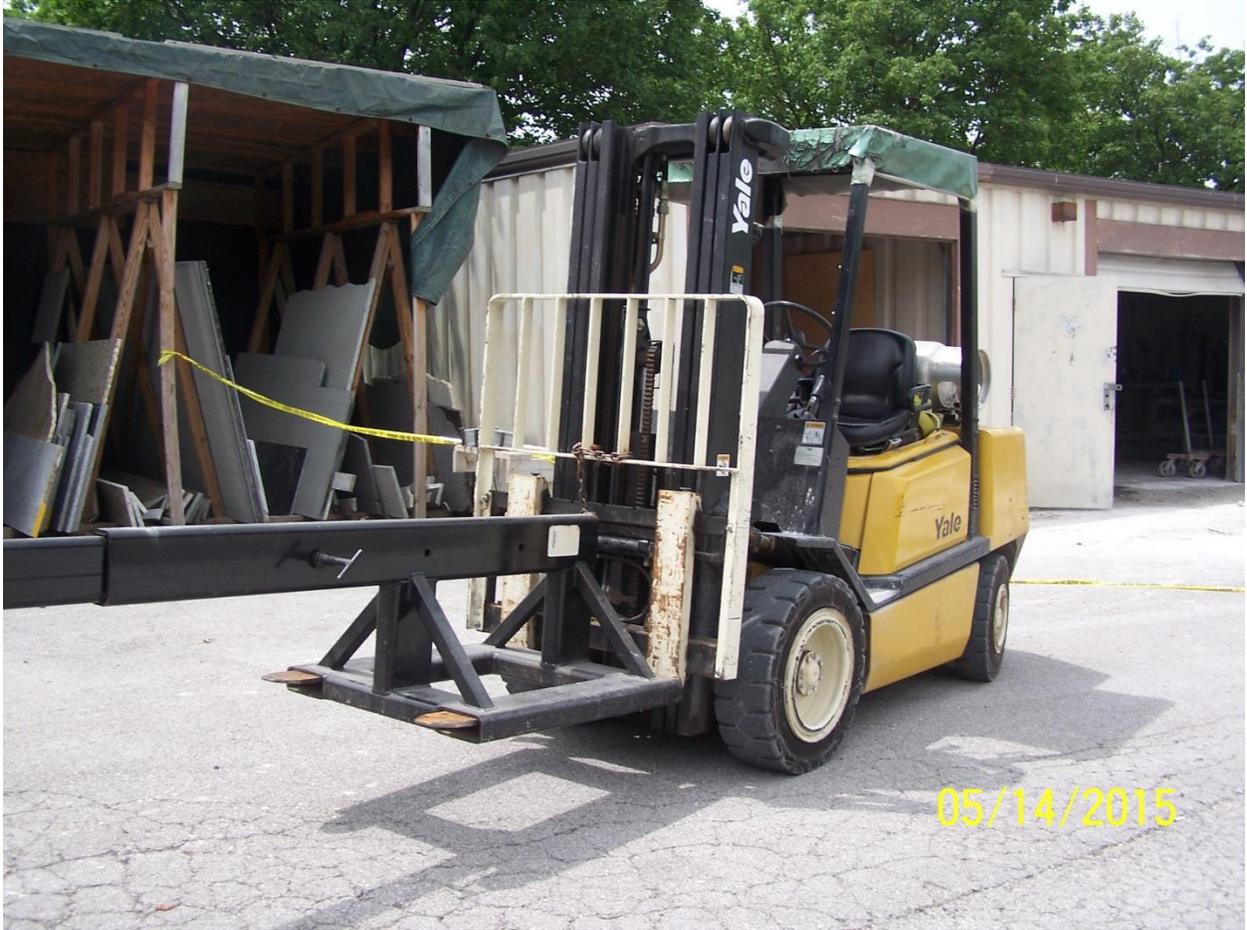
On Thursday, May 14, 2015, a granite delivery driver arrived at the employer's business around 9:30 am, to deliver previously ordered granite. The victim and the forklift operator brought out a forklift truck to unload five slabs of granite. The forklift had a boom with a slab clamp to move the granite slabs (see photos #1 and #2).

Photo #1: Forklift and boom used

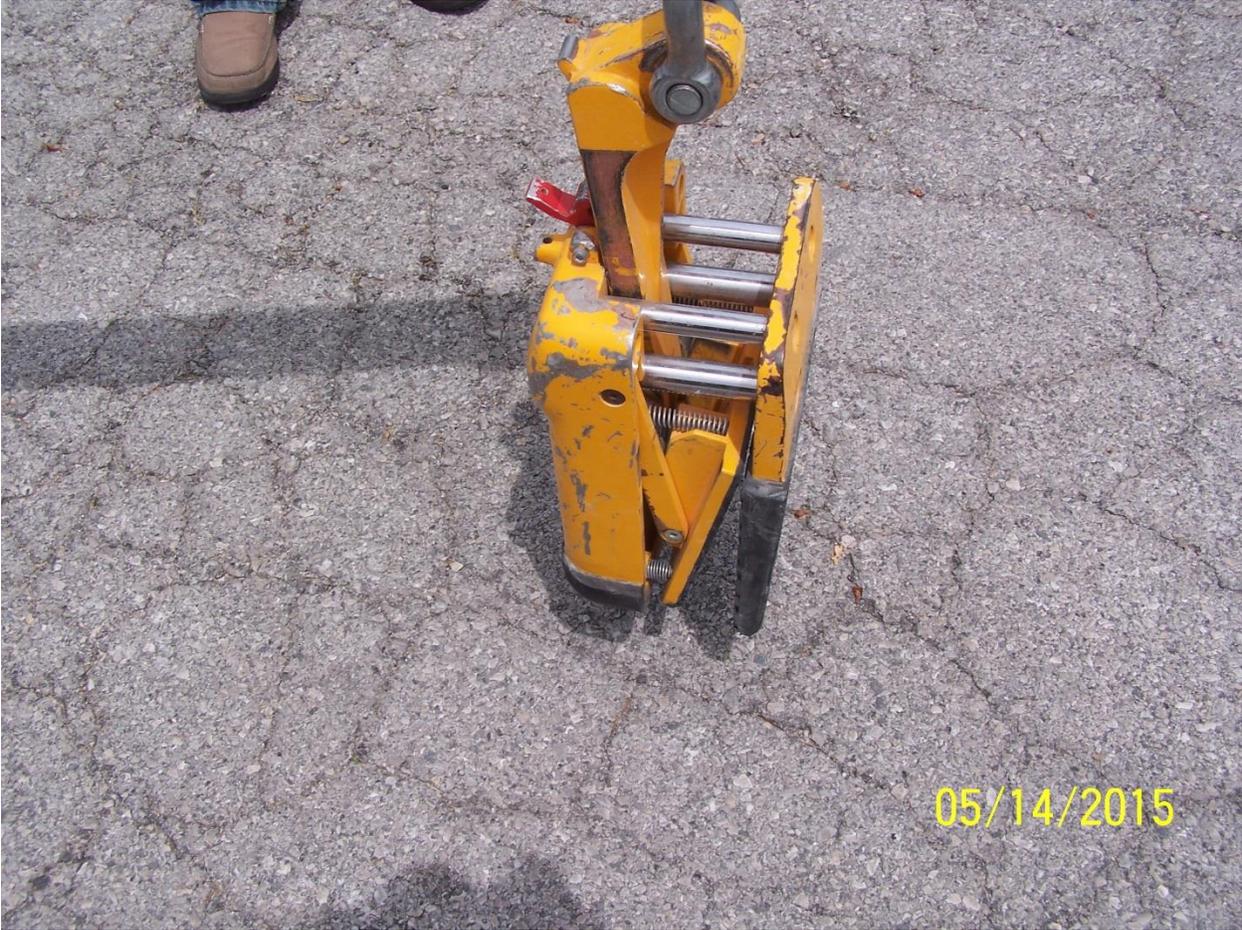
The forklift operator drove the forklift to the flatbed truck and positioned the forklift so that the truck driver could reach the boom and place the clamp securely in the middle of the 1000 lb. slab of granite. Once the slab was secured, the forklift operator took the slab to the storage area,

Photo #2: The slab clamp

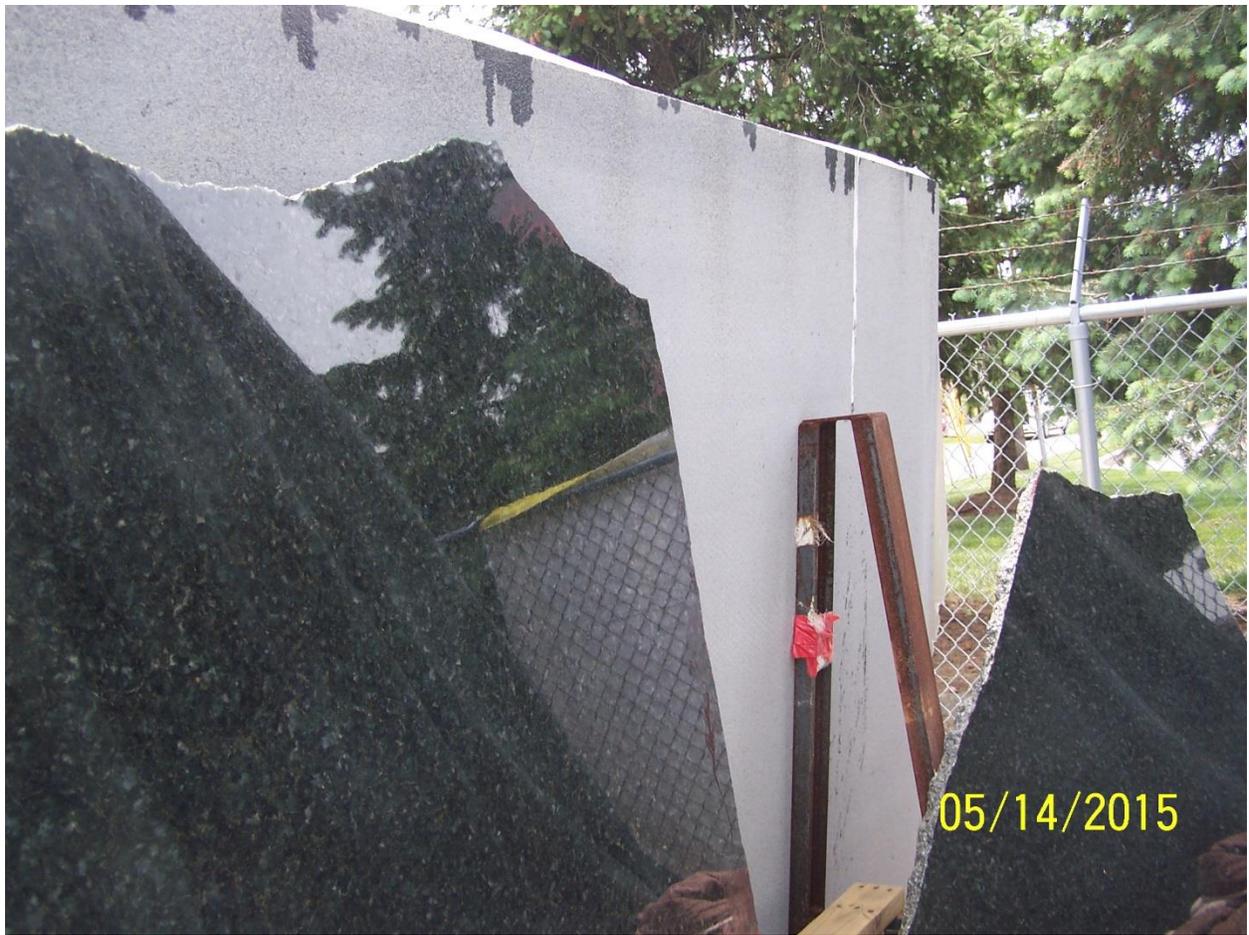
placed it on the concrete, and returned for the next piece. The forklift operator unloaded four pieces of granite. The fifth and final piece of granite was unloaded from the truck. This slab measured 121 inches long by 79 inches tall and 1000 lbs. The forklift operator stated he had set the last slab of granite on the ground. (Once the granite is on the ground the clamp automatically releases.) The forklift operator stated that the victim stood directly in the middle of the large piece of granite guiding it into place, which was his usual practice. The forklift driver backed away once the clamp released. The victim was positioned directly in the fall shadow of the granite slab. Before the victim could move from the fall shadow, a gust of wind may have caused the granite to shift, striking the victim in the head and pinning him under the granite slab.

Employers should use engineered heavy duty stone slab storage racks to protect their employees and their product. Individual compartments ensure integrity and protect each slab. Slab storage racks also protect against slabs being blown over. The wind speed at the time of the incident was 21.9 mph and may have contributed to the slab tipping over.

Photo #3: 5th piece of granite that hit the victim

Recommendation No. 4: Employers should always use stone slab storage racks designed by engineers with individual compartments to support the granite and marble slabs.⁴

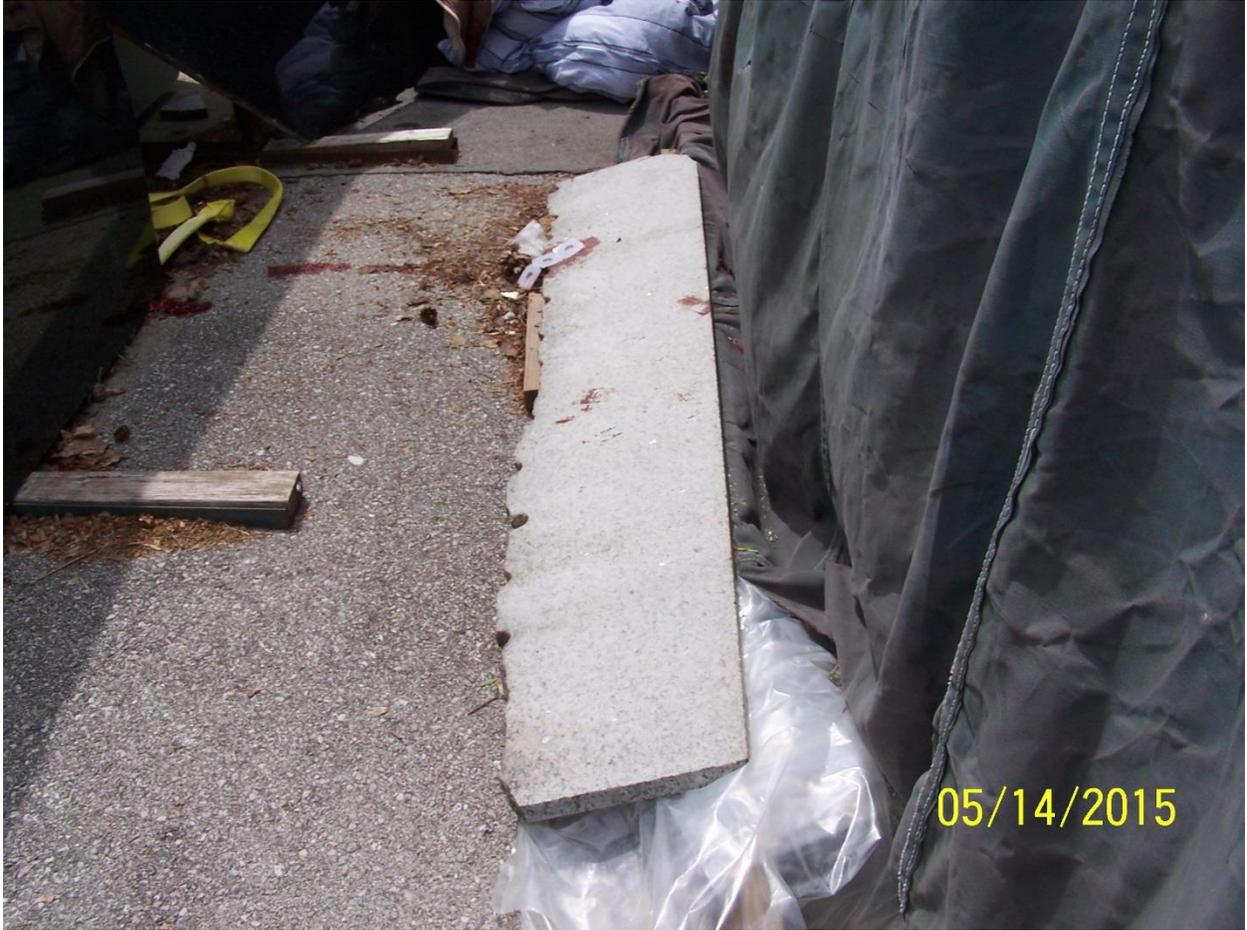
The incident scene was the company parking lot. There was a makeshift storage area on the right hand side of the lot. The storage area had a roof and tarps on two sides, leaving the front side exposed to outside winds. This is where granite was placed as it was unloaded from trucks. The area where the incident occurred was outside the covered storage area and inside a chain link fence and in an open area to the left of the covered storage area.

Photo #4: incident scene

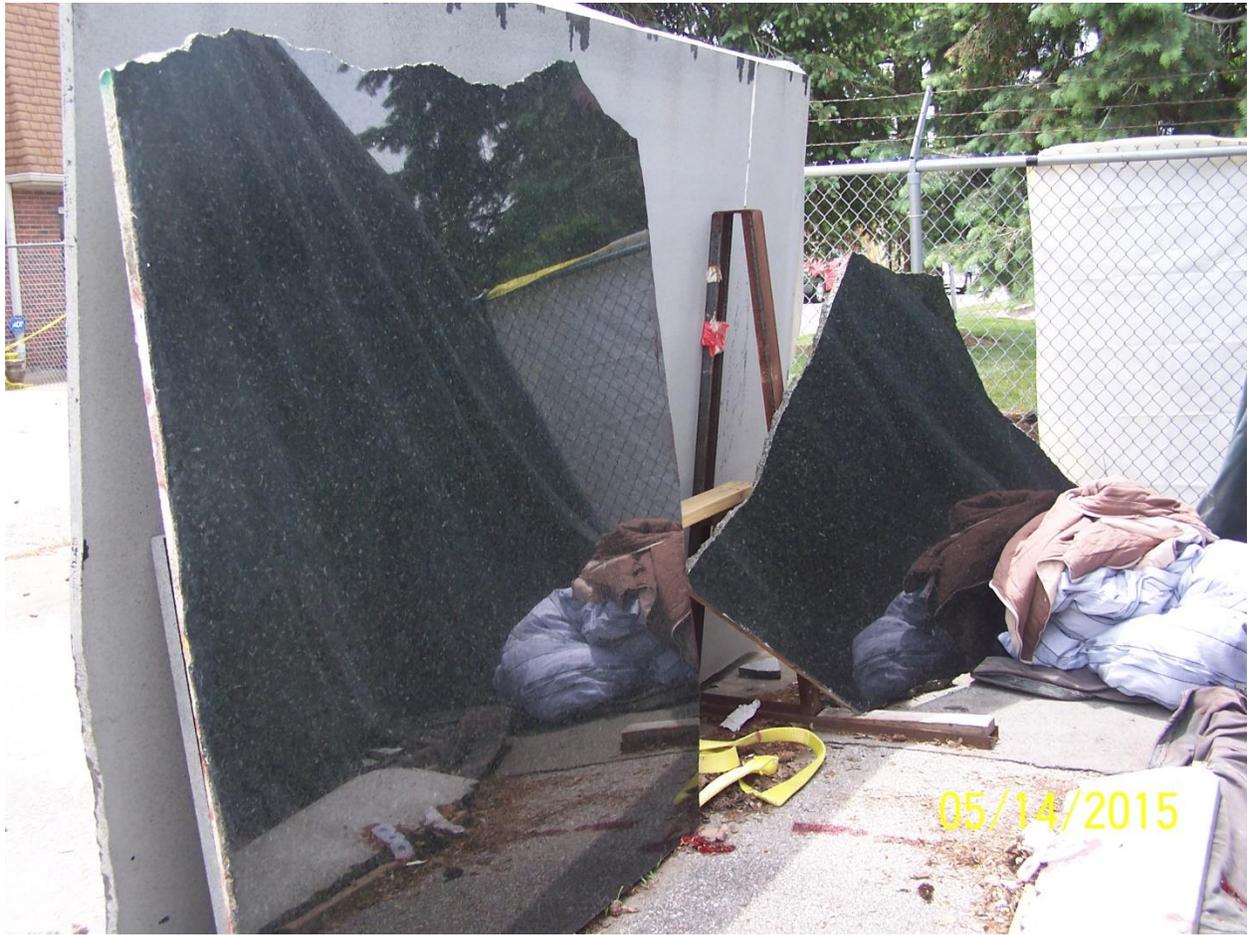
Photo #5 Incident scene
