Driver Exits Burning Semi-Truck and Falls to His Death

CASE SUMMARY

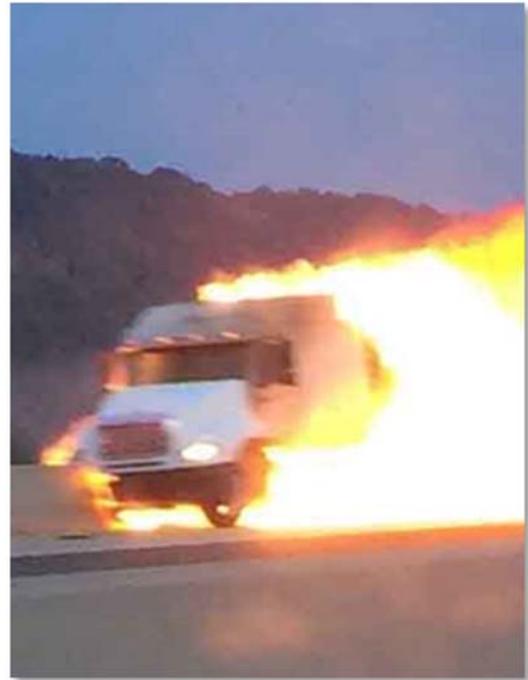
On Friday, June 8, 2015 a 52-year-old semi-truck driver was traveling southbound on a six-lane interstate. He suddenly braked hard and swerved to the right striking the right shoulder of a bridge concrete barrier wall spanning a river. The right gasoline tank on the truck ruptured and caught fire as a result of the friction.

Figure 1. The semi-truck engulfed in flames following the incident.

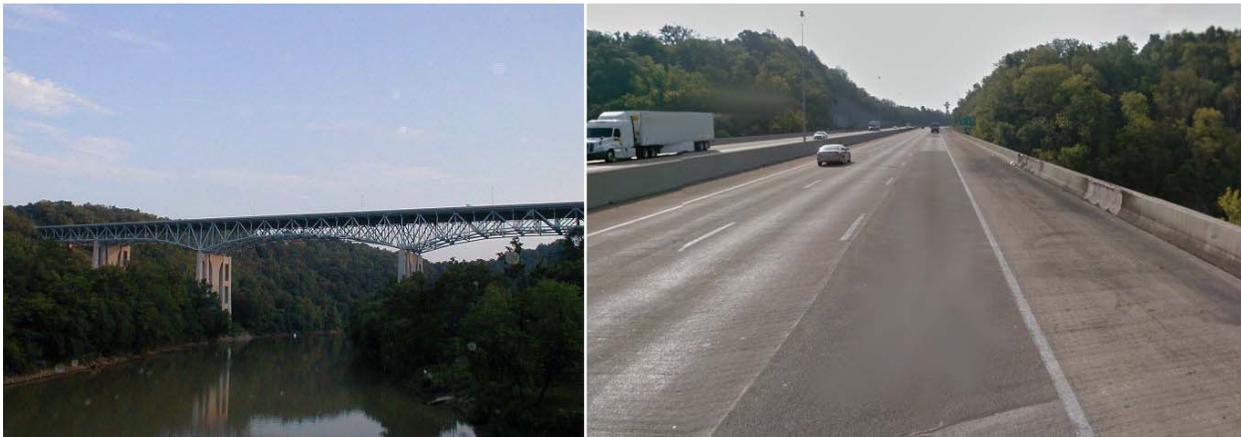
Figure 2. Interstate bridge where the incident occurred.

The incident scene was a southbound six-lane interstate bridge span, 250 feet above a major river. The stretch of roadway was clear and straight with barrier walls on each side and in the middle to divide the interstate. The bridge was lighted for nighttime travel. The tractor trailer was a 2006 Columbia 120 Freightliner.

Although the bridge span was well lit at night, the incident occurred at 6:15 am (dawn) which may have contributed to the driver being unaware of the large drop to the river.

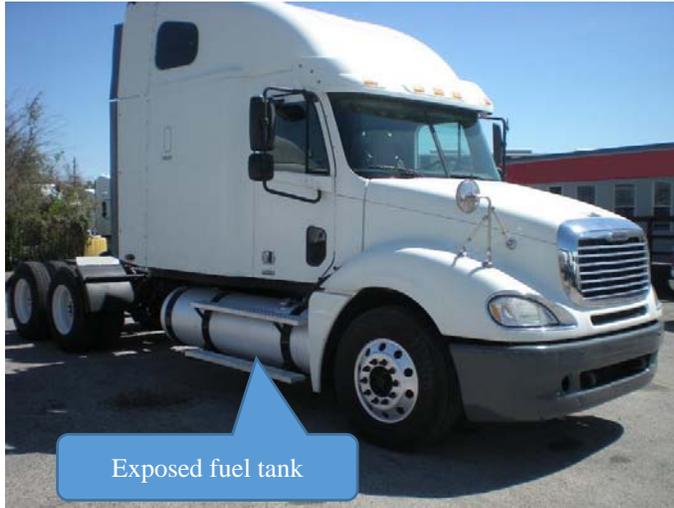
The equipment was a 2006 Freightliner Columbia 120 with dual side-mounted fuel tanks, one on each side. This type of design has been shown to make the fuel tank more susceptible to explosion during a collision. The truck was not equipped with a standard fire extinguisher.

Figure 3. Stock photo of a 2006 Freightliner Columbia 120, similar to the unit involved in this incident.

Recommendation No. 4: Employers should ensure that their tractor trailers are equipped with fire extinguishers.³

According to the Federal Motor Carrier Safety Administration (FMCSA) each truck, truck tractor, and bus must be equipped with a class B: C type fire extinguisher and Underwriters Laboratories rating of 10 or more. This type of fire extinguisher is designed to work on electric fires as well as burning liquids.⁴ While a fire of this magnitude could not have been contained with this type of extinguisher, having one on board at all times can help to contain smaller fires and prevent them from spreading and growing.

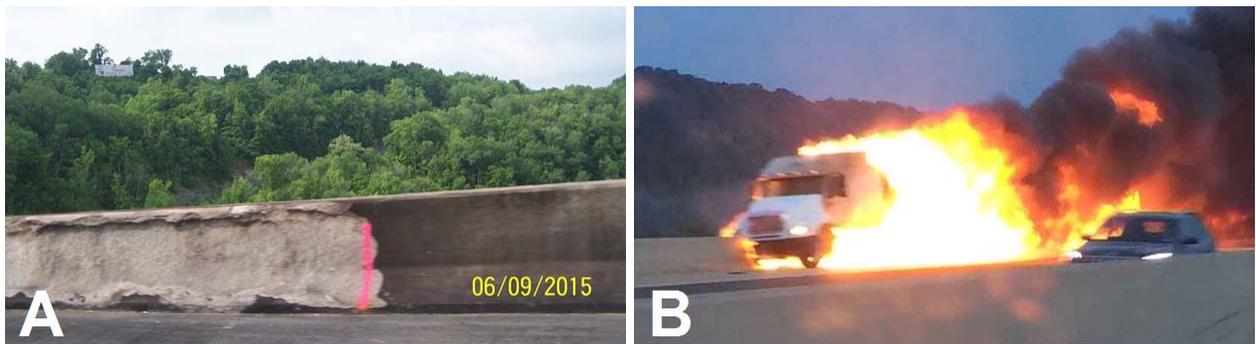
Figure 4. A) Damage to the concrete railing from the semi-truck. B) The semi-truck in flames.

On June 8, 2015, at approximately 6:15 am, a semi-truck driver drove southbound on a major interstate, lost control on a bridge, and struck the right shoulder concrete barrier bridge wall (see

figure 1). The vehicle rode the top of the barrier, which caused the right fuel tank to rupture and catch fire. The vehicle came to rest several hundred feet down the roadway with the right side leaning over the bridge, continued to burn and then exploded (see figure 5).

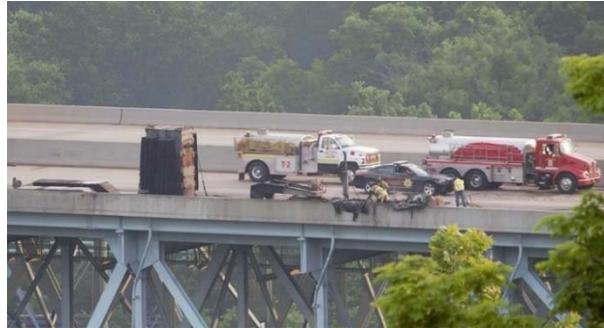
Witnesses stated they felt heat from the fire five lanes away. The police arrived 15 minutes later. The southbound lanes were immediately shut down and crews worked quickly to contain the fire. Once the fire was contained, the response team noticed there was no driver inside the cab of the tractor. A team of fire fighters began searching for the driver.

Figure 5. Emergency crews working the scene.

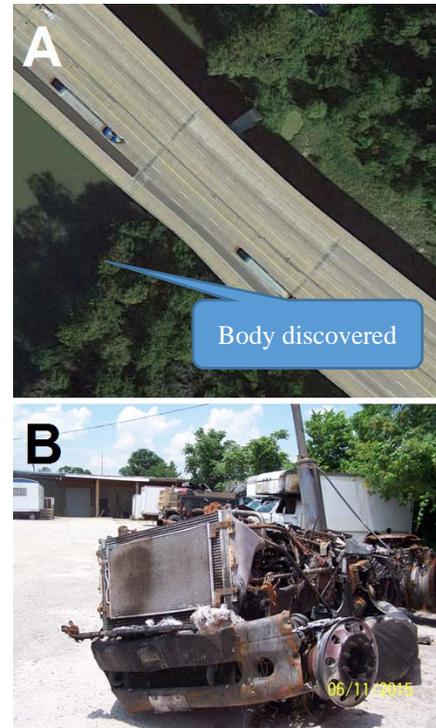
After an extensive search, fire fighters discovered the victim's body 170 feet below the bridge in a steep, wooded area next to the bank of the river (see figure 6A). The victim was pronounced dead at the scene.

The cause of death was multiple blunt force injuries due to falling 170 feet off a bridge onto a steep bank.

Figure 6. A) Area of woods where the victim was found. B) The charred remains of the semi-truck.

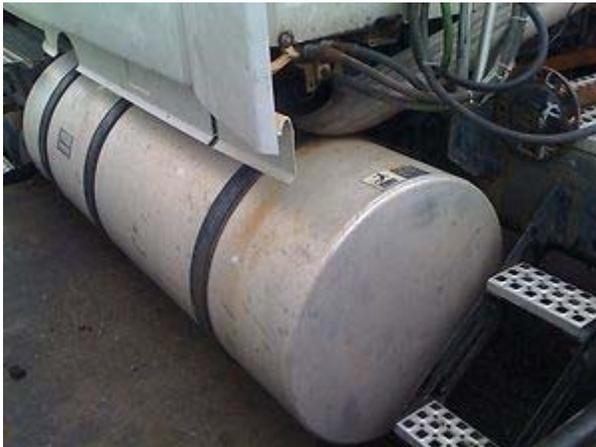
Semi-trucks have two 140 gallon, or greater, diesel fuel tanks, one on each side of the semi. These exposed tanks are at risk for penetration and a resulting fire. A 2012 study of Kentucky motor vehicle collisions found that large trucks are at higher risk for collisions involving fires than passenger cars and pickup trucks.¹ Manufacturers should consider redesigning and relocating fuel tanks on large commercial vehicles to reduce the risk of penetration and fire. Special attention should be paid to increasing the distance that displaced truck components must traverse before coming into contact with the fuel tanks, and to providing protective barriers between the fuel tanks and the frame of the truck.

Figure 7. Stock photo of a side mounted fuel tank commonly found in semi-truck designs.

Recommendation No. 1: Manufacturers should consider the redesign and relocation of fuel tanks to reduce risk of penetration and fire.
