19-Year-Old Construction Laborer Crushed in Trench Collapse While Laying Sewage Pipe

CASE SUMMARY

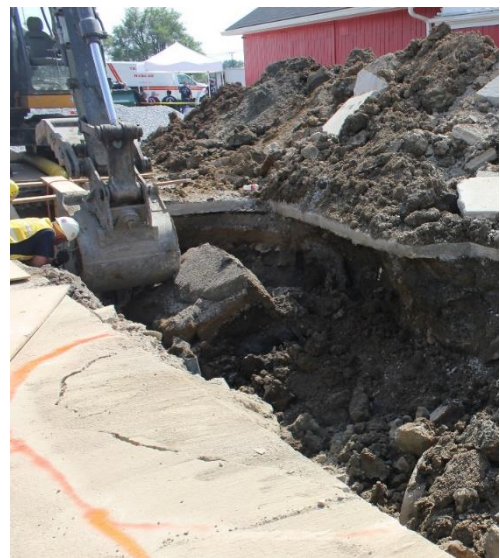
Figure 1. Trench following the rescue efforts.

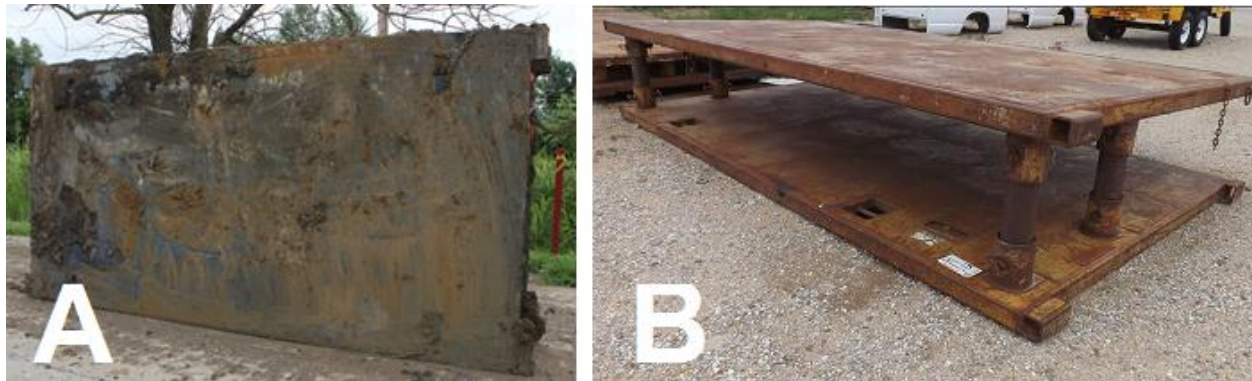
Although the workers used a trench box, it was not tall enough for the trench. The trench was 12 feet and 2 inches deep, while the trench box measured only 8 feet tall. This left the construction laborers inside the trench vulnerable to 4 feet and 2 inches of exposed wall.

Figure 3. A) Trench box used to protect the workers, the walls of which were 4 feet and 2 inches too short for the job; B) stock photo of the type of trench box used, side angle view.

A trench box protects employees from exposure to soil collapsing into the trench where work is being performed. The trench box wall measured only 8 feet high, while the trench itself measured 12 feet and 2 inches high. This left 4 feet and 2 inches of ground and concrete exposed, placing the workers below at danger of a partial trench collapse. A properly sized trench box could have helped protect the workers from the hazard.

Recommendation No. 1: Trench boxes used in excavation projects should have a wall height greater than or equal to the wall height of the surrounding trench.³
