## Construction Siding Subcontractor Installer Killed when Oversized Scaffolding Platform Destabilized and Telescopic Forklift Overturned

### CASE SUMMARY

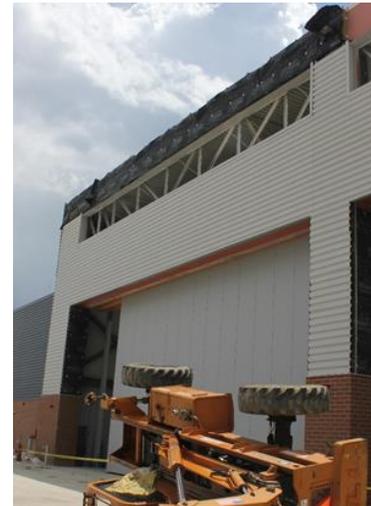
**Figure 1.** Telescopic forklift overturned at jobsite.

- The rough terrain forklift truck was not designed to lift personnel
- The platform on the lift was too long, causing the forklift to become unstable

- The operator tilted the lift while lowering the manned scaffold platform
- The employee was not trained to operate the lift

- Employers should provide appropriate siding equipment on the job site and ensure all employees are trained to operate the siding equipment.
- When lift equipment is required to elevate siding installers, choose only equipment specifically designated by the manufacturer for that purpose.
- Avoid tilting a forklift truck when the platform is elevated.
- When using a forklift approved by the manufacturer for personnel lifting, the width of a scaffolding platform should not exceed the width of the forklift wheel base.

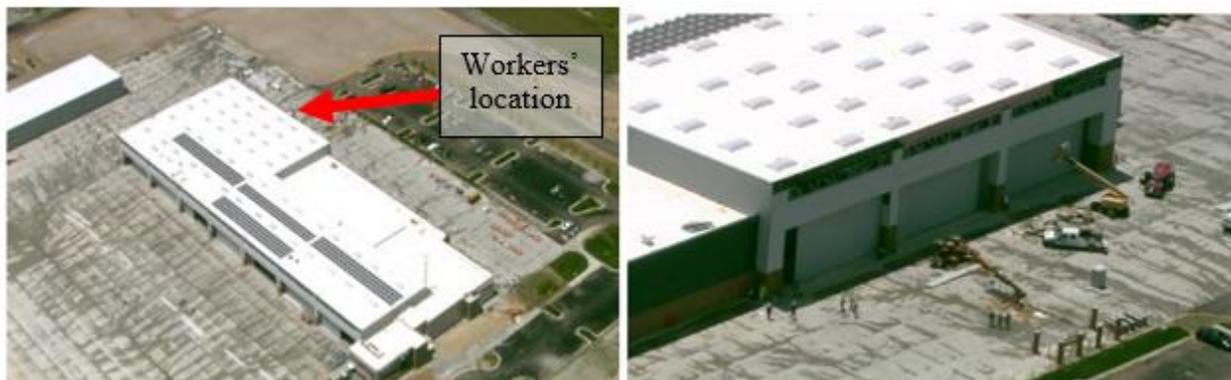
**Figure 2.** Aircraft hangar where the incident occurred.

The incident scene was a concrete parking lot where an aircraft hangar was under construction. The siding installers were installing insulation on the north wall of the building (figure 2) at the time of the incident, at an elevation of approximately 40 feet.

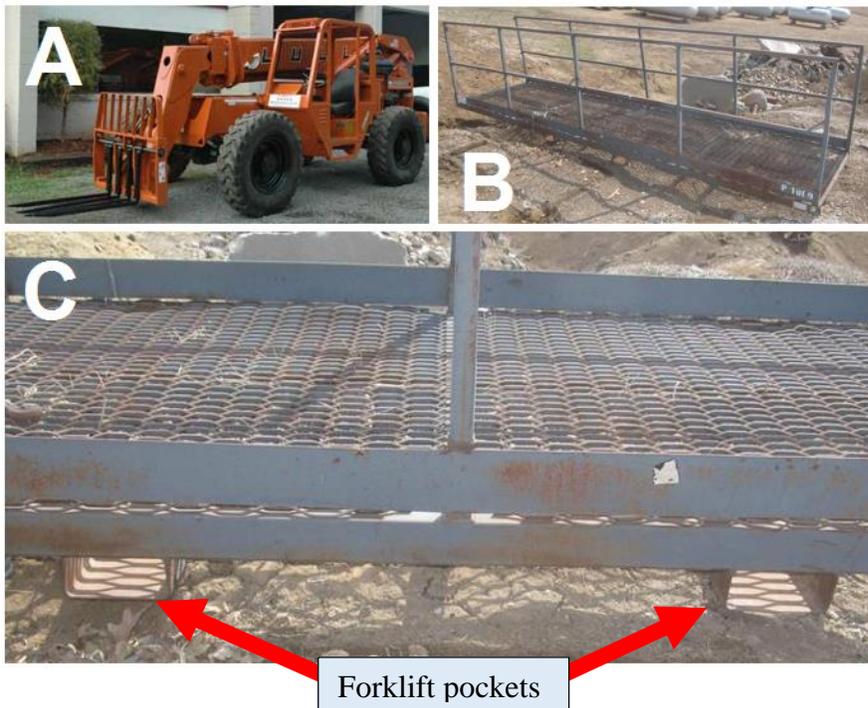
The equipment at the job site was a Lull model 844C rough-terrain telescopic forklift<sup>1</sup> with a wheelbase width of 8 feet and a load capacity of 8000 pounds (Figure 3A). The operator's manual warned that this equipment should only be used for material handling, and should never be used to lift personnel. This forklift model was not factory equipped with stabilizers to prevent it from tipping over.

**Figure 3.** A) Stock image of a Lull 884C rough-terrain telescopic forklift. B) Stock image of an Arrow brand platform, model 90WP48-192. C) Forklift pockets shown on actual platform.

Arrow brand man platform model 90WP48-192 was used as an attachment to the forks at the end of the forklift boom. This platform was constructed of steel and measured 4 feet by 16 feet, with 43 inch high side walls spanning the length of the platform and no end walls (Figure 3B). Additionally, there were forklift pockets located on both the middle of the long side and on the short ends of the platform to support scaffold platforms (Figure 3C).

The rough terrain forklift truck that was used had a chassis with two axles spanning 8 ft. wide. The platform was 4 ft. by 16 ft. This caused the platform to extend 4 ft. beyond the wheel base on each side of the forklift. According to the operator’s manual and AMSE/ANSI B56.6 1992 safety standards, “A platform of the lift shall not have a greater width of the forklift.”<sup>4</sup>

According to 29 CFR 1926.451(c)(2)(iv), front end loaders and other similar equipment, including rough terrain forklift trucks, should not be used to support scaffold platforms unless they have been specifically designed by the manufacturer to do so.<sup>2</sup> The Lull operating manual stated not to use the rough terrain forklift truck as a personnel lift, as it was designed to handle material only.

**Recommendation No. 4:** When using a forklift approved by the manufacturer for personnel lifting, the width of a scaffolding platform should not exceed the width of the forklift wheel base.

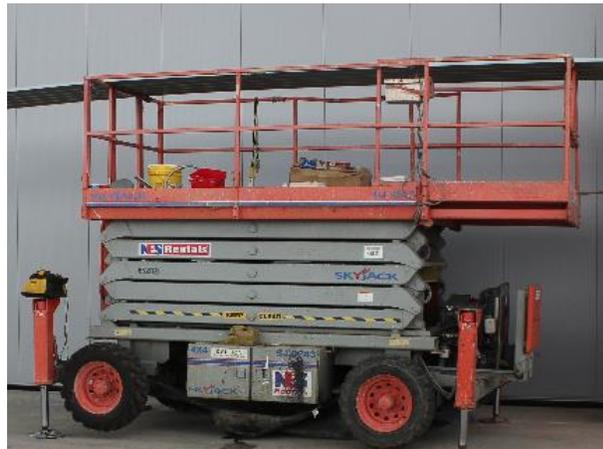
**Figure 4.** Skyjack SJ8243 Scissor lift which was located on the construction work site that would have been appropriate for lifting the personnel. This lift had a maximum height of 43 feet.

Located on the premises of the construction site was a Skyjack brand SJ8243 Scissor Lift which is specifically designed for the lifting of personnel (Figure 4). The Skyjack model had a maximum platform height of 43 ft., which would have been sufficient to safely access the working area. It is unclear why the Skyjack Scissor Lift was not used.

**Recommendation No. 2:** When lift equipment is required to elevate siding installers, choose only equipment specifically designated by the manufacturer for that purpose.

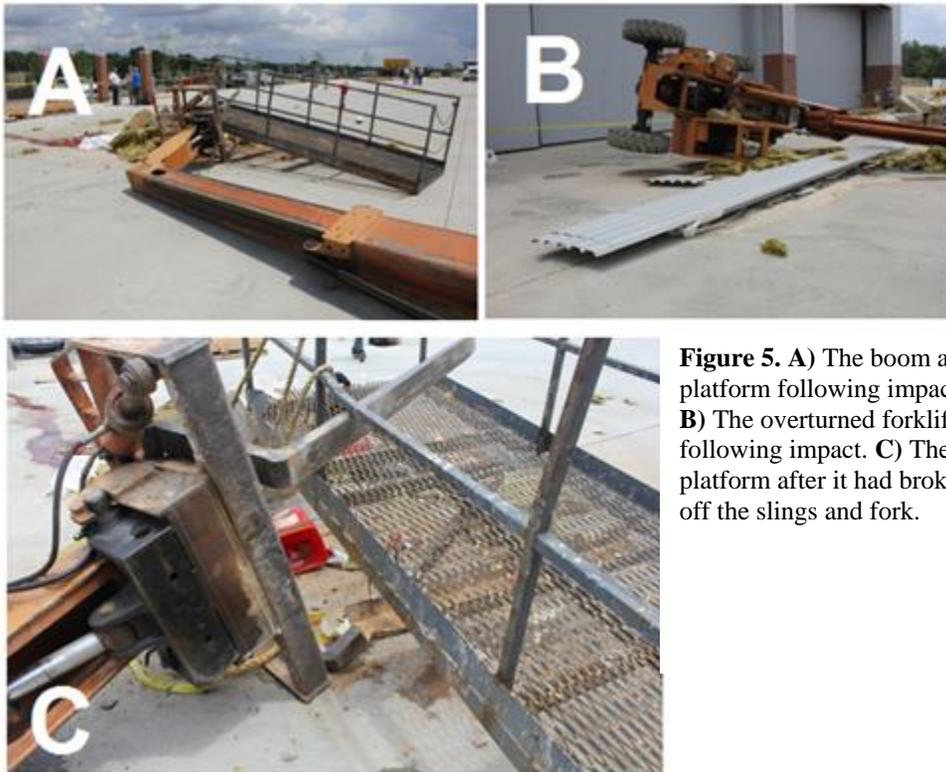
At 11:25 am the employees signaled to the foreman that they were ready to come down. Concerned that the platform may scrape the side of the building during descent, the foreman used the forklift's chassis tilt function to tilt the platform to the left away from the side of the building. The foreman stated that when he tilted the frame of the forklift, he lost control of the tilt and in doing so, the tilt continued to increase. As the tilt increased, the weight of the extended platform caused the forklift to lose its equilibrium and overturn onto its left side, slamming the platform onto the concrete below. Upon impact, the sling used to secure the platform to the fork broke away and the platform's left-side guardrail broke off. While the foreman was able to avoid injury by jumping away, the two siding installers, who were secured to the platform, were thrown onto the concrete lot. A nearby laborer

**Figure 5.** A) The boom and platform following impact. B) The overturned forklift following impact. C) The platform after it had broken off the slings and fork.

The foreman tilted the chassis of the forklift to avoid scraping the siding of the building during the platform's descent. In doing so, he lost control of the lever, causing the platform and the

forklift to lose balance and overturn. The Lull Operators Safety Manual states the following:  
“Always level machine before raising boom. Never tilt frame with the boom raised. Machine may tip and cause serious personal injury or death!”<sup>3</sup>

**Recommendation No. 3:** Avoid tilting a forklift truck when the platform is elevated.
