REPORT#: 15MI086

Owner of Farm Land Died Due to a Tractor Run Over

Michigan Fatality Assessment and Control Evaluation (FACE) Program

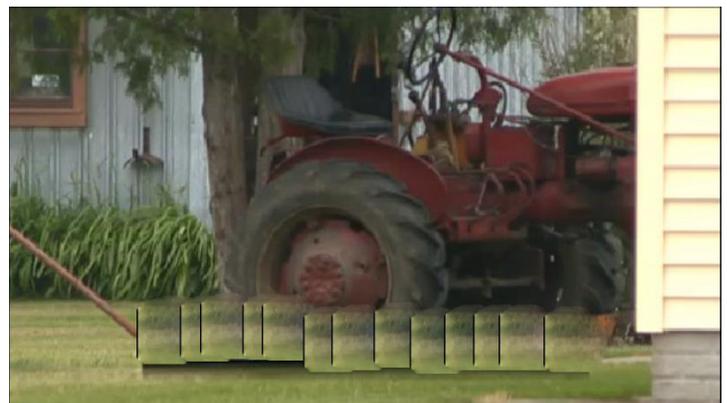
The exact sequence of events is unknown. Although several scenarios were discussed at the time of the site visit and were present in the hospital record, MIFACE agrees with FM#1's assessment of the two most likely hypotheses: the decedent was standing on the ground at the side of the tractor and either 1) reached up purposefully to start the tractor or 2) was reaching up for balance and inadvertently hit the starter. Because the tractor was in reverse gear, the tractor began to move backward. The decedent was struck by the mower deck, knocked to the ground, and was dragged by the mower deck several yards before the tractor movement was stopped by a tree (See Photo 1). FM#2 ran to the house and told

Photo 1. Incident tractor against tree

- Decedent started the tractor from the ground rather than the operator platform/tractor seat.
- Improper tractor shut down procedures.
- Tractor tires not chocked during maintenance activity

Recommendation #1: Start tractors from the operator seat only, not from the ground.

Recommendation #2: Tractor operators should always utilize proper tractor shut-off procedures prior to exiting the tractor seat.

Recommendation #3: When performing maintenance on equipment with wheels, if any wheels are in contact with the ground, block/chock one or more of these wheels in both directions to prevent equipment movement.
