Occupational Fatality Report

Mechanic Fatally Injured When the Dump Truck Tire He Was Inflating Ruptures - Massachusetts

Release Date: February 26, 2018
Investigation: # 15-MA-030-01

Massachusetts Department of Public Health
Occupational Health Surveillance Program

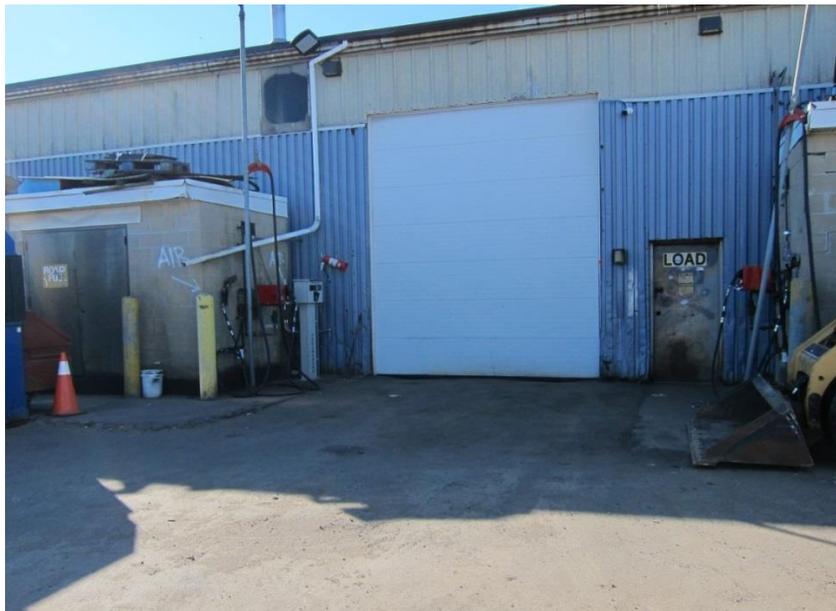
Figure 1 – Truck maintenance garage

The incident occurred at the company headquarters that included offices, the truck and equipment lot, maintenance garage, and an area where construction debris was crushed and processed. This location was a mixed industrial and commercial area in a metropolitan community. The site contained many parked trucks and other pieces of heavy equipment that were owned by the company and used for contract work or rental. The garage where the victim worked was accessed through one large bay door on the rear of the building that faced the parking area (Figure 1). The incident occurred just outside the bay door where the truck was parked upon returning for service.

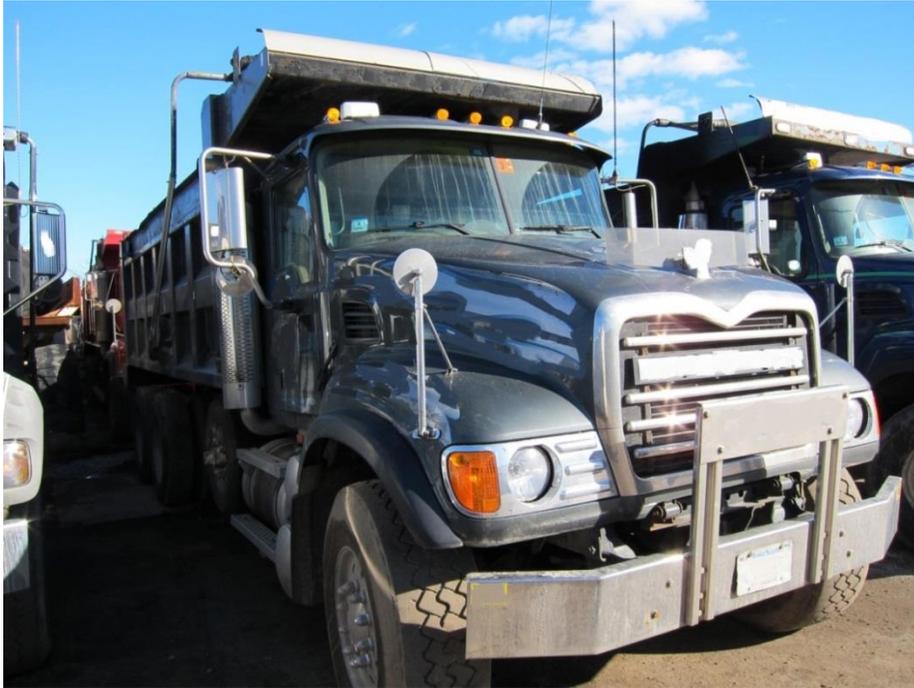
Figure 2 – Truck involved in the incident

The vehicle involved in the incident was a tri-axle dump truck manufactured in 2003 (Figure 2). The company owned and maintained six tri-axle dump trucks. The truck involved in the incident was outfitted with tubeless tires mounted on single-piece rims. The tri-axle setup included three axles in the rear: two dual-wheel axles plus a single lift/pusher axle that was located just in front of the tandem dual axles (Figure 3). The lift axle (Figure 4) was activated by the operator of the truck using controls in the cab, and was used to help support a loaded dump bed and assist with stability while turning. The lift axle was powered by compressed air and had controls that regulated and balanced the air pressure balancing the axle. Increasing the air pressure would push the axle downward, putting the tires in contact with the ground to support some of the weight of the load. While the truck was unloaded the lift axle would be in a raised position, keeping the tires a few inches off of the road surface as in Figure 3.

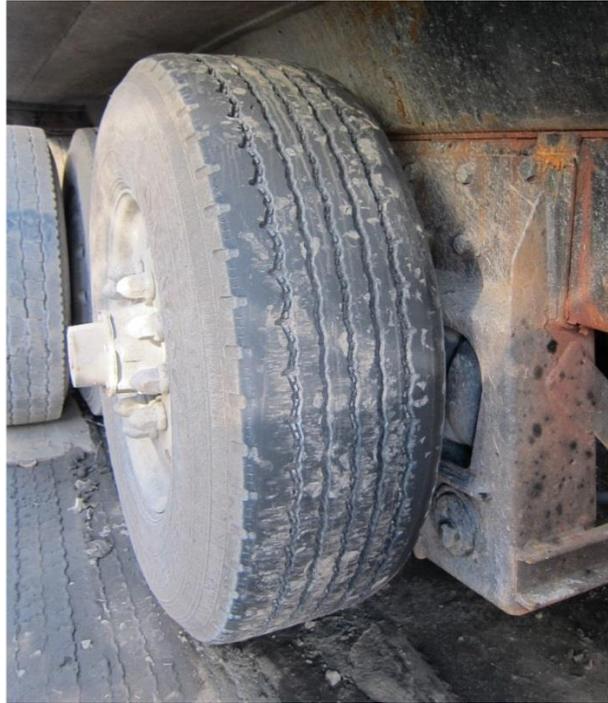
Figure 4 – Lift axle, right side of truck (shown with replacement tire)

The tire involved in the incident was a tubeless three-and-a half-foot diameter truck tire with a casing consisting of five layers/plies of steel on the tread surface and one layer of steel on the sidewalls. The tire was size 385/65/22.5 with a width of just over 15 inches, and was mounted on a 22.5" single-piece rim. This size tire is wider than the tires mounted on the other axles of the truck. The extra width allows for the tire to support more weight than a standard width tire. When inflated to the recommended max 130 psi this tire was rated to support just over 9,900 pounds. It is unknown if the tire had been original to the truck, but at the time of investigation a tire of a different brand than the tire involved in the incident remained on the opposite side of the axle.

It is likely the sidewall of the tire was compromised when it was driven on under load. With the addition of more air to the tire, the sidewall burst in what is termed a zipper failure.^{1,2} Individual strands in the sidewall of the tire stretched and snapped. This led to increased stress on the adjacent strands and a cascading failure that ripped through the sidewall of the tire, releasing the pressurized air. This type of rupture usually occurs on the top sidewall of the tire as that is the area that undergoes the most stretching when the tire is under load. Because the victim was standing facing the tire, the air blast struck him in the chest.

Recommendation #2: Ensure that tires are properly inspected before inflation if they have been driven on while underinflated

Discussion: In this incident, it is unknown if the driver of the truck effectively communicated to the victim that the underinflated tire had been driven on while delivering a load that morning. We do know that the victim did not deflate and inspect the tire for signs of damage and perform a controlled re-inflation of the tire. While the actual low pressure of the tire was not documented, it is believed the pressure was below 80% of the recommended pressure.

Driving on underinflated, overinflated, or overloaded tires can cause damage to the sidewalls that may not be visible on the outside surface of the tire. Adding air to tires with damaged sidewalls can cause them to fail. For this reason if a tire is driven on while underinflated it is necessary to remove the tire from the rim and conduct a thorough inspection before re-inflating. Recommendations and consensus standards from the Tire and Rim Association, Tire Industry Association, and Rubber Manufacturers Association as well as regulations from OSHA describe that any truck tire that is driven on while it is at less than 80% of the recommended inflation pressure should be taken out of service and inspected under controlled conditions.^{3,4,5} This includes deflating the tire, removing the valve stem and demounting the tire from the rim, conducting a visual and physical inspection of the tire for defects or signs of damage, and re-inflating the tire in a restraining device and under controlled conditions in order to observe and listen for any signs of failure. This sort of inspection cannot be performed in the

field, so arrangements would need to be made to swap the underinflated tire for a spare tire or tow the truck to a garage where the tire can be properly inspected.

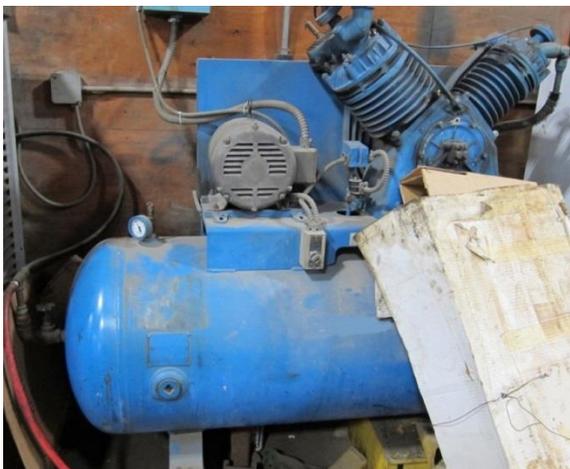
Figure 5a – Air compressor

Also involved in this incident was the air compressor used to inflate the truck tire (Figure 5a). This compressor was located inside the garage, near the rear of the maintenance bay. The air supply hose

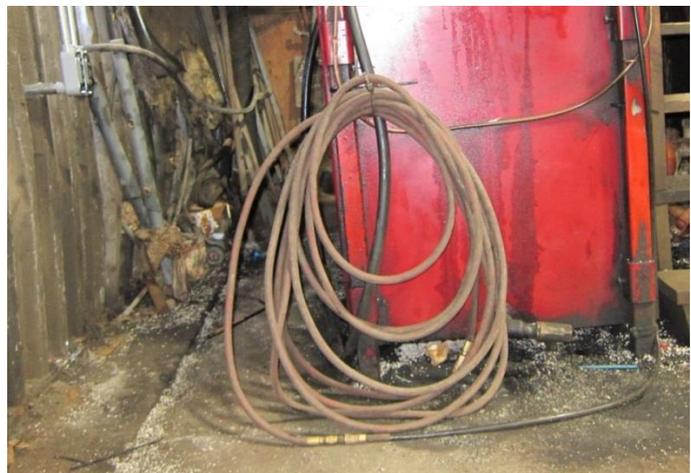
Figure 5b – Air supply line

was routed from the compressor to nearby the garage bay door, where a coil of hose was stowed (Figure 5b). Additional hose was routed through a hole in the wall of the building (not shown) in order to provide an air supply line outside the garage, next to the fuel pump (Figure 5c). The chuck that was attached to the air supply line was not at the scene at the time of the site visit but photographs were reviewed by FACE investigators. It was a straight dual-head chuck with manual inflation action and was activated by pressing the chuck onto the tire valve. The chuck could not be locked on to the valve and would have required the victim to hold it in position to inflate the tire. The chuck reportedly belonged to the victim, as the mechanics at the company were responsible for supplying most of their own tools.

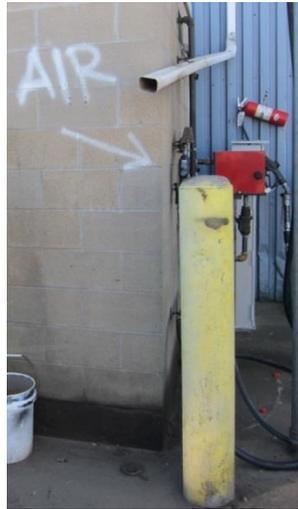
In this incident, the chuck and inflator the victim was using did not meet these requirements. It was reported that the device used by the victim belonged to the victim and came from his own tool set stored at the maintenance garage. It is the norm in some industries for mechanics to supply, maintain, and store their own tools at their place of employment. Because the victim and other mechanics were responsible for maintaining company-owned vehicles and equipment, it is reasonable for the company to supply any specialty tools required to complete their tasks. Whether or not workers supply their own tools, it is important for the employer to ensure that the proper tools are used.

Figure 5c – Location where air hose and chuck were routed through wall of building and stored outside the garage door near the fuel pump

Recommendation #3: Ensure that employees have the necessary tools and equipment in order to safely complete any maintenance of truck tires they are expected to perform.

Discussion: In order to safely inflate large tires, OSHA requires that the inflation device allow the worker to fill a tire while outside of the trajectory of any blast forces (see Recommendation 1). This sort of remote inflation can be accomplished by using a chuck that has the ability to lock onto the valve on the tire. Also required is either a manual inflation valve with a pressure gauge or a regulator that can be set to the desired PSI. These components must be positioned along the air line such that the user can perform the inflation while remaining outside of the dangerous trajectory area, so an extension hose of suitable length is typically connected between the controls and the chuck.

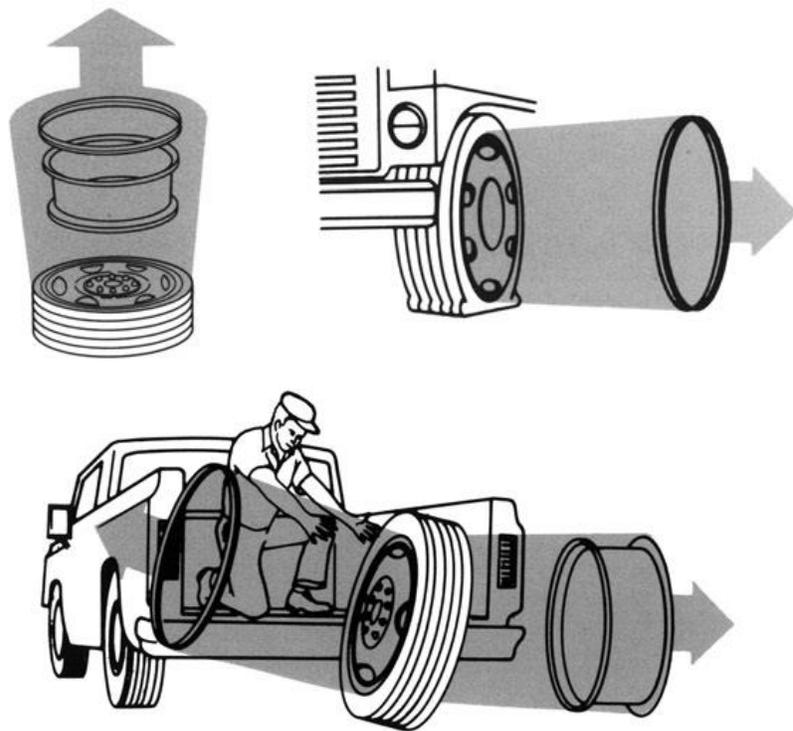
Discussion: Large truck tires are a source of hazardous potential energy because of the volume and pressure of the air they contain. If this air pressure is released during a tire or wheel failure, the forces are enough to seriously injure or kill. Depending what part of the tire or wheel fails, the air blast and tire or wheel pieces can project in different directions (Figure 6). Typically when an inflated tubeless tire sidewall fails, the forces will project laterally. For this reason it is important to stay clear of the sidewall of the tire and wheel at all times while performing work on the tire or wheel. This can be done using techniques and tools, such as standing to the front or rear of the tire and using air chucks that can be locked on to the inflation valve. (See Recommendation 3.)

Figure 6 – Trajectory of typical blast forces during tire/wheel failure: tires laid on the ground will direct forces upward; tires on a truck will direct the forces outward from the truck body; unmounted tires will direct forces along the axis of the tire

Recommendation #1: Ensure that employees never position themselves in the trajectory of inflated or partially inflated tires while servicing any tire or wheel component
