REPORT DATE: 10/23/18

Fatality Assessment & Control Evaluation

Owner of Farm Land Died Due to a Tractor Overturn to the Side into a Ravine

REPORT#: 15MI031

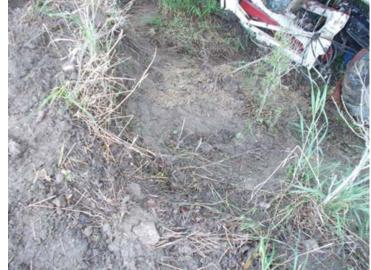
There was a deep ravine (depth unknown) with steep sides on one edge of a planted field. To access the northern rented fields, the decedent had to drive alongside the ravine. The last row of the soybean field planted was approximately two- to three-feet from the edge of the ravine. In the area of the incident, there was a washout of the ravine edge (Photo 1). It is unknown when the washout occurred. The incident occurred approximately ½ mile from the road near the decedent's home.

Photo 1. Ravine washout

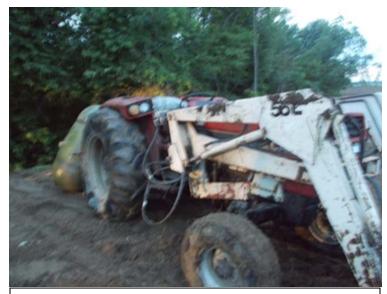
It is unknown when the decedent began his southbound journey home; prior to or when the rain began. Due to the rain, the field area was wet and muddy. The scene photographs of the responding police show that the decedent was utilizing the safe work practice of traveling with the loader bucket just a few feet above the ground (Photo 2). The ravine was located to the decedent's right side, on the passenger side of the tractor. To avoid injury to the newly planted soybean

Photo 2. Tractor after removal from ravine. Note height of bucket arms and fiberglass tank positions

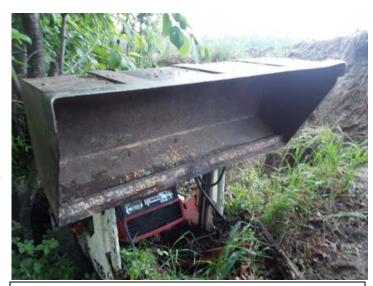
plants, the decedent was traveling as close to the edge of the ravine as possible. While traveling home, the driver's side tires began to pick up mud because they were in the field area, while the passenger's side tires were in the grassy area of the wooded tree line/ravine edge. Upon coming to a washout at the top of the ravine the tire tracks show the tractor sliding off the edge and overturning into the ravine (Photo 3). The decedent was pinned beneath the overturned tractor.

While the event was unwitnessed, a possible scenario was developed from the available information. Wet conditions believed to be present with soil type and grass surface may have combined with turning, braking and movement of spray solution in the tank to cause a magnified turn into the ravine when the washout was encountered. There was no indication the brake pedals were locked together. If they were not, the application of braking to the ravine side brake could have increased the magnitude of the turn. The "pendulum" effect of a less than full spray tank combined with the "unloading" of front wheels may have allowed the front wheels to slide on the wet grass toward the

Photo 3. Tractor overturned in ravine. Note steepness of walls and washout

Recommendation #1: Tractor owners should ensure their tractors have a manufacturer-approved, certified, tractor specific rollover protection structure (ROPS) and seatbelts installed.

Discussion: Rollover protective structures (ROPS), when used in combination with a seatbelt, are 98 percent effective in preventing death and serious injury in the event of a tractor overturn. The tractor had originally been equipped with a factory-installed non-foldable rollover protection structure. The decedent removed the solid bar ROPS because he could not drive it into a storage building (an excepted practice under OSHA/MIOSHA standard 1928.51(b)(5)). He did not ensure that equivalent protection was provided – such as a foldable ROPS. If the decedent had a tractor dealership install a foldable ROPS – when the unit was used for a non-excepted practice, and if the ROPS and seatbelt were used as intended, the decedent might have survived the tractor overturn.

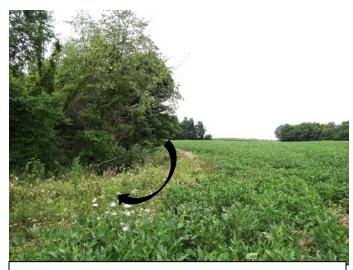
Discussion: The outside row of soybeans was planted approximately two- to three- feet from the edge of the ravine edge. This limited distance between the edge of the field and the ravine narrowed the traveling room the victim had to avoid injury to the crop. A planting boundary should be established so that the outside planting row does not impinge on an access area to other fields/areas. The grass boundary from the edge of the ditch should be at least equal to the depth of the ditch. A good rule of thumb is to stay back from the edge of the ditch as far away from the bank as the ditch is deep. The weight of the tractor could cave the bank in if too close to the shear line.

When a ditch/ravine depth is unknown, if possible, make a best effort to have marking posts several feet away from the edge of ditch when equipment movement occurs between the crop field edge and the ditch/ravine edge. It is unknown how well the ditch was defined at the time of the incident. The path, as shown in Photo 4 (taken at the time of the MIFACE site visit) has tall grass and shrubbery at the very edge of the ditch and growing up from the sides of the ditch, making it difficult to determine the ditch edge.

It does not appear that the ditch bank caved in, but the victim was operating the tractor too close to the ditch according to the police report, thus allowing the tractor to enter the ditch.

Photo 4. Field edge close to ravine edge. Arrow shows direction of travel

Recommendation #2: Establish crop-planting limits/boundaries to maintain farm machine access to other fields/areas.

Consideration should be given to field edge clearing and maintenance timing. Factors to consider include but are not limited to:

- Are there hidden hazards at the time of activity?
- Are control practices required when crops are present or can they be completed when the field is fallow, preplant or post-harvest?
- Can specific hazards, such as ravine edges, be effectively marked for growing season passage?
