Bark Company Owner Dies After Being Crushed By Ecology Block Wall

Investigation: # 15WA02901

Release Date: December 19, 2016

SHARP Report: 52-39-2016

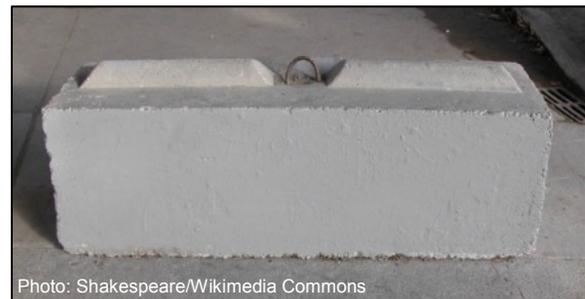
Photo 1: Concrete ecology block

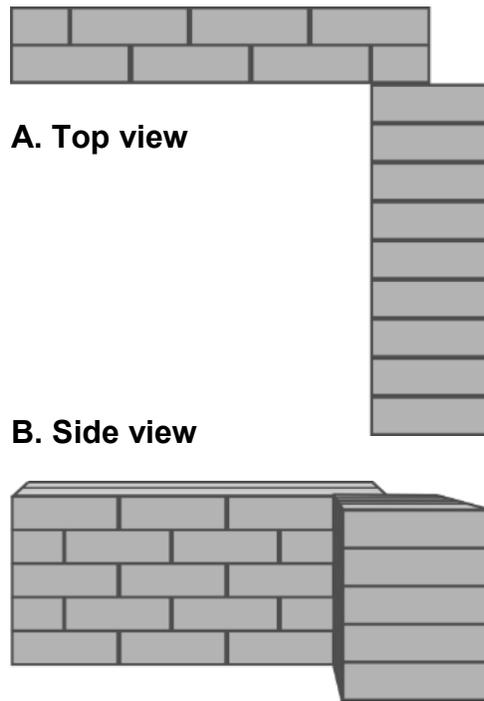
Figure 1. Two views of planned bunker design

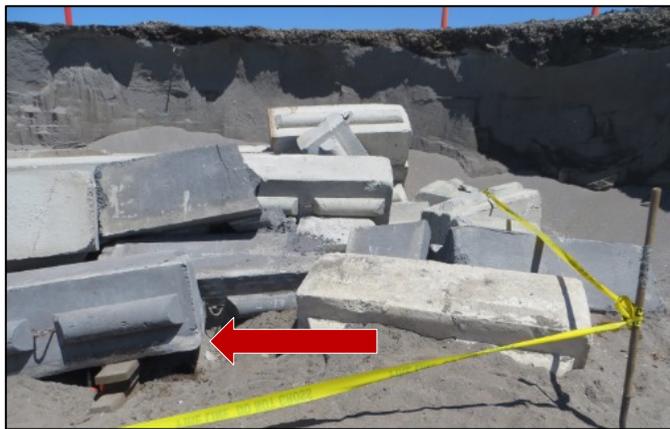
As the block was set down on the sand against the base of the first section (figure 2), the walls became unstable and began to collapse. The victim and workers ran to try to avoid the falling blocks. Witnesses reported that, at some point, as he was running, the victim paused for a moment to look behind him, and then began running again. Before he was able to get clear, one of the blocks that had been on the top of the wall struck him from behind and landed on him, crushing his right leg and pinning him against the ground. Both of the other workers were able to escape uninjured.

Figure 2. Placement of block (in red) immediately preceding wall collapse

Photo 2. Collapsed ecology block wall. Arrow indicates block that struck victim

Discussion: In this incident, a loose, dry sand based proved too unstable to support the weight of the walls. If dry-stacked ecology blocks or similar materials are to be used to create bulk material storage areas, structures must be built on firm footing. Develop siting criteria for ecology block wall construction to ensure that structures are only built on foundations that can safely support the weight of the walls. The evaluation should take into account details such as soil type, possibility of compaction, and whether there will be adequate water drainage. A registered professional engineer may be able to provide guidance on development of these criteria and foundation requirements for specific walls.

Recommendation 1: Plan and design bulk material storage areas for safety and stability. Make sure all walls, whether temporary or permanent, are built on a stable foundation able to support the weight of the structure.

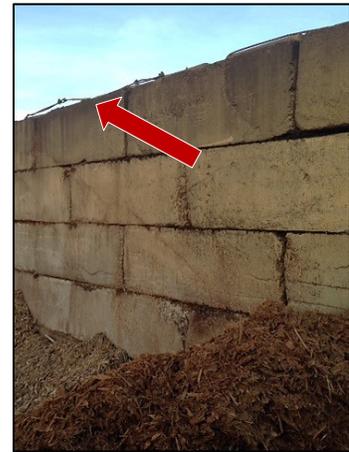
Photo 3. Steel cable threaded through ecology block picking eyes at top of wall

The company’s program also includes standard procedures for increasing the stability of walls when necessary, including doubling walls and binding blocks together using steel cabling anchored or bolted to the blocks (photos 3-5). Cabling was used frequently before the incident, as well.

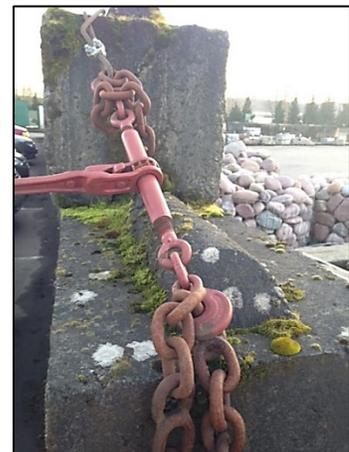
Photo 4. Ratchet mechanism for tightening wall cable

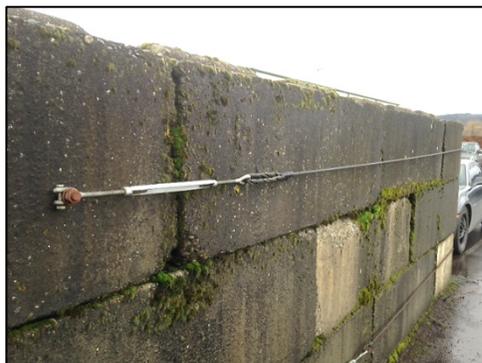
Photo 5. Steel cable bolted into side of ecology block wall
