**California Department of Public Health
Occupational Health Branch**

**FATALITY ASSESSMENT AND CONTROL EVALUATION PROGRAM
(CA/FACE)**

**A Hydroblasting Laborer Dies When He Falls
Into an Underground Vertical Pipe and Suffocates
Case Report: 16CA001**

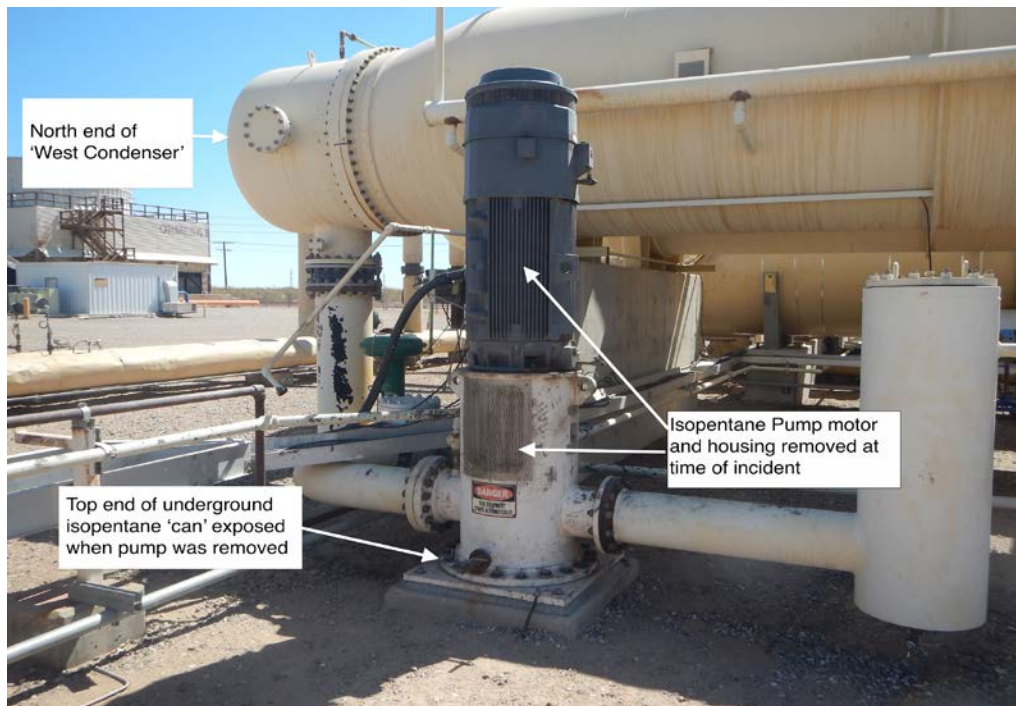
Exhibit A

On the day of the incident, the employer's morning crew began its shift at 6 am. At approximately 9:30 am a geothermal facility crew pulled the isopentane pump motor and housing from their base, and pulled the pump mechanism out of the 24-ft.-deep 'can'. The pump was located just south (approximately 12 ft.) from the north end of the 'west condenser' (see Exhibit A, below), where the employer had set up a scaffold.

When the geothermal crew removed the pump, they exposed the vertical 'can' opening which was beneath the pump. The 'can' consisted of a 2 ft. diameter circular pipe which descended vertically 24 ft. from ground level. The bottom of the 'can' was capped and, at the time, contained an estimated 150 gallons of liquid isopentane. A geothermal plant employee found a nearby sheet (4 ft. x 4 ft., 1-2 inches thick) of insulation jacketing that had been temporarily removed from the turbine, and used it to cover the exposed 'can' hole in order to minimize contamination of the isopentane. On top of this sheet of insulation jacketing, two 6 ft. scaffold boards were placed across the top of the 'can'. These boards were likely taken from the scaffold set up by the contractor on the south end of the 'west condenser'. The geothermal facility did not notify the employer that the pump had been removed, and that the underlying isopentane 'can' had only an improvised cover. Later that day, the two scaffold boards were removed, leaving only the insulation jacketing covering the top of the 'can'. It is not known who removed these boards and for what purpose.

Based on interviews and physical evidence, the victim may have decided to take a shorter route to the south end of the 'west condenser', where his support crew had been instructed to set up plastic sheeting to collect the runoff water. Rather than walk around the entire bank of condensers, he may have taken the shortcut that was frequently used by the crew. This involved climbing over the low-lying horizontal pipes and electrical conduit at the north end of the condenser. Standing on top of the flanged pipe end (that had recently been disconnected from the removed pump housing), approximately 1 to 2 ft. off the ground, he may have jumped onto the sheet of insulation jacketing covering the open end of the 'can'. The victim likely landed on the blanketing with both feet within the circumference of the underlying opening. The insulation jacketing covering the top of the 'can' did not support his weight and the victim slid down into the liquid isopentane.

- Lack of established geothermal plant procedures for safely enclosing or covering 'can' openings created when pumps are removed.
- The geothermal facility did not notify the employer that by removing the pump they had created a new hazard in the employer's jobsite.
- The employer's foremen did not conduct inspections of their jobsite for newly-created hazards.

Recommendation #1: Hazardous openings should be enclosed with guardrailing and affixed with a warning sign. Alternatively, the openings should be covered with a tool-secured cover strong enough to support foreseeable loads; the cover should be affixed with an appropriate warning placard.

Discussion: The geothermal plant had no procedure to safely enclose or cover 'can' openings created when pumps were removed. There were no guardrail or fabricated covers designed for this use available to the crew. In the past, the crew had used a range of materials to improvise covering or enclosing 'can' openings. In this incident, if there had been an established procedure on which the crew had been trained, together with either a railing or a fabricated cover for the crew to use, the exposed 'can' opening would have been eliminated.
