**California Department of Public Health
Occupational Health Branch**

**FATALITY ASSESSMENT AND CONTROL EVALUATION PROGRAM
(CA/FACE)**

**A Heating, Ventilation, and Air Conditioning (HVAC) Contractor
Dies When He Falls Through a Skylight
Case Report: 16CA005**

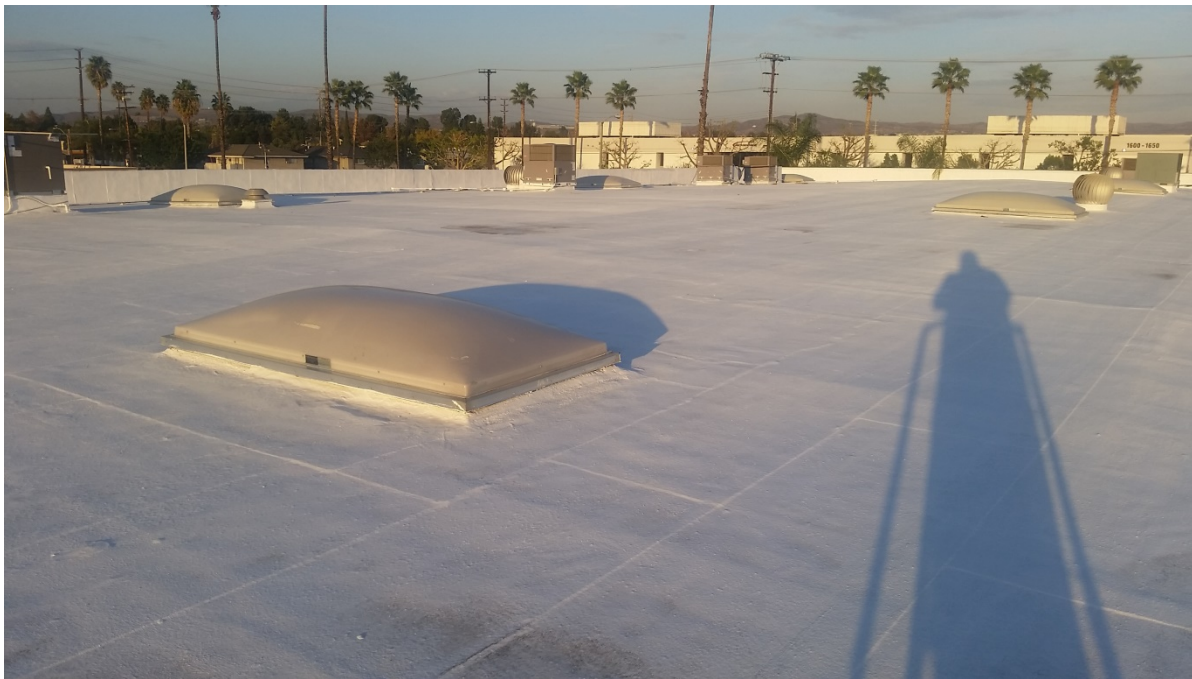
The scene of the incident was a converted warehouse that was being used as a dance and martial arts studio. The warehouse was constructed in 1972 and was approximately 130 feet long by 60 feet wide. There were six skylights on the roof. The AC equipment was located approximately five feet from the adjacent skylight. In order to encourage more enrollments, the owner of the dance studio decided to expand within the warehouse, adding theme rooms for different age groups. The construction of the theme rooms was almost complete. The owner of the dance studio asked the victim for an estimate to install additional air ducts from the air conditioning unit on the roof to each room below.

Exhibit 1. The flat roof of the warehouse showing the skylights and AC units.

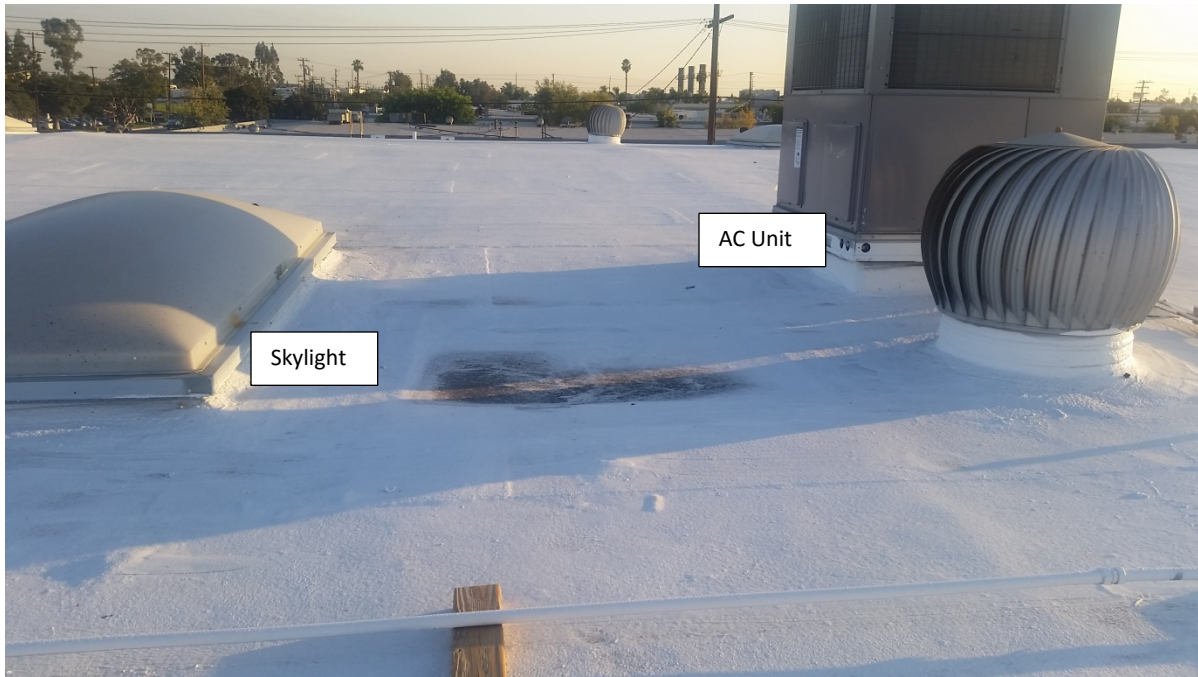
After completing a survey of the electrical panel, the victim climbed up a fixed exterior ladder on the back side of the warehouse to gain access to the flat roof of the building. He then traversed over to one of the AC units to inspect the components to determine whether additional duct work was possible. Another contractor was working below (inside the warehouse), completing the finishing touches on the theme rooms. He stated that all of a sudden he heard a scream and a crashing noise that came from one of the other theme rooms. He hurried over to the room and found the victim lying on the concrete floor underneath the broken skylight. He then went to the front office to inform the owner and called 911. Both the owner and contractor stayed with the victim until emergency medical services arrived. The victim was transferred to a local hospital where he succumbed to his injuries 19 days later.

Exhibit 2. The incident scene.

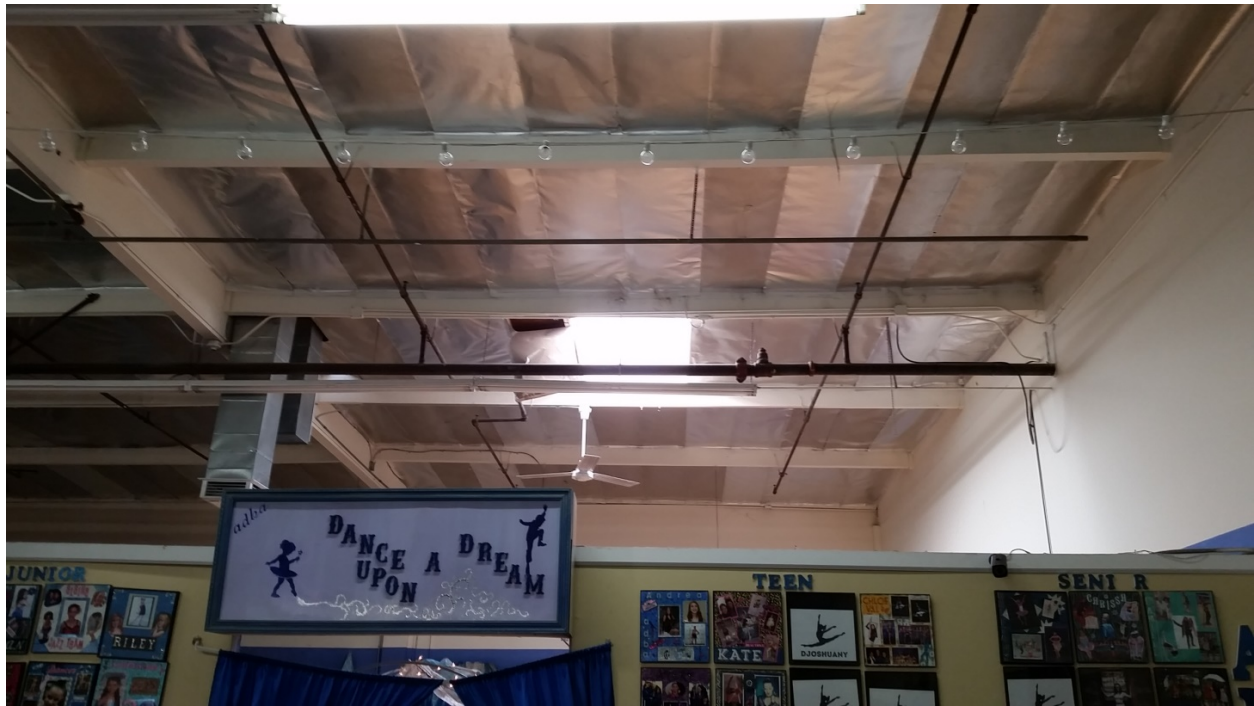
Discussion: In this incident, the skylight in close proximity to the AC unit created a serious safety hazard. Although the job was of short duration, the victim was still at risk in the event he fell onto the skylight cover. The skylight's plexiglass fixture can and should be designed to serve the function of providing ambient outdoor light into a building, while having sufficient strength to support at least twice the weight of employees, equipment, and materials that may be imposed on the cover at any one time. Architects, engineers, and employers should work together to ensure that skylight fixtures specified in the building plan meet this strength requirement. These skylight fixtures should be permanent and of sufficient strength to protect workers who access the roof from inadvertently falling through them. Until adequate design requirements are in place and skylights installed to protect workers from falling through them, HVAC contractors may not know if the skylights in their work area can support their weight. Therefore, HVAC contractors need to ensure that safety nets, screens, covers, or guardrails are in place around skylights in the immediate work area. Had the building owner installed these protective barriers around the skylights, this incident could have been prevented.

Exhibit 3. The dance studio theme room skylight opening involved in this incident.

Recommendation #2: Ensure that building owners install safety nets, screens, covers, or guardrails around skylights within six feet of HVAC equipment.
