Tree Trimmer Electrocuted and Dies While Trimming Tree Away from Power Lines

CASE SUMMARY

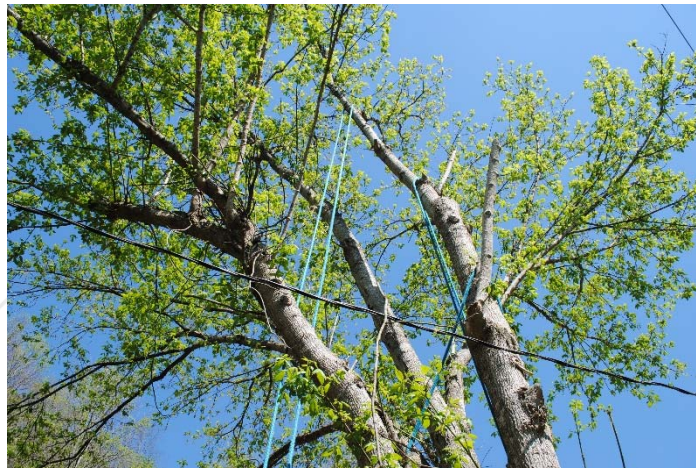
Figure 1. Tree the victim was trimming when he was electrocuted.

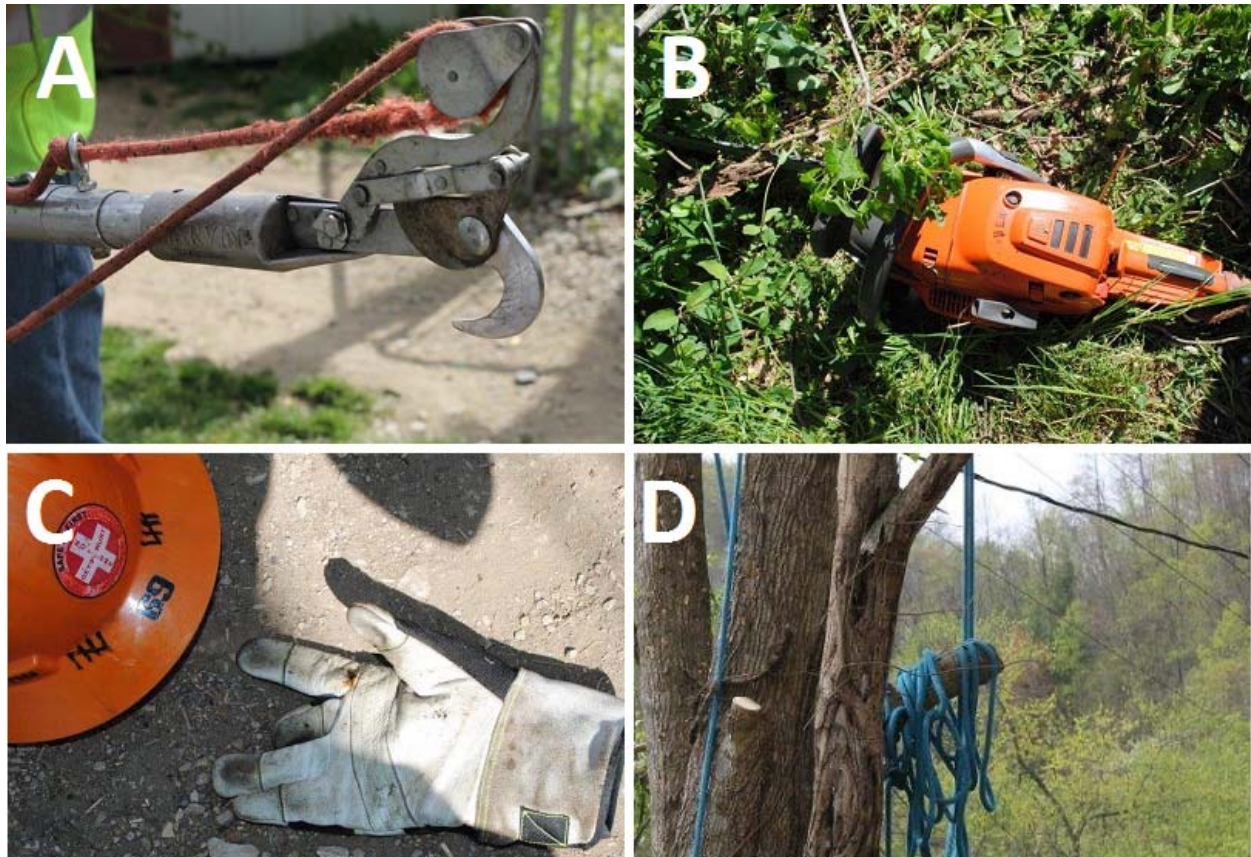
Figure 5. Insulated pruner pole (A); chainsaw (B); hard hat and leather work gloves (C); and climbing rope (D).

The following equipment found at the scene was used by the victim: insulated pruner poles (Figure 5A), a chainsaw (Figure 5B), a hardhat and leather gloves with burn marks (Figure 5C), and a climbing rope (Figure 5D). Both gloves had scorch marks indicating where the electrical current entered the victim's body.

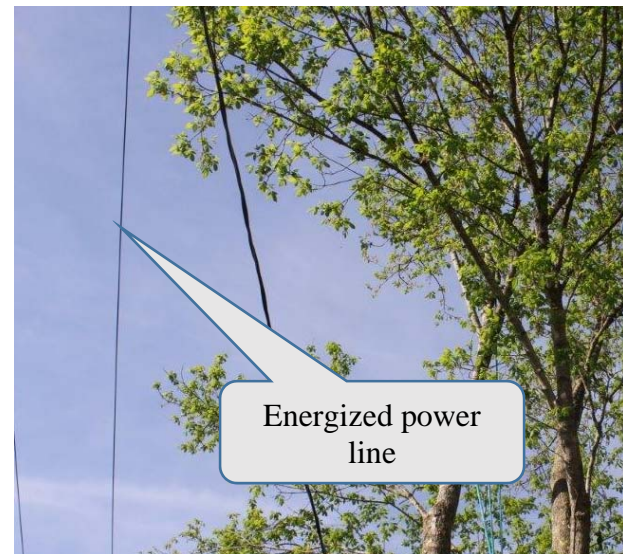
Figure 6. Energized power line in proximity to the tree's branches.

Recommendation No. 1: Insulating equipment, such as insulating rubber gloves and sleeve combinations, or insulated power line sleeves, should be used when tree trimming work is to be performed within the minimum approach distance (MAD).
