School Custodian Struck and Killed by Pick-up Truck on School Grounds While Performing Crossing Guard Duty

CASE SUMMARY

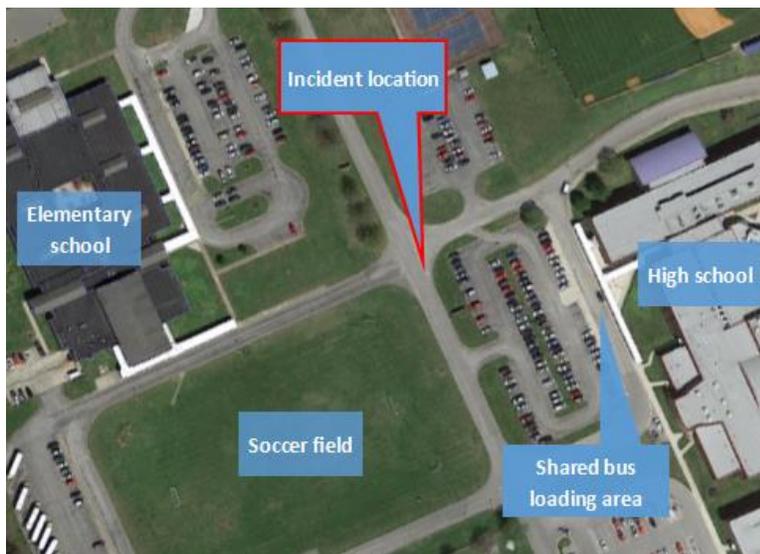
Figure 2. Aerial view of the school grounds; the victim was struck in an intersection connecting drivers to the high school, elementary school, and soccer field. The red line denotes the approximate walking path of the victim, starting at the high school.

The incident occurred in the intersection of two access roads which connected drivers to an elementary school, a high school, and a practice soccer field (see Figure 2). The posted speed limit in this area was 15 miles per hour. On the day of the incident, the victim was to perform crossing guard duties in this intersection, so that children from the elementary school could safely reach the shared school bus access area in front of the high school. The intersection where the victim was struck did not feature crosswalks, sidewalks, or other crossing safety features (see Figure 3, A and B).

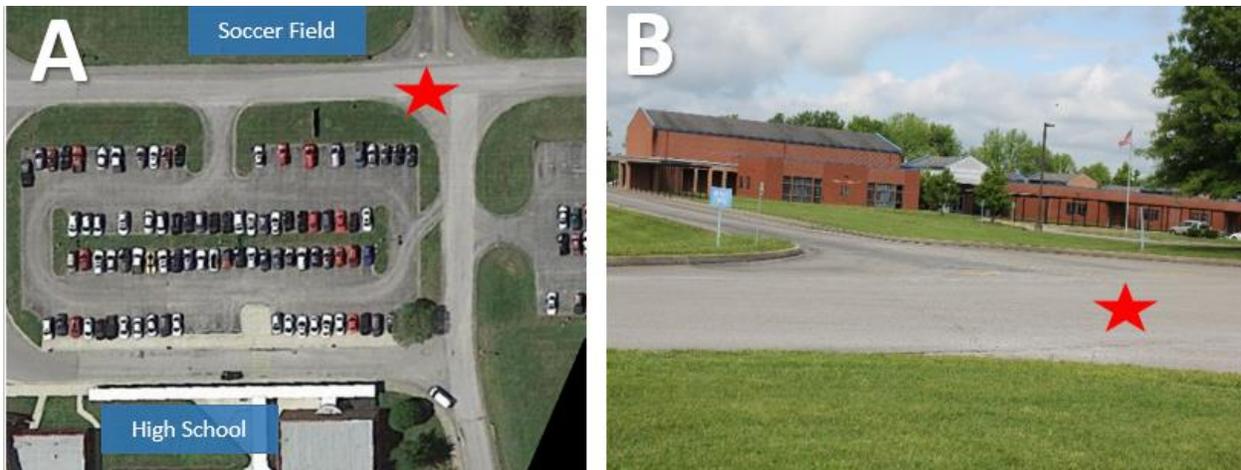
Figure 3. Aerial view of the school grounds (A); view of intersection where victim was struck, looking towards nearby elementary school (B). The red star in each photo denotes the approximate location at which the victim was struck.

to cross the access road intersection that separated the two schools. On the day of the incident, the victim was assigned crossing guard duties in this intersection to provide the elementary students safe access to the shared bus access area. Absent from this intersection were crosswalks, sidewalks, or other safety features such as signage, etc.

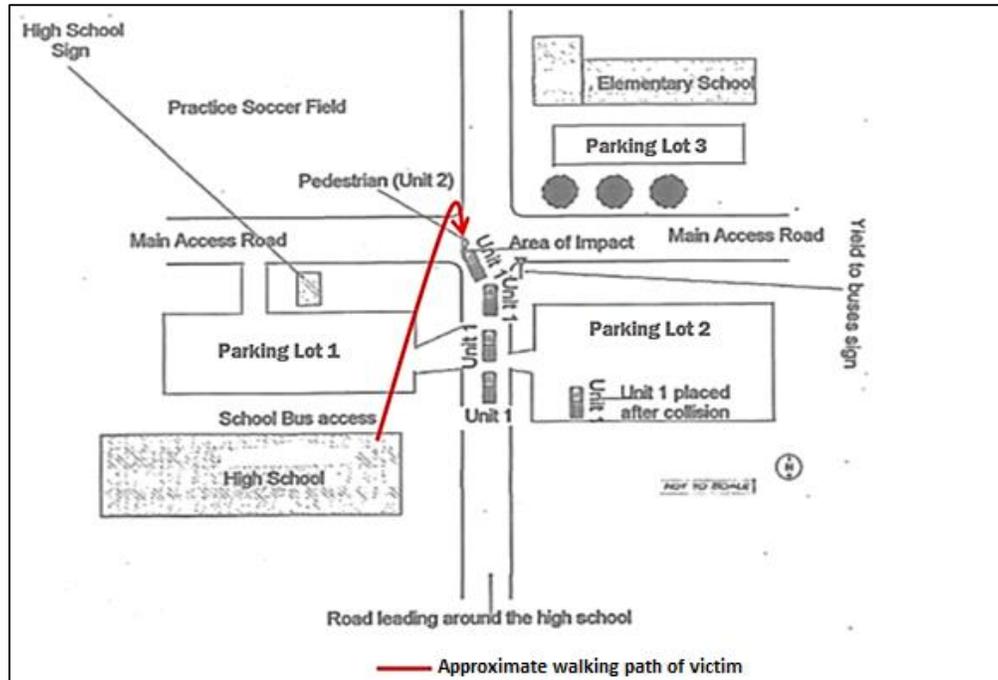
Figure 4. Incident diagram of the scene and the fatal incident. The red line indicates the walking path of the victim. Unit 1 was traveling away from the high school and turning left onto the main access road when the victim was struck. (source: *Kentucky Highway Patrol*).

Equipped with his high visibility safety vest and handheld stop paddle, the victim exited the main high school building and spent a few minutes talking with several employees, who were waiting in front of the high school for buses to line up and students to begin loading. After saying his good byes, he walked toward the intersection separating the elementary school from the high school where he would perform his crossing guard duties. He took his normal route of walking through the faculty parking lot (Figure 4, Parking Lot 1).

During this time, a fellow school employee was in his Chevrolet pickup truck traveling next to the high school and toward the intersection (Figure 4, Unit 1). The fellow school employee had stopped and talked with two co-workers before preceding towards the access road intersection. There was no stop sign but a yield to bus sign in this intersection. The victim had almost crossed the main access road when, according to witness account, he abruptly reversed direction and walked back across the road into the direct path of the Chevrolet pick-up truck that was making a left turn (Figure 4, red line). The fellow school employee said that he had just looked to his right for traffic clearance and was traveling less than 5mph, when he felt a bump and witnessed the victim stagger and fall straight backwards. He immediately exited the truck to help the victim.

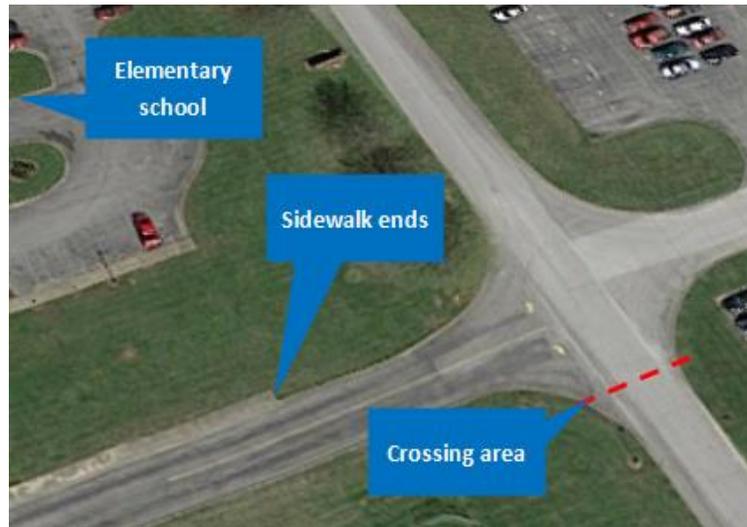
Figure 6. Intersection and crossing area. The elementary school crosswalk did not extend to the intersection.

Both the high school and the elementary school main entrance areas had sidewalks and crosswalks connecting to the nearest parking lots; however, the intersection where the victim was struck did not feature sidewalks, crosswalks, or other pedestrian safety features. A sidewalk extending from the elementary school stopped short of reaching the intersection. Although there was a ‘yield to buses’ sign in the side of the intersection from which the pickup truck driver was traveling, there were no stop signs in the intersection. The four-way intersection should have featured stop signs since children and other pedestrians were expected to cross. School personnel indicated that buses and other vehicles often traveled in this intersection. The speed limit on the school campus was 15mph; the crash report did not state the estimated speed of the driver at the time of the crash.

Recommendation No. 1: Schools should provide a walkable campus by installing sidewalks, crosswalks, stop signs, and other safety features in areas where pedestrians might be exposed to traffic.

A 2008 report by the National Highway Traffic Safety Administration found that roadways lacking crosswalks accounted for 42 percent of all pedestrian fatalities from 1997-2006.¹ Sidewalks and crosswalks should be planned, designed, and installed to facilitate safe walkability and roadway crossing in areas where pedestrians are exposed to passing traffic. Sidewalks should be regularly repaired and crosswalk stripes repainted so that they are readily visible both to pedestrians and motorists. To further protect pedestrians, pedestrian crossing warning signs should be placed in advance of crosswalks to alert approaching motorists, and stop lines should be painted on the road as a stopping point for motorists. This incident may have been prevented if such pedestrian safety features had been in place.
