MIFACE INVESTIGATION REPORT #16MI071

SUBJECT: 23-year-old laborer was overcome and drowned when he entered a 10,500-gallon molasses tank to reposition a drain pipe.

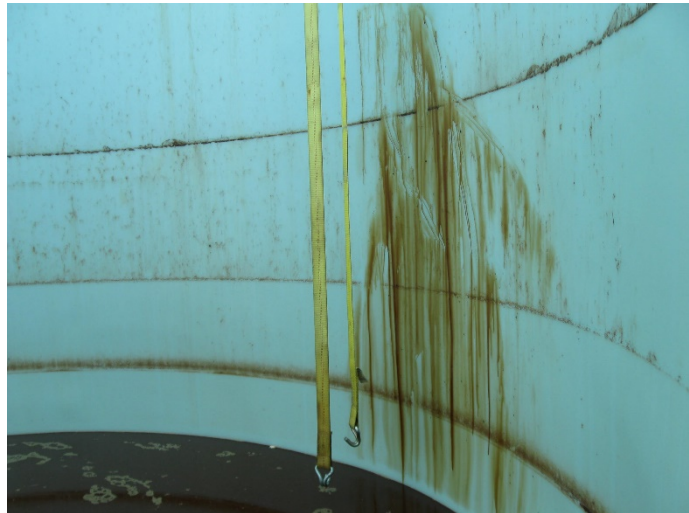
Figure 1: Inside tank wall following decedent's attempt to climb out

After entering tank, the decedent rotated the valve down into the remaining mixture, and moved back to the straps in an attempt to use them to climb out of the tank, walking his feet up the tank's

wall (evidence of the decedent's attempt to climb the inside of the tank can be seen in Figure 1). The coworker observed through the tank opening (shown from inside the tank in Figure 4) that the decedent slipped and fell back to the bottom of the tank and subsequently appeared to be standing still while holding the straps. The coworker yelled to the decedent asking if he was alright, but did not receive a response. The decedent then made another attempt to climb the side of the tank but again fell. The coworker unsuccessfully attempted to haul the decedent up using the straps. The coworker then descended from the top of the tank and ran to tell the owner and other coworkers that the decedent was trapped inside the molasses tank.

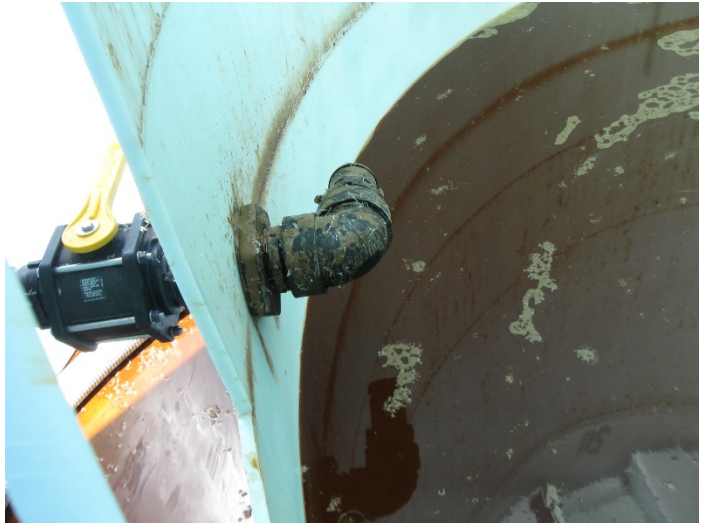
Figure 2: Valve used to pump out contents of tank. Molasses and water mixture remaining in tank can be seen to right of photo.

After a period, the flow of the mixture through the pump stopped due to the level of the mixture falling below the intake portion of the valve on the interior of the tank (Figure 2), leaving about 2 feet of mixture still in the tank. The coworker told the decedent that this was likely sufficient, as the tank was going to be refilled with water soon. The coworker then left the area to begin working on another task elsewhere inside the building.

- Tank manufacturers should explore the feasibility of permitting tank users to rotate fittings/inlet piping and/or perform other tanks from outside of the tank to minimize or eliminate the need to enter the tank.

In many cases a job or task requiring a confined space entry may be able to be completed from the exterior of the space, with different or modified equipment. In this incident, the decedent entered the space in order to rotate an inlet siphon on a valve fixture that the investigators were able to confirm with the equipment manufacturer was unable to be rotated from the exterior of the tank. If confined space entry is deemed to be likely during an assessment of anticipated work tasks, employers should explore whether equipment might be selected, or the equipment or work task

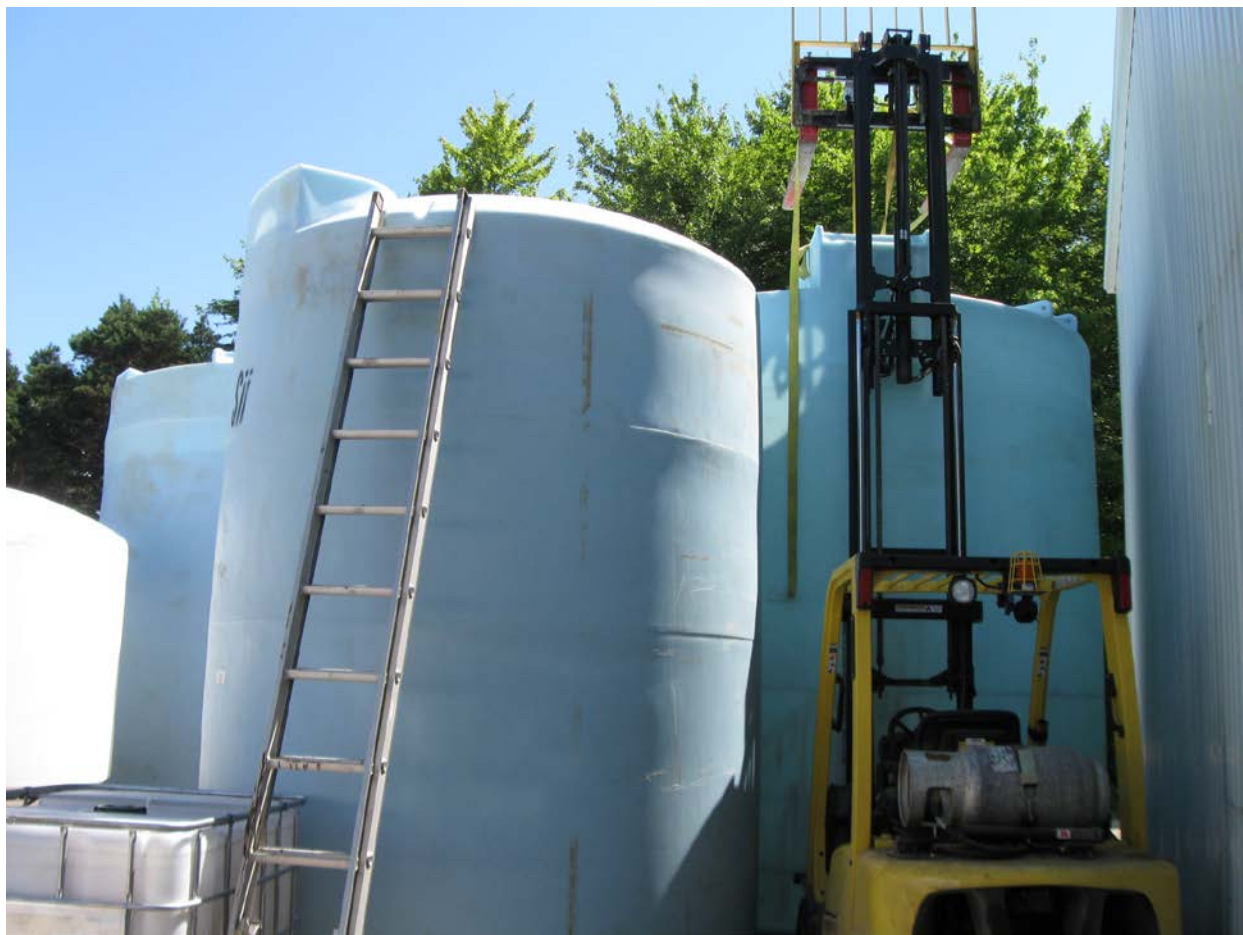
Soon afterwards, he observed the decedent gathering items to enter the tank so that he could rotate the intake valve to remove more of the residual mixture. The decedent had donned fishing-type waders and a 3M 6800 full-face respirator with ammonia cartridges. The decedent had also positioned a hi-lo truck adjacent to the tank, attached two ratcheting cargo straps to the mast of the lift, draped them over the forks, and suspended them through the unlocked 15”-diameter opening in the top of the tank (Figure 3). The decedent climbed the ladder leaning against Tank 1 and then walked across the top of Tank 1 to the top of the incident tank. The coworker advised him not to enter the tank, and then remained and ascended to the top of the tank to observe the decedent during his entry. The decedent requested that the coworker not inform the owner of the entry. The decedent then used one strap in each hand to rappel to the bottom of the tank.

Figure 3: Tank 1 with ladder and hi-lo and straps positioned for entry at incident tank.

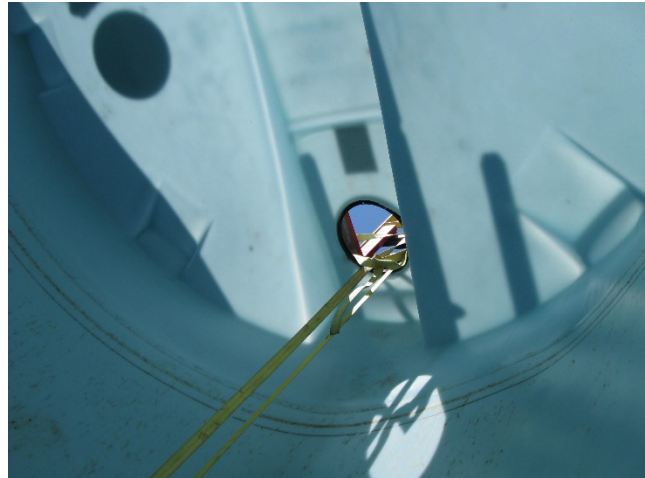
Figure 4: View of tank opening from inside.

- Prevent unauthorized access to confined spaces via the use locks or barriers.

Even in cases in which confined space entries are anticipated or required, tank hatches or entry points should be locked or otherwise blocked when an entry is not in progress. Hatches should only be opened by the business owner or other supervisor in charge of overseeing permit-required confined spaces, and only for entry by employees who have been trained in the confined space hazard awareness and entry protocols. If the hatch on the molasses tank had been locked, with entry only able to be granted by the business owner or an appointed delegate, such as the coworker of the deceased, then the decedent would not have been able to gain entry to the tank without approval. Instead, this layer of control was missing and employees were able to gain access to the molasses tank (and other tanks) whenever they deemed fit, without approval of the employer (and over the objections of coworkers, in this instance).

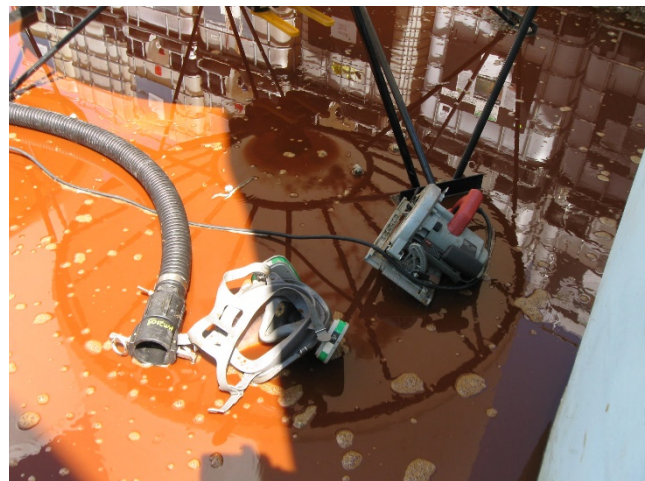
Once the coworker reached the owner and other employees within the building, one employee called 911 and another ran to get a circular saw while the coworker and owner ran back to the tank. Using the saw, they cut a rectangular opening in the side of the tank to extricate the decedent, who had collapsed and was submerged under the molasses-water mixture (Figure 5). The decedent was pulled from the tank and CPR was administered until emergency services arrived. The decedent was transported to a hospital, where he was unable to be revived and was declared dead.

Figure 5: Saw used to extricate decedent alongside remaining tank contents and decedent's respirator.
