REPORT#: 16MI090

Ironworker Fell 25 Feet While Working From/Relocating a Ladder in a Shaft way

Michigan Fatality Assessment and Control Evaluation (FACE) Program

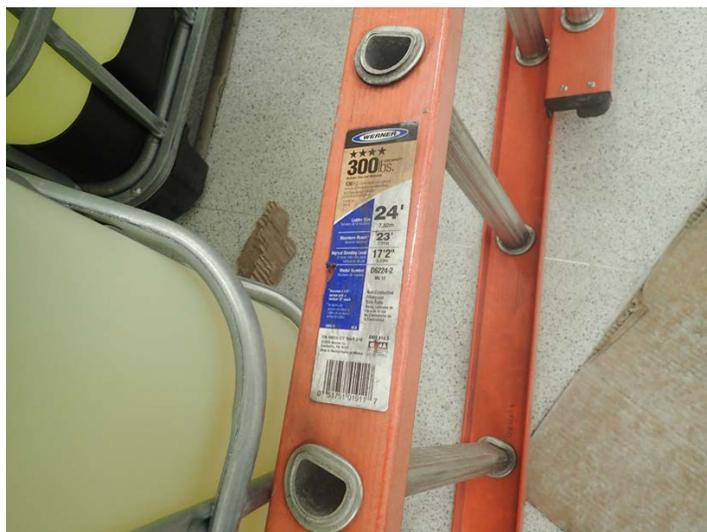
Photo 1. Ladder used by decedent

The 24-foot fiberglass extension ladder involved in the incident was missing the manufacturer-supplied rope or equivalent to raise or lower top section of ladder from the base section.

The fiberglass two-section extension ladder was not properly maintained; It was missing the manufacturer supplied rope or equivalent to raise or lower top section of ladder from the base section.

Recommendation #2: Ensure ladders are inspected, set up and used correctly. Remove ladders from service if found defective.

ladder and should not be removed, or if removed when the ladder is disassembled, it should be re-installed when the ladder is reassembled.

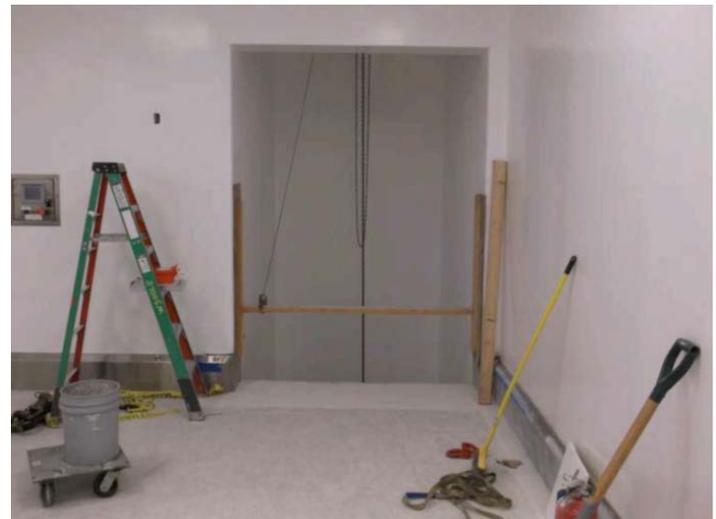
At some point during the construction process, a make-shift wood barrier system using two pieces of wood was installed at the opening on the north side of the shaft way on the second floor. The two wood guardrail pieces were wedge-fit into the opening with cardboard protecting the wall areas; the guardrails did not overlap beyond the opening nor mechanically fastened to the wall. It is unknown when the top section of the wood barrier was removed leaving only the mid-rail, located approximately 21 inches above the floor (See Photo 2). A coworker indicated the top rail was removed for easier positioning of the ladder.

Photo 2. Lifeline attached to midrail at time of incident

After moving the chain fall, the ladder was to be removed so a scissor lift could be used within the shaft way. The decedent came down from the ladder and stopped on the bottom rung. The apprentice indicated the decedent removed the retractable lifeline from his harness and secured it to the mid-rail. The decedent, still wearing his harness, then attempted to retract the fly section of the ladder. It appeared that the decedent positioned himself on the 2nd and/or 3rd rung of the ladder base. The decedent was lifting/bumping the fly section to unlock the rung hooks and allow the ladder to compress in order to get it out of the opening. In the process of doing this, the ladder base slipped inward, into the opening and fell feet first, striking the lift equipment and rotating approximately 180° before landing on the first floor. The decedent fell 25 feet to the concrete first floor, landing in the northeast corner of the shaft way. The decedent's foreman was in the area prior to the incident and was just walking away when the incident occurred. He was with a factory rep for the company that supplied the equipment. The foreman had to leave the building to call 911 because of poor reception inside the building.

Recommendation #1: Workers should always use fall protection when working above a height per the appropriate regulatory requirement. In this incident, the decedent was performing a steel erection activity, and fall protection was required when working at a height above 15 feet.

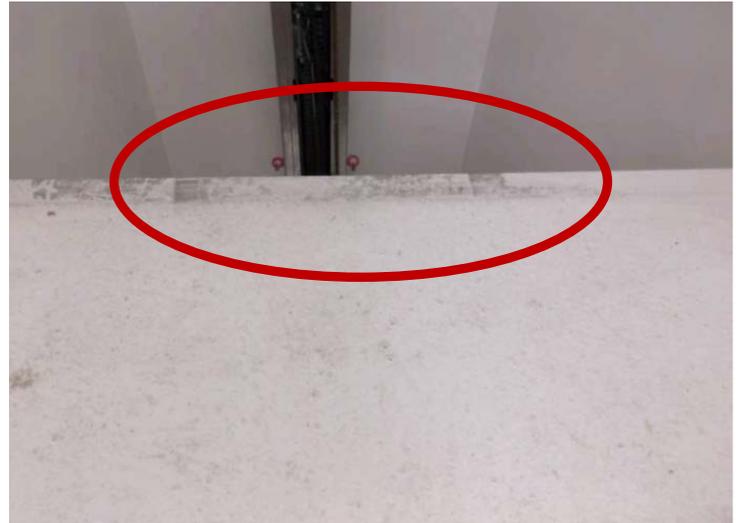
Photo 3. Ladder marks on edge of second floor

The ladder was not tied, blocked, or otherwise secured to prevent displacement at either the top or at the base when it was positioned across the shaft way. The bouncing motion of the ladder as the decedent attempted to unlock the rung locks contributed to the ladder feet sliding from their position at the edge of the shaft way into the open shaft way. If the ladder feet had been appropriately secured, the ladder base would not have moved.

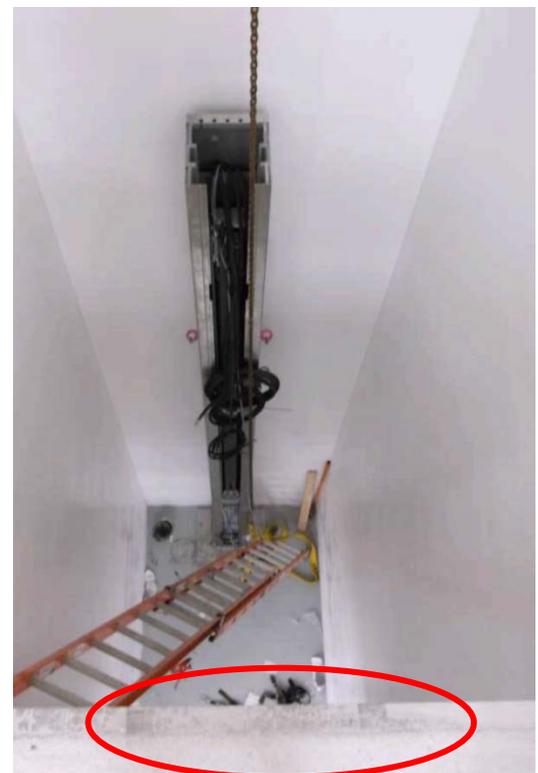
Photo 4. View of shaft way from second floor. Red circle locates the ladder feet marks on the edge of the shaft way

A fiberglass extension ladder set across the elevator shaft opening with a horizontal projected distance of approximately 8 feet and a vertical distance approximately 16 feet. The pitch exceeded the allowable 1:4 ratio. Employees using the ladder were exposed to a 22-foot fall to interior of the elevator shaft.

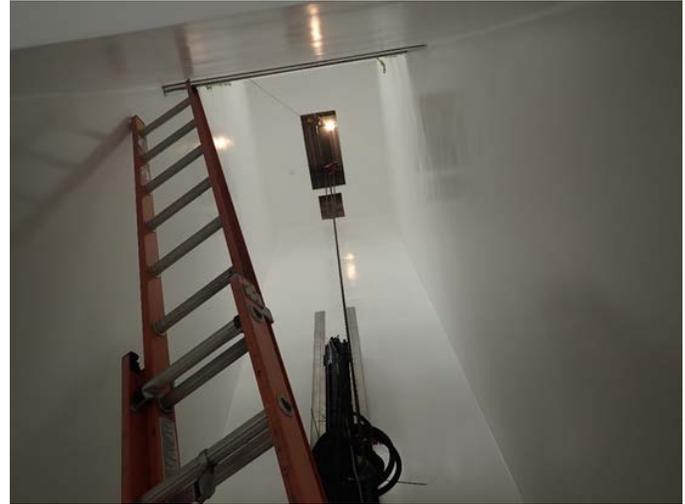
The top guardrail was re-installed after the incident and was wedge-fit into shaft way opening with cardboard, protecting the wall areas from scratching. The ladder also appeared damaged from possibly striking the top of the installed lift equipment.

Photo 5. View of shaft way looking up from the ground floor.

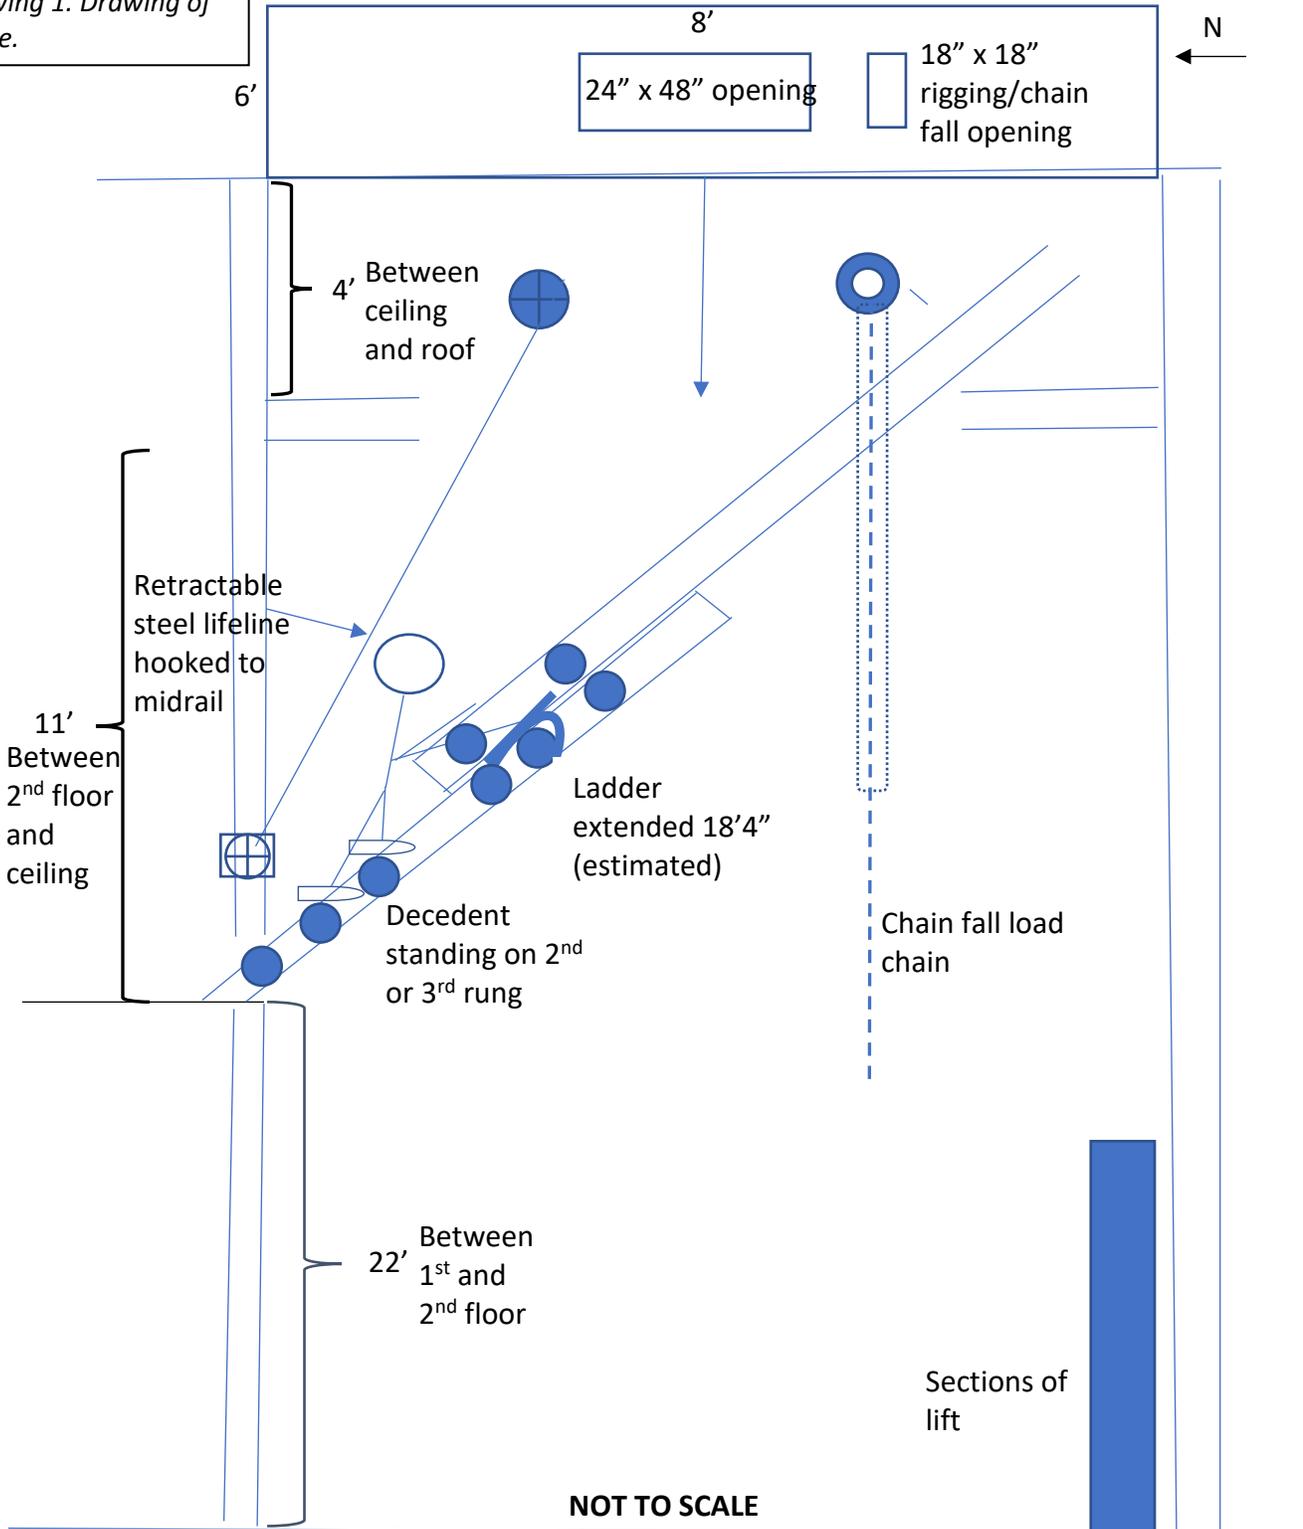
Drawing 1. Drawing of Scene.

See Drawing 1 on Page 12 for an overview of the incident scene.
