## ***FATALITY INVESTIGATION REPORT***

### **Crab fishing vessel capsizes and one crew member drowns**

**REPORT#:** 2016-07-1

**REPORT DATE:** June 2020

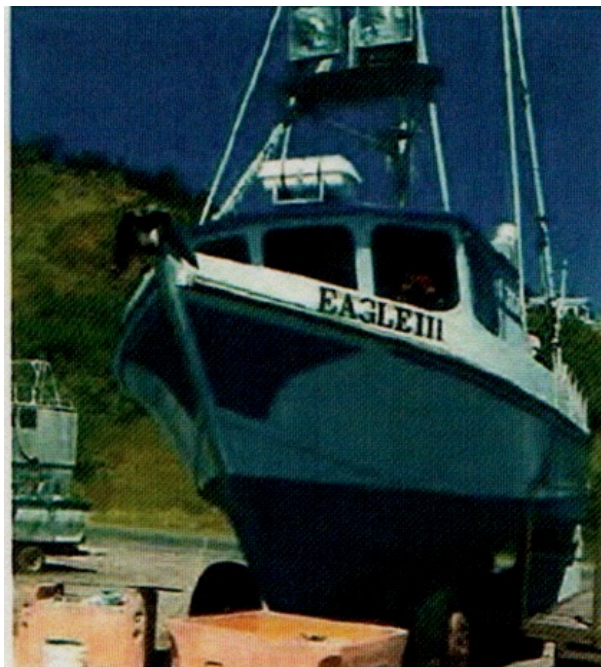
**Photograph of a similarly-sized crab fishing vessel**
