MIFACE INVESTIGATION REPORT #16MI104

SUBJECT: Concrete Finisher Electrocuted When Bull Float Contacted an Energized Power Line

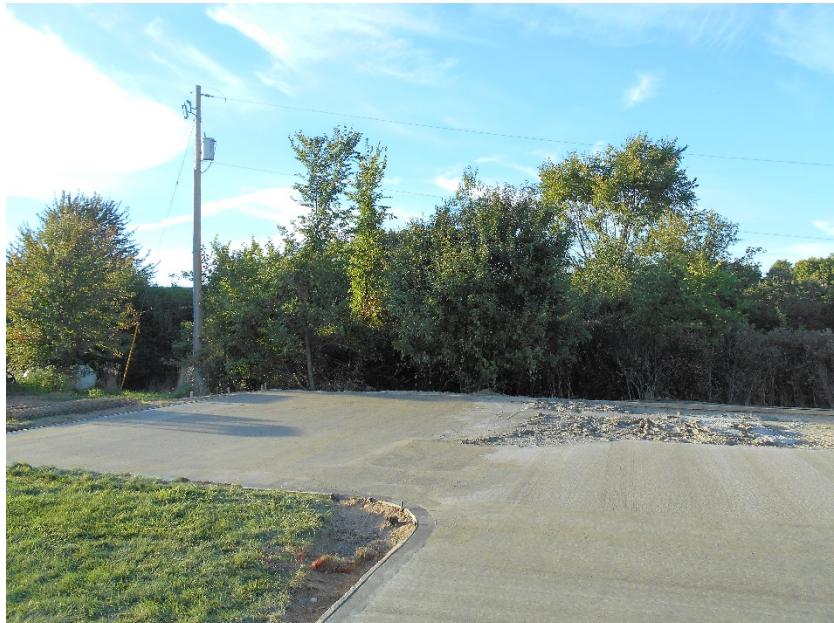
Figure 1: Overview of incident scene

pole. The utility company measured the height of the two overhead lines after the incident. The bottom neutral line was 17 feet high and the 7,200-volt primary line was 23-feet high vertically and 24 feet from the edge of the concrete forms. There were two visible impact burn points on the wire. One was a 1.5-2-inch width of the bull float pole and the second contact was approximately 2.3-3.0 feet long where the pole may have slid along the wire. Emergency response was called and the decedent was transported to a local hospital where he died.

As the slab being poured was approximately 33 feet wide, the decedent had to walk around the edge of the slab in order to reach the entirety of the concrete being poured. The decedent began the process of smoothing the poured concrete on a patch of lawn directly adjacent to the garage, in the southwest corner of the driveway. From there, he moved north along the western edge of the driveway repeating the process, before he relocated along the northern edge of the driveway around 9:30 AM (Figure 1, photo facing north).

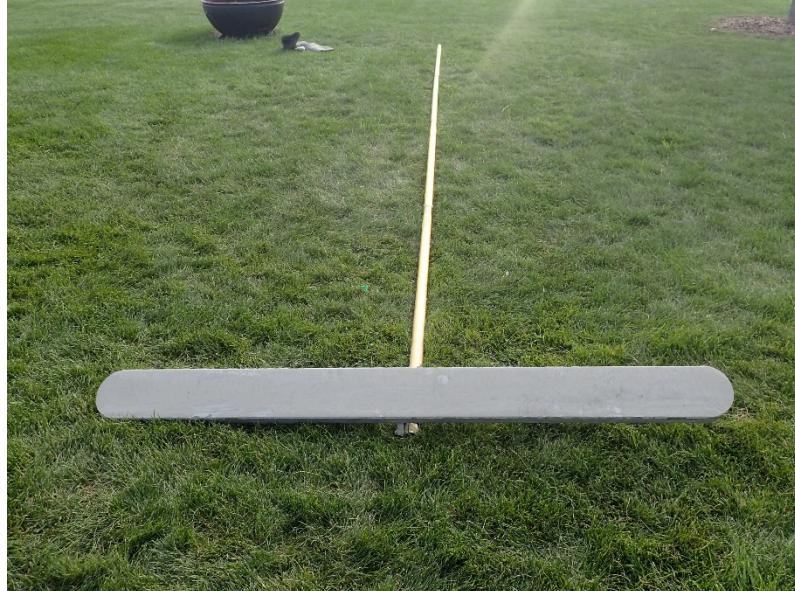
An employee was engaged in concrete finishing work, when the 29-foot aluminum handle of his bull float came in contact with a 7200-volt overhead power line.

The decedent arrived at the site as one of 10-12 workers present that day at 7:00 AM. The area to be poured was delineated with pieces of lumber, which were in turn held in place with metal pins driven into the ground. Concrete pouring commenced around 8:00 AM. The decedent was reported to have used a bull float attached to four or five 6-ft aluminum handles connected in sequence, which gave him approximately 24-30 feet of reach. This was corroborated by the MIOSHA investigation that stated that the bull float had 29 total feet of reach. The handles were connected to the float via a mechanism that altered the angle of the handle-float joint via the axial rotation of the handles, which allowed for the float to maintain level contact with the concrete along the length of its use without progressively elevating the handle as the float was drawn nearer (Figure 2).

Figure 2: Bull float used by decedent.

- Use bull float handles that are non-conductive and/or insulated.

MIOSHA Construction Safety Standard, Part 25 Rule 2520 states that the handle of a bull float being used near an energized electrical conductor must be either constructed of nonconductive material or insulated in a nonconductive sheath. These requirements aside, according to the employer he and many other contractors are aware of the availability of such nonconductive handles, but have frequently chosen to continue using aluminum handles because of weight and durability concerns. However, these concerns can be mitigated at least partially by restricting the use of non-aluminum handles to only those work sites where electrical hazards have been identified during the worksite hazard assessment, prolonging the lifespan of the non-aluminum handles. Worker rotation can also be used if the increased weight of non-conductive handles leads to more frequent exhaustion on the part of the worker using the float. Since the incident, the employer has purchased multiple fiberglass handles and has instructed employees to use them when working near overhead power lines.

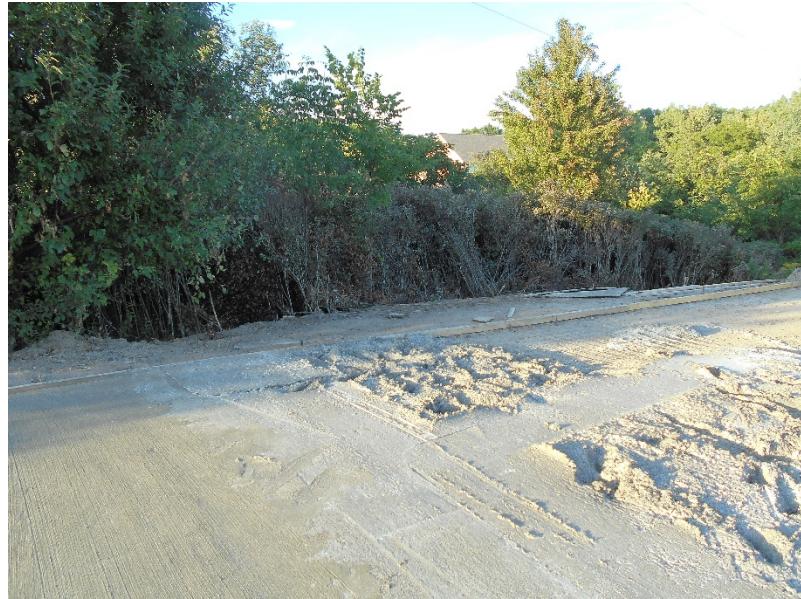
Once along the northern edge of the driveway, the decedent was unable to hold or use the entirety of the bull float handles horizontally, as the vegetation along the top of the gully began approximately 8 feet behind him (Figure 3). This may have required him to elevate the 29-foot handle more than usual. Once elevated, the handle made contact with the energized power line.

Figure 3: Vegetation along north end of worksite
