MIFACE INVESTIGATION REPORT #16MI149

SUBJECT: Farmer Died When Clothing Was Entangled in a Rotating Power Take Off Shaft

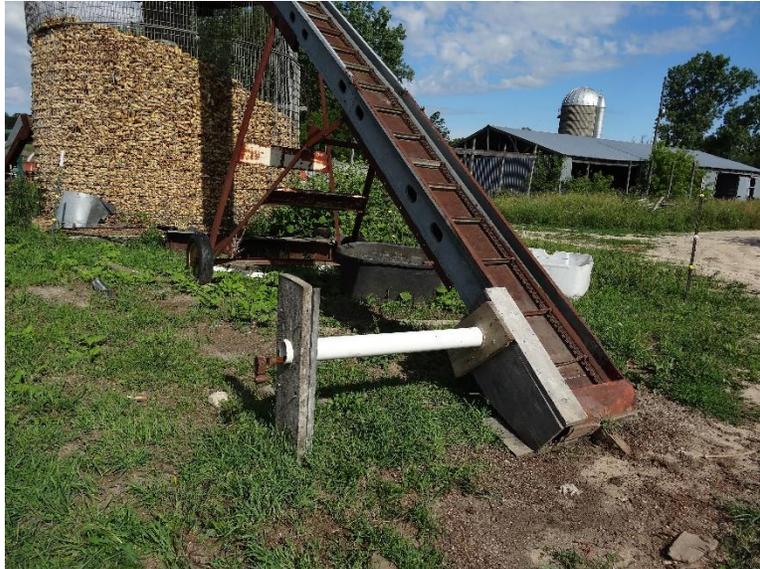
Figure 1: The PTO-driven corn elevator and corncrib.

- The entire power take off driveline, including the PTO stub on the tractor, the shaft, and the point of connection to the corn elevator were all unguarded during operation.
- Best safety practices regarding PTO operation were not observed; clothing with loose sleeves should not be worn and a task should not be performed while standing near and/or stepping over a rotating PTO shaft.

- Cover the entire power take off driveline, including the PTO stub on the tractor, the shaft, and the point of connection with shield or guards in good working condition whenever they are being operated.

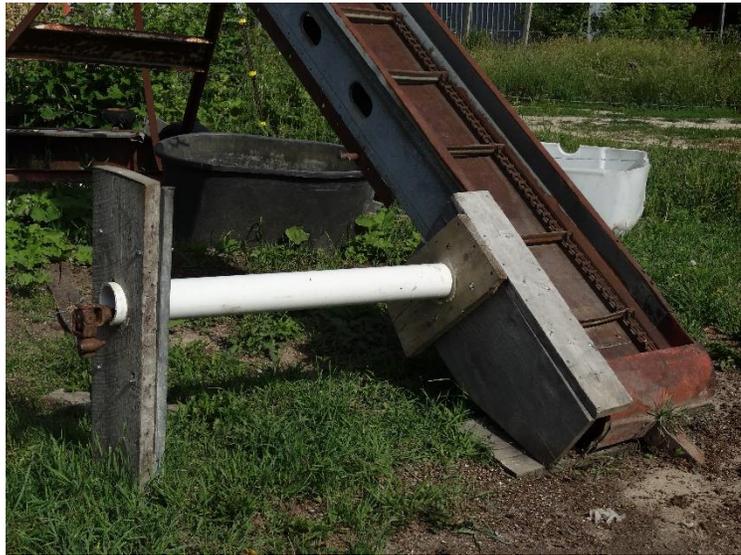
Figure 2: PTO shaft sheath

Following the incident, the owner had a custom sheath made of PVC pipe constructed and installed around the power take off shaft connected to the corn elevator (where the owner left it, only having connected and disconnected the shaft at the tractor end). The sheath was held in place and fixed at the height of the PTO connection via both a wooden post planted into the ground at the tractor end and an attachment to the corn elevator itself at the other end (Figure 2).

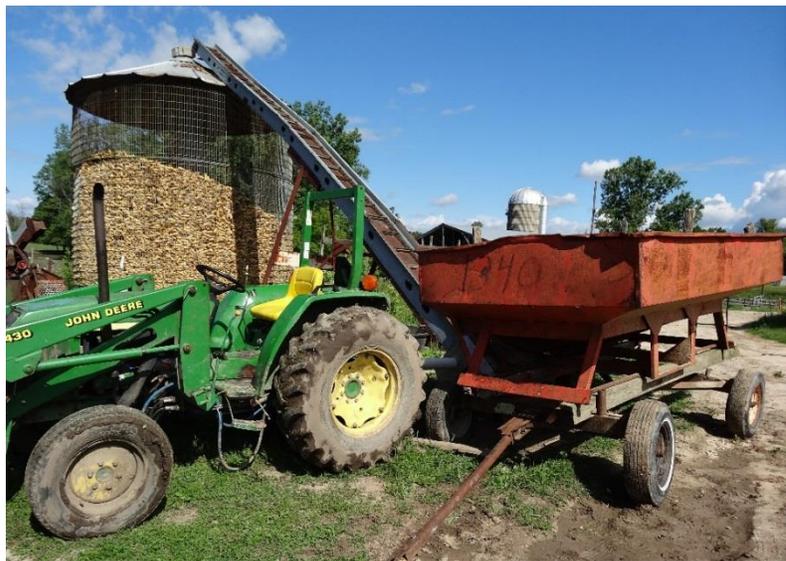
Figure 3: Recreation of incident scene and layout

north of the tractor, and the wagon's discharge door directly above the elevator to the west (Figure 3). To unload the corn, the farm owner and/or the decedent opened the wagon door, which was located on the side and center of the wagon. The wagon door was opened and closed through the rotating of a wheel via the pulling of a looped chain, which cranked the door open or closed along its tracks.

The PTO shaft, the elevator itself, and the tractor formed a small rectangular space with approximately 16 inches present between the shaft to the west and the wagon to the east. The PTO shaft, as well as the points of connection to both the tractor and the corn elevator, were unguarded. The owner stated that he was never in possession of guards for the shaft or the PTO stub on the tractor itself.

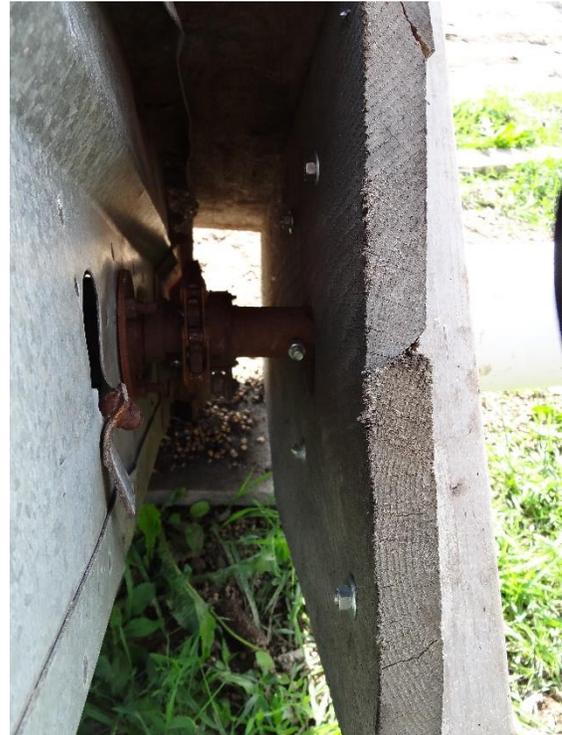
Figure 4: Unprotected PTO-elevator connection point with new PTO shaft shielding

Following this incident, the owner had an inexpensive shield designed for the PTO driveline shaft out of PVC piping (see Figure 1, above), propped up by (and bolted to, to prevent the shield itself from spinning) a wooden post on the end to be connected to the tractor PTO stub and an attachment to the corn elevator itself on the other end. Though this new shield provided protection from the PTO driveshaft, it still left the connection points to the tractor and elevator (Figure 4) mostly unguarded. Notably, since it appeared that the decedent's sleeves became caught at the point where the driveshaft connected to the elevator, making sure such connection points are fully shielded is important to preventing similar accidents from occurring in the future. MIFACE researchers mentioned to the farm owner that this connection point should also be shielded; he agreed and indicated he would do so. Additionally, the shaft on the base of the elevator on the south side was also not shielded. This was pointed out to the farm owner; he hadn't recognized the potential entanglement hazard and immediately indicated he would take care of the issue.
