**REPORT#: 17KY034**

**REPORT DATE: 6-29-2018**

## Dump Truck Driver Loses Control and Flips Truck Resulting in Fire

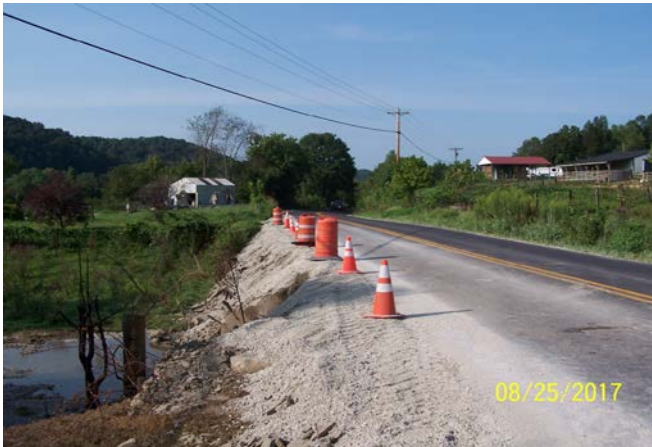
The incident took place on a rural two-lane state highway without guardrails. An eight-foot steep embankment dropped off from the right shoulder of the road. The Sheriff's department referred to this culvert as a cattle crossing, where rock and rebar protruded from concrete retaining walls. The state highway on which the truck travelled posted a 55 mph speed limit; however, prior to entering the curve, an advisory speed limit sign was posted, recommending 35 mph. Advisory speed placards are not regulatory signs; they are warning signs. The curve warning sign indicated that vehicles should slow down to navigate the curve safely.

Photo 1: Embankment at the crash site. Barrels and cones added post-incident.  
(photo property of KY FACE)

According to the Kentucky Transportation Cabinet Division of Highway Design, a trained engineer uses American Association of State Highway and Transportation Officials (AASHTO) roadside design guide to determine if a guardrail is needed. A slope steeper than a 3:1 warrants the consideration of guardrail.

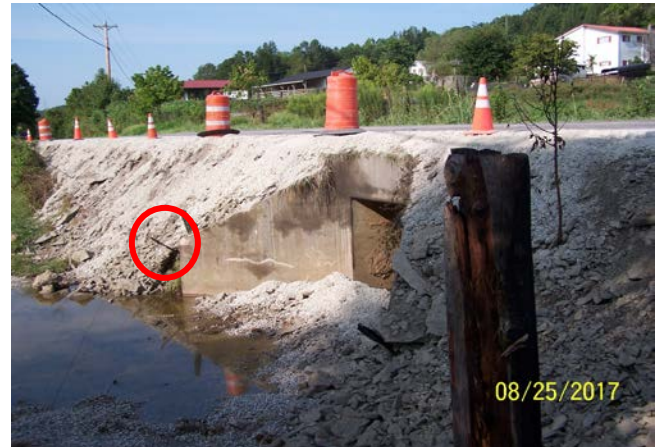
Photo 2: Rebar that the fuel tank struck. (photo property of KY FACE)

The truck left the roadway on the passenger side and flipped onto its right side into the culvert eight feet below the highway. As the truck flipped, the fuel tank struck a piece of rebar that was protruding from the concrete retaining wall leading to a water drainage tunnel under the highway. The fuel tank ruptured, causing a small fire in the engine that rapidly began to spread as fuel leaked from the tank.

Discussion: According to the Kentucky Transportation Cabinet’s (KYTC) website page concerning roadway maintenance, the roadway maintenance branch is responsible for several programs, including “Contract maintenance activities such as upgrading existing roadside guardrail, drainage structure maintenance and replacement, concrete pavement repair, slide repair, asphalt patching and other miscellaneous maintenance contracts as required”<sup>8</sup>. Generally speaking, culverts are hydraulic conduits used to convey water from one side of a highway entrance to the other for the purpose of drainage, making their repairs the responsibility of the KYTC. In this incident, a single piece of rebar measuring approximately 16 inches was protruding from what is referred to as a ‘box culvert’ - a rectangular four-sided concrete structure used in managing and storing storm water. According to the Kentucky Division of the Federal Highway Administration, in instances when small culverts run on a private landowner’s property, it is the responsibility of the landowner to inform the KYTC of structural deficiencies. The KYTC would then travel to the site and make repairs. An open records request filed by the KY FACE team revealed that no repair request for this particular culvert was submitted. In order to prevent similar incidents from occurring in the future, the KYTC should consider a campaign to educate landowners on how to file maintenance requests via the KYTC website when a road, bridge, or culvert that runs on the owner’s property is in obvious disrepair. Had the landowner informed the KYTC of the protruding rebar, it is possible the repair would have been made prior to the incident and subsequent fire.

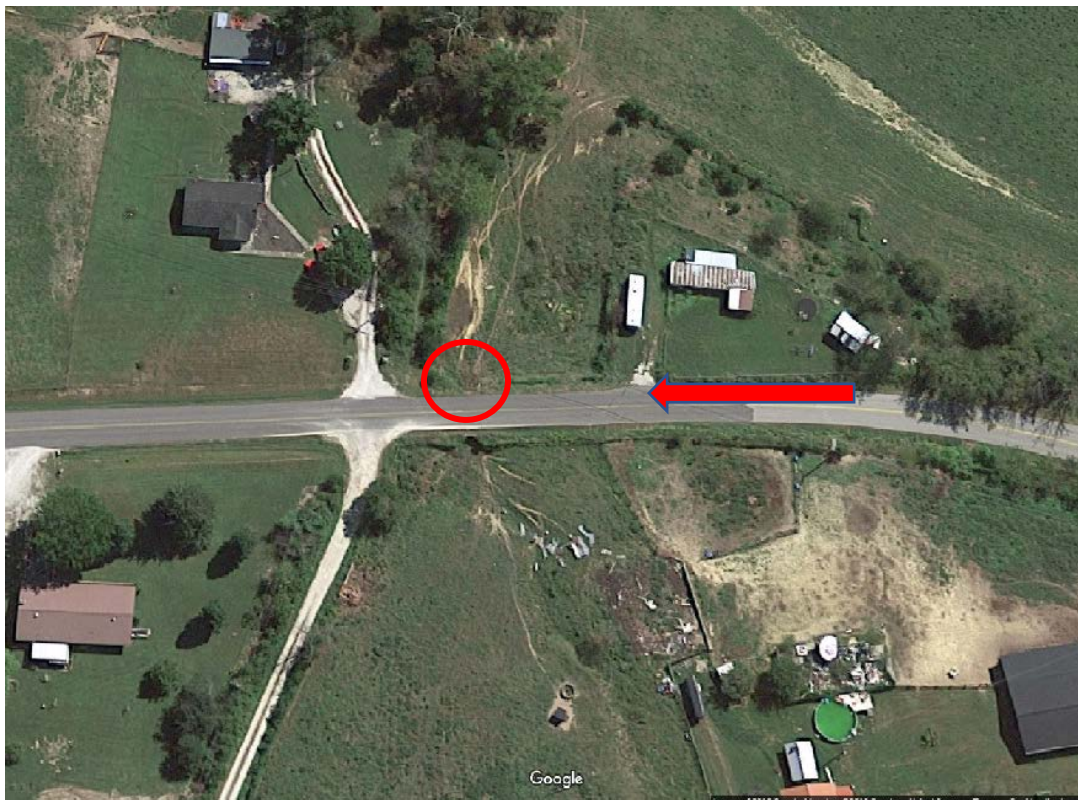
Photo 3: Aerial view of crash site. Circled area shows final resting spot of the overturned truck. (photo courtesy of Google Maps)  
Arrow shows direction of travel

Tire marks suggested the truck gradually drifted to the right, went off the road and into a small ditch area. The driver attempted to drive out of the ditch 224.10 feet from the final resting spot of the truck. The deputy sheriff stated the truck driver was traveling over the recommended speed limit of 35 mph. While the speed limit along the state road was posted at 55 mph, the curve was posted at 35 mph with an advisory speed sign prior to the curve. As the victim entered the curve, neighbors who lived in the vicinity stated they heard the driver trying to apply the truck's compression release engine brake – commonly referred to as a Jake brake - in an attempt to slow the truck. The deputy stated the Jake brake failed to slow the truck to a safe speed, causing the loaded truck's center of gravity to shift toward the passenger side, and the driver to lose control of the vehicle.

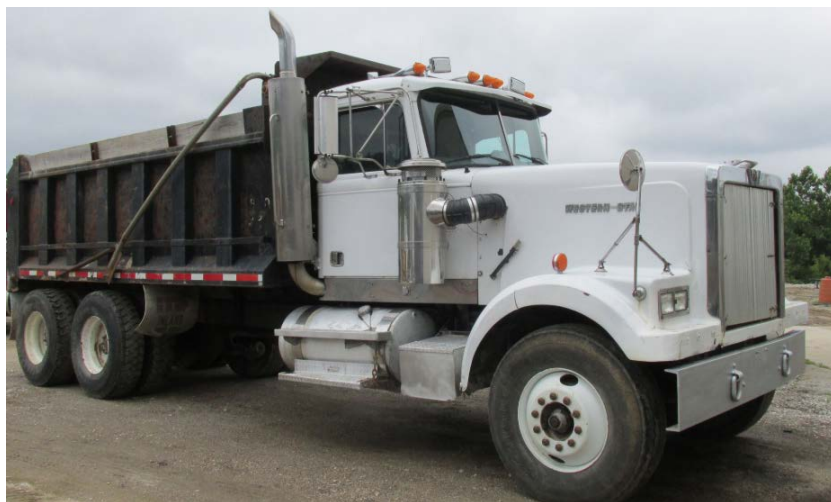
Photo 4: 1987 Western Star 4900 series dump truck (Stock photo)

Discussion: Large truck manufacturers should consider an engineering redesign and new placement of fuel tanks within all trucks. With the high number of truck crashes that result in fire, this redesign could save lives as well as equipment. According to the Bunn et al. (2012), large truck vehicle fire rates in Kentucky were significantly increased when compared to light trucks and passenger cars.<sup>6</sup> The study recommended the fuel tanks would be better protected within the truck body and not exposed.

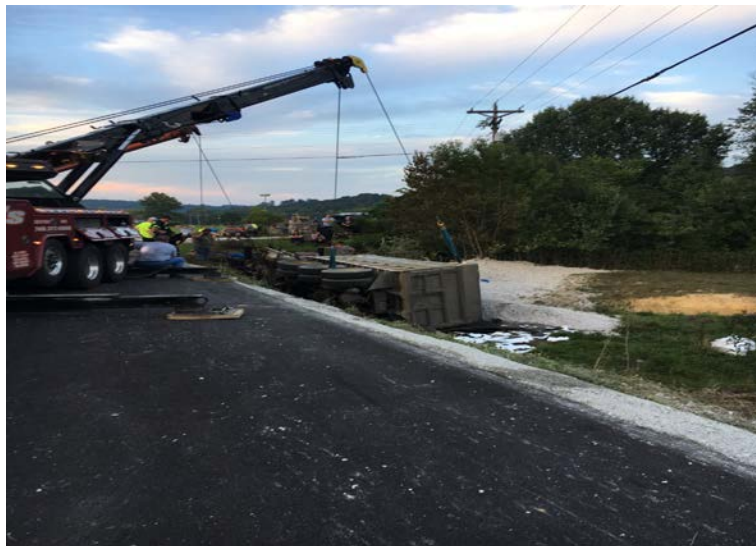
Two neighbors, a husband and wife who heard the crash and saw the smoke from their residence, ran to assist the driver. When they arrived and noticed the fire, the husband desperately tried to pull the unconscious driver out of the burning truck through the front windshield that had become dislodged, while his wife called for emergency assistance and the fire department. The couple stated the driver was thrown and trapped along the passenger side of the truck where the flames were hottest, making it impossible to pull his unconscious body from the burning truck.

Photo 5: Crashed dump truck. (Photo courtesy of witness)

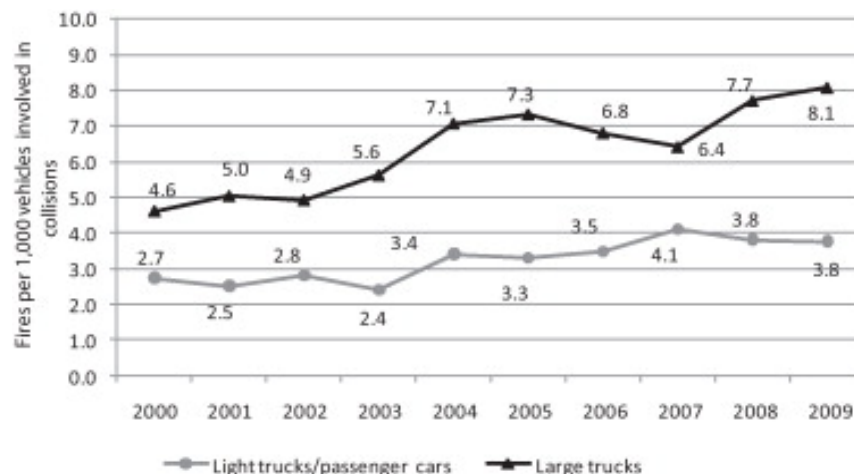
Fig. 1. Vehicle fire rates due to motor vehicle collisions, 2000–2009.

The article states, *“There could be many reasons for large trucks being more likely to catch fire in a motor vehicle collision. The average large truck weight (typically up to 80,000 pounds) can result in a greater impact force in collisions with a fixed object. There are fuel tank placement differences between large trucks, and light trucks, and passenger cars, which could account for fire likelihood differences between vehicle types in head-on and single vehicle collisions. Increased exposure occurs in large trucks because the two fuel tanks on the semi-tractor are exposed under the cab and are located directly behind the front axle.”*
