# MIFACE INVESTIGATION REPORT #17MI007

## SUBJECT: Truck Driver Died After Being Thrown Back by Air Release from a Pressurized Tire Sidewall Failure

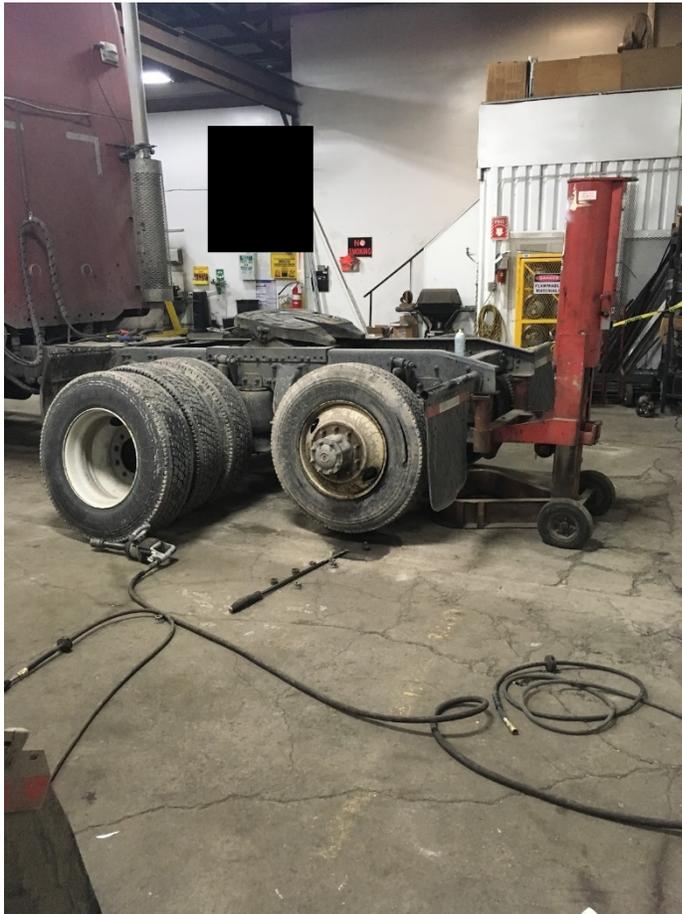
Figure 1: Incident scene

The decedent was starting his shift in the evening, having finished approximately 12 hours previously. The driver brought his Freightliner truck in to the maintenance department because of a flat tire on the inside wheel of the third axel on the driver's side. The decedent's truck was the only one present in the maintenance area that evening. The tire was a General Tire Model ST250, and had previously been retreaded. The driver accompanied the truck in the maintenance area (Figure 1), and was assisting two mechanics by setting and releasing the air brake as needed.

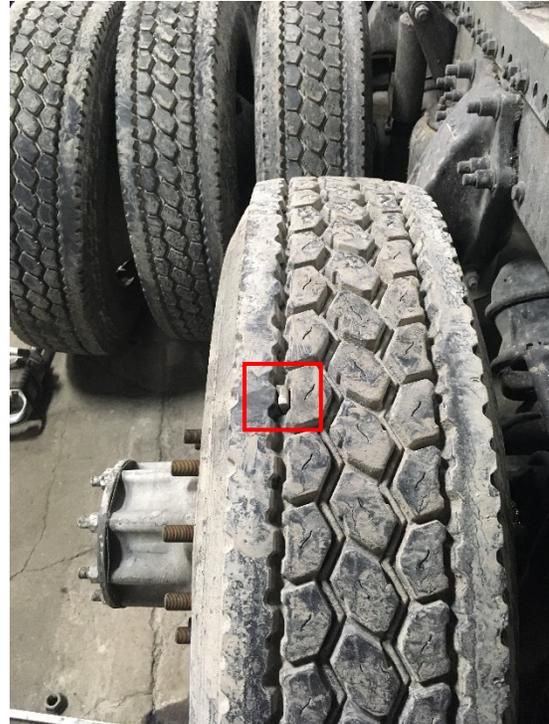
The mechanics initially tried inflating the tire with an air chuck and, when this failed, jacked up the truck to relieve pressure on the tire and attempted to inflate it again. After a further lack of success, the mechanics removed the outer tire, and used a TSI Cheetah bead seating tool to get the tire to take its bead. Following further attempts to inflate the now-seated tire using a clip-on air chuck, it was noticed that the tire had a leak. While one of the mechanics left to retrieve a tire plug kit, the decedent released the air brake and approached the tire to inspect it. He noticed a small piece of metal sticking out of the tread of the tire (Figure 2), and pointed this out to the remaining mechanic. According to the interview, the mechanic began letting air out of the tire in order to remove the piece of metal.

*Figure 2: Metal debris stuck in tire*

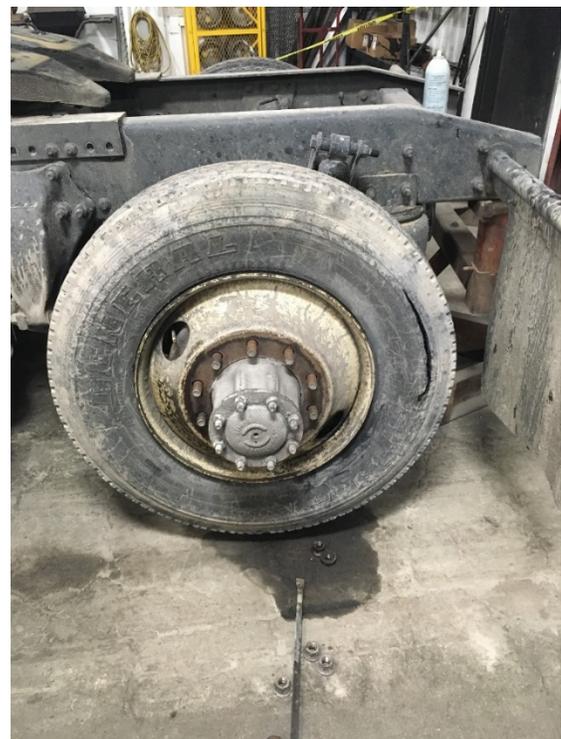
The mechanic warned the decedent about standing directly in front of the tire. At this time, the sidewall of the tire ruptured (Figure 3). The decedent was standing directly in front of the tire sidewall, approximately three feet away according to the MIOSHA investigation. The tire model

had an inflation pressure of 105 pounds per square inch; however, as the tire was flat and in the process of being repaired, it is unknown what the pressure of the tire was at the time of rupture. The driver was knocked back by the force of the pressurized air release, striking his head on the concrete floor, according to the mechanic present at the time. The decedent landed on his back with his head approximately 12 feet away from the tire.

*Figure 3: Ruptured tire sidewall*

During their training for pre- and post-trip inspections, drivers should be instructed on how to look for signs of wear or damage on their tires, such as extensive or uneven tread wear or cracks or breaks in the rubber of the tire, including in the sidewall. Care should be taken to inspect inside dual tires, such as the one involved in this incident, as signs of damage might more easily be missed on inside tires due to their location. If a tire has been found to be underinflated (or, as in this instance, flat), the integrity of the sidewall should be carefully inspected, as this is a known contributor to the weakening of tire sidewalls.

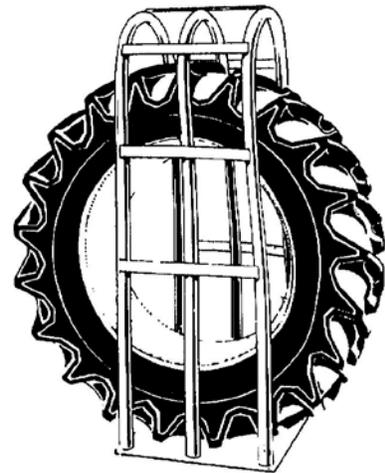
Figure 4: Illustration of a tire cage (source: <https://www.osha.gov/Publications/OSHA3086/osh3086.html>)

- Use best safety practices, such as a tire cage, when performing tire maintenance, and provide training on the procedures.

Maintenance personnel, alongside any other employees or drivers authorized to be present during truck maintenance, should be trained in in best safety practices regarding tire maintenance and repair, including methods to prevent, or minimize the effects of, a tire explosion. The inflation of a tire should be performed while the tire is restrained within a device such as a tire safety cage. Cages absorb some of the impact of a tire explosion, and shield employees from components of the tire or rim that may be projected during the explosion. During this incident, the tire was being inflated and worked on while it was still mounted on the truck. The use of a cage or other restraint might have weakened the effect of the explosion and better communicated the hazards present to unaware employees, including the decedent.
