**REPORT#: 17MI045**

**REPORT DATE: 10/22/19**

Water Treatment Plant

## Plasterer/Drywall Installer Dies From 30-Foot Fall Through Skylight

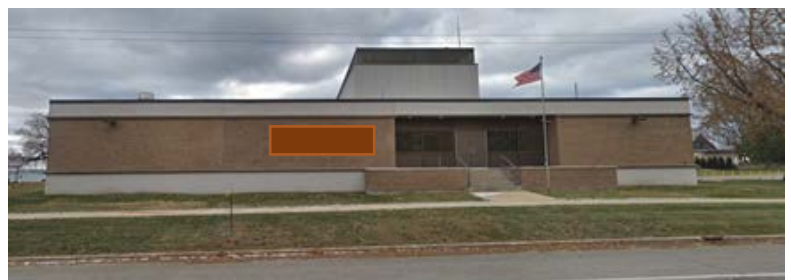
Photo 1. Front of water treatment plant undergoing renovation.

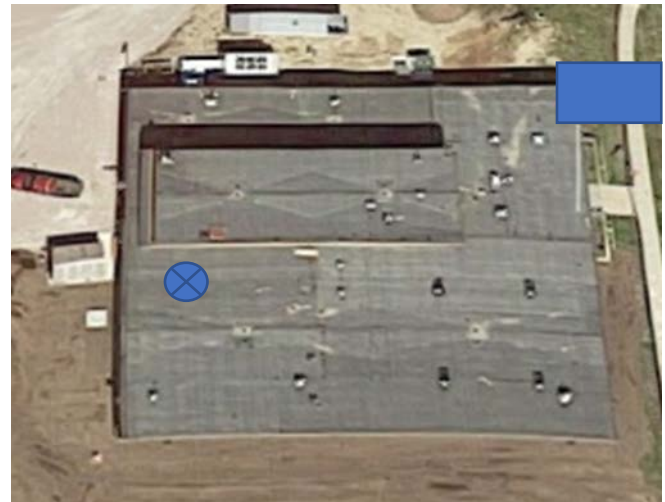
The penthouse was on the northern half of the one-story building, toward the western side (See Photos 1 and 2). At the time of the incident, there were no elevated warning lines or ropes along or near the edge of the roof. The distance from roof to the concrete floor below was 30 feet 8 inches.

Photo 2. Water treatment plant building roof. Blue circle with X was approximate location of incident skylight. Picture courtesy of Google maps.

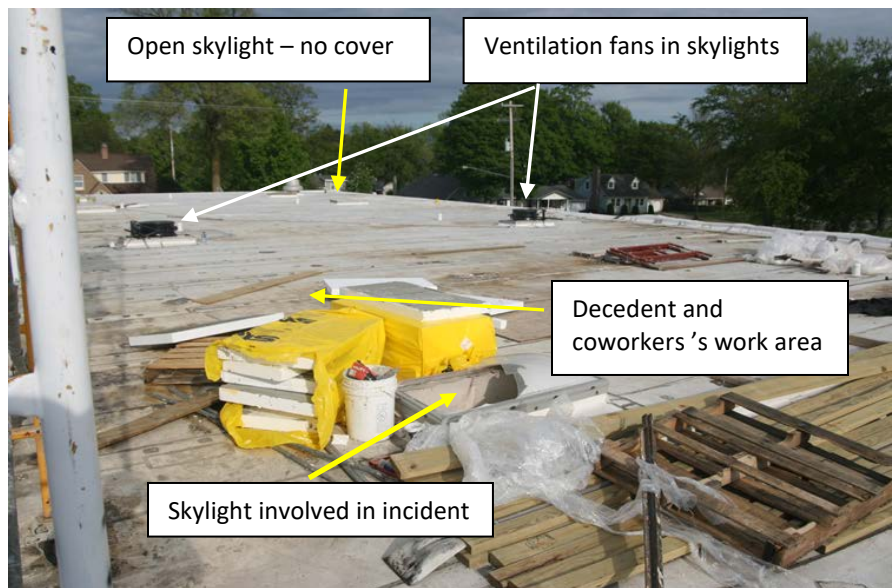
Several skylights had previously had their covers removed and no barricade or cover had been placed around/over them. Two of the opened skylights had ventilation fans placed in them, providing air movement to the first-floor work sites (Photo 3). The decedent's employer did not know which firm removed the skylight covers.

The skylight involved in the incident was within 11 feet from the southern penthouse wall. Next to the southern wall was a scaffold that was erected by either Firm 1 or Firm 2. The distance from the roof edge is unknown. The lumber seen in Photo 3 belonged to another contractor.

Photo 3. Incident area showing skylight involved in incident, open skylights with ventilation fans, and open skylight with no cover

After the incident, Firm 2 installed ¾-inch plywood over the 10 skylights and spray-painted "hole" on each piece of plywood. Firm 2 also placed warning lines at the roof edge.

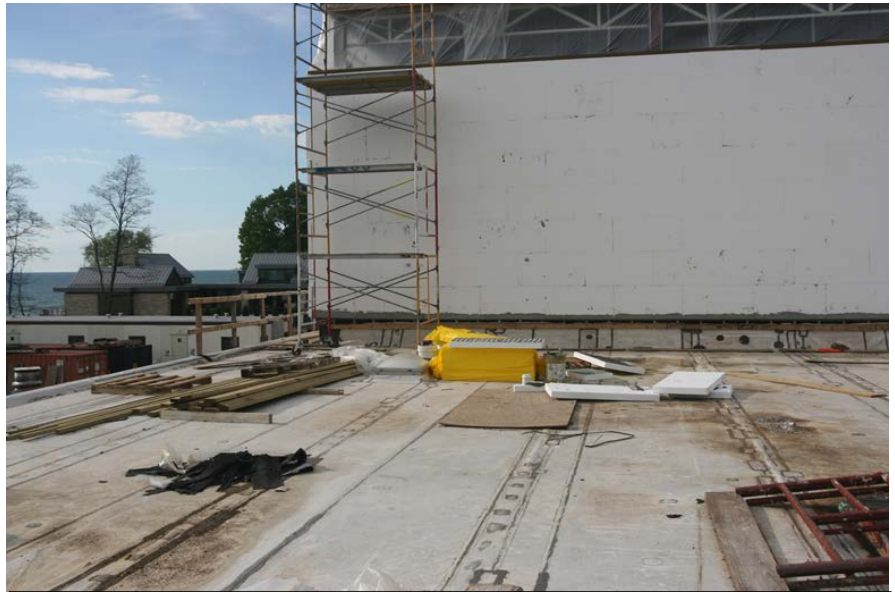
Photo 4. Incident area, looking north

to 10-feet from his mudding position to the boom truck. The decedent's path placed him between the skylight and the south side of the penthouse which had the scaffold positioned next to it (Photos 4 and 5).

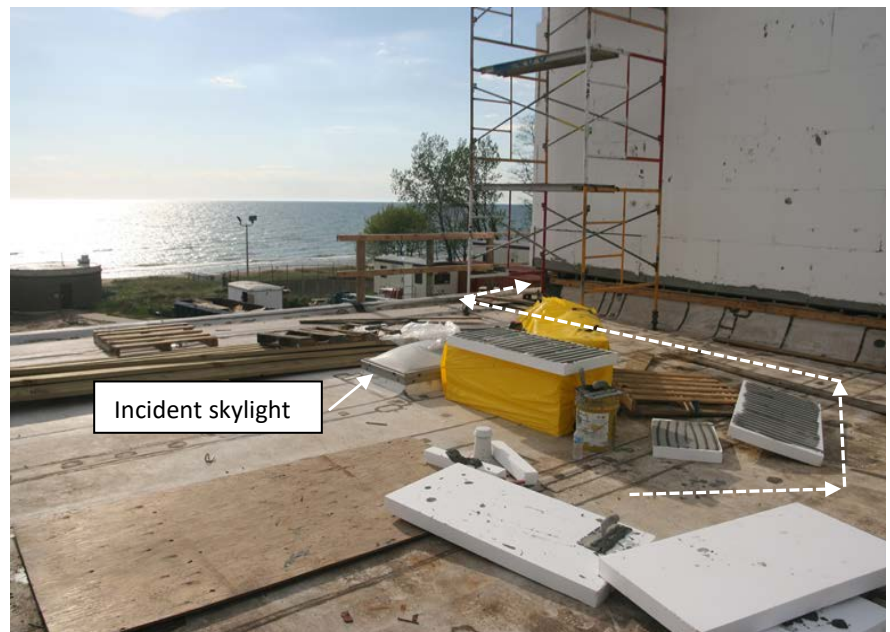
Photo 5. Incident area. Dotted lines show most likely path of decedent when he carried the prepared foam board to the owner working in the boom lift

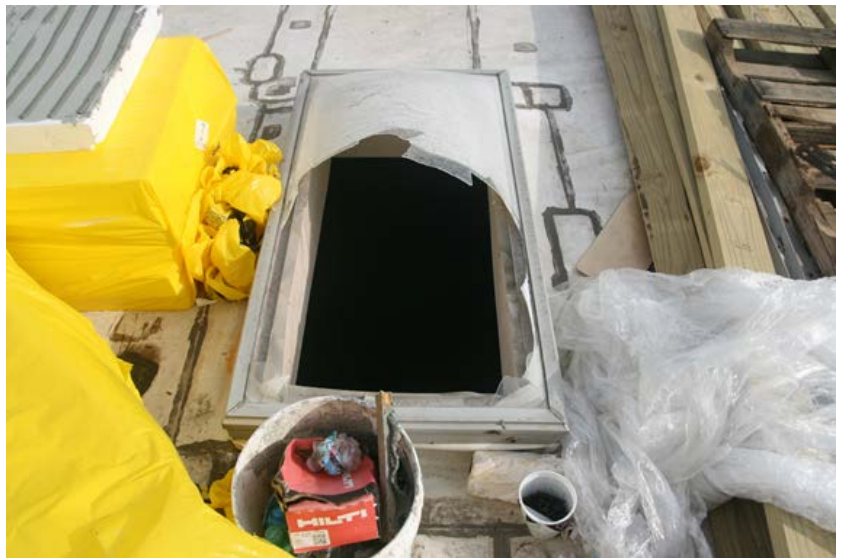
*Photo 6. Skylight involved in incident*

Plastic dome-type skylight cover was not capable of supporting twice the weight of employees who were working on the roof of the City water treatment plant. (*MIFACE removed the name of the city*)

Plastic dome-type skylight cover was not identified or marked for employees who were working on the roof of the City water treatment plant. (*MIFACE removed the name of the city*)

***Recommendation #1: Employers working on roofs should develop, implement, and enforce a comprehensive, written health and safety program that includes safety requirements when working near/around roof openings and skylights. This should include fall protection measures such as skylight screens or covers, guardrails, or a personal fall protection system.***

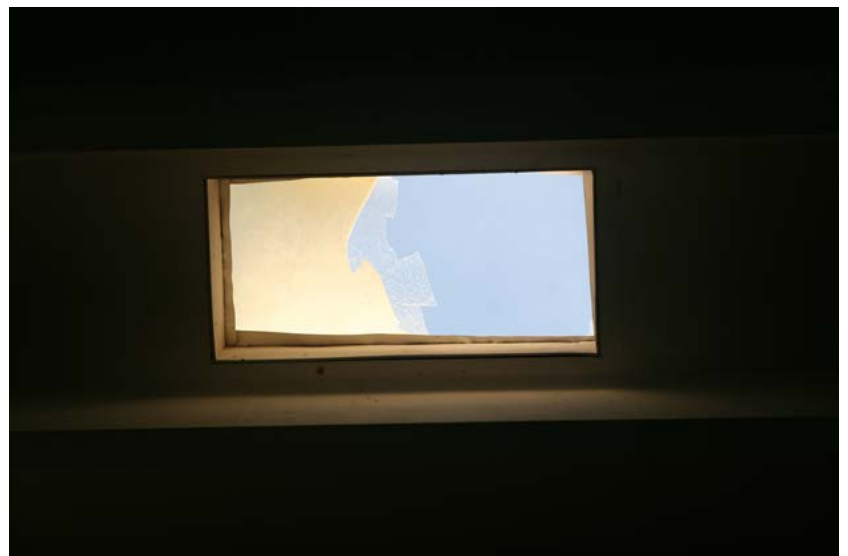
*Photo 7. Incident skylight. Photo taken while standing on floor 30 feet below skylight.*
